RECOVERY AND STATUS REPORT OF DTL/SDTL FOR THE J-PARC AFTER EARTHQUAKE

T. Ito[#], K. Hirano, Japan Atomic Energy Agency, Tokai, Japan
 K. Nanmo, F. Naito KEK, Tsukuba, Japan

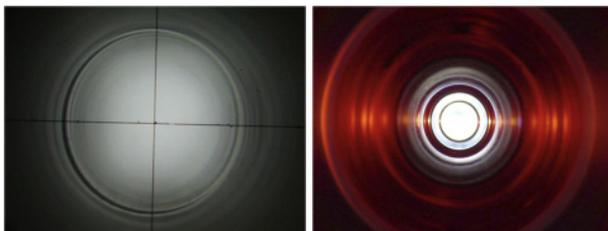
Figure 1: Pictures of the DT bore. Left:DTL, Right:SDTL

For the DTL bore picture (left picture), the black circular arc of the left side is broader than right side. This means that the DT bore center or DT position is decidedly sifted in a horizontal direction. On the other hand, the circles in the SDTL picture (right picture) were nearly

arranged in a concentric pattern. Therefore we judged that there was no clear displacement of the alignment of the DT position for the SDTL.

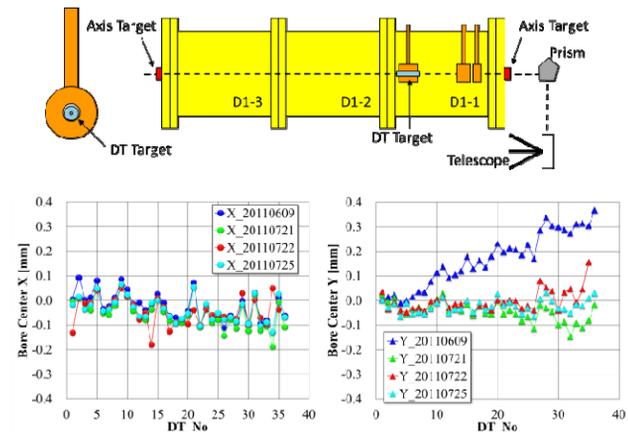
Figure 2: Schematic view of the measurement system and the measured center position of the DT bore.

The graph shows the measured displacement of the DT bore center for the unit tank D1-1. The abscissa is DT number and the ordinate is the displacement of the bore center from the telescope axis.

There is about 0.2mm misalignment of bore center for X direction. The displacement for Y direction is less than X displacement except for the large DT number with large reading error. The reason is that the DT is swung like pendulum by horizontal vibration of earthquake because the DT is fixed at the top of the cavity.

There is a line with large tilt for Y measurement. This means that the unit tank D1-1 is inclined with respect to the telescope axis. This tilt line was measured before re-alignment of the DTL unit tank. Namely, the accelerator tunnel was deformed by the earthquake and the DTL was deformed along a floor of the tunnel. After re-alignment of the unit tank, the deformation of the DTL for Y direction is resolved (i.e. other three lines).

Each DT in the DTL contains an electric quadrupole magnet (DTQ). Therefore the misalignment of the DT should be corrected in order to accelerate the beam with good quality. However it is necessary for the realignment of the DT to remove all electric cable for the DTQ and to separate the long DTL into the short unit tanks. It is really hard work to re-align the DTs. Since the beam simulation with the observed misalignment of DTs shows that the effect of the misalignment of DT is allowable level for the beam loss, we decided not to re-align the displaced DTs. [4] [5].

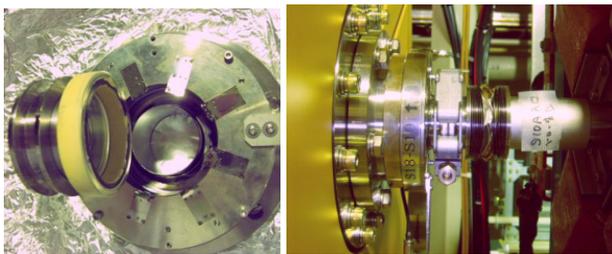
Monitors installed between the cavities had big damage. Many Beam Position Monitors (BPM), Current Monitors (CT) and bellows jointed to these monitors were broken. Therefore, the vacuum cannot be kept and the inner surface of the DTL and the SDTL were exposed to the air. Figure 3 shows the broken current monitor and bellows. The CT was broken at the brazing point between the ceramic cylinder and the metal pipe.

Figure 3: Broken CT (left) and bellows (right)

As it was impossible to repair the damaged monitors and the bellows, new equipment was made immediately.

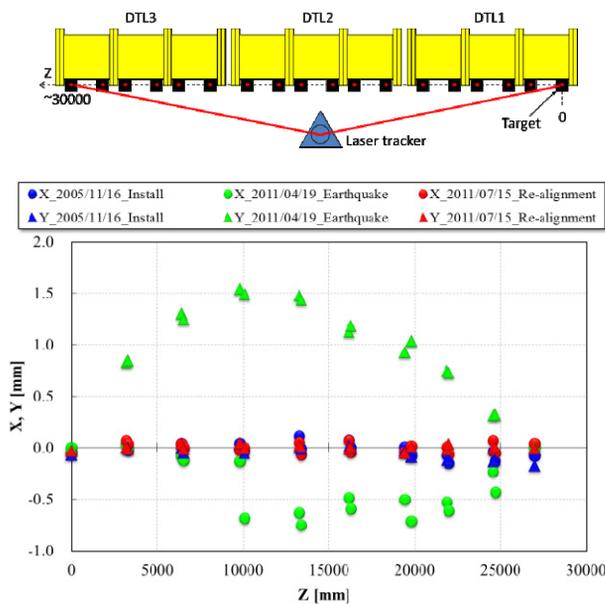
After the earthquake, the unit tank had large displacement for both directions X and Y. As the result of the re-alignment of the unit tank, the position was nearly equal to the position the after the installation measured in 2005.

Figure 4: Displacement of the unit tank position.

For DTL section, we determined the beam axis as the adjustment length of the unit tank was the minimum (~ a few mm). The unit tank was also aligned with docking condition and without removing the feeder cable to reduce the recovery work time.

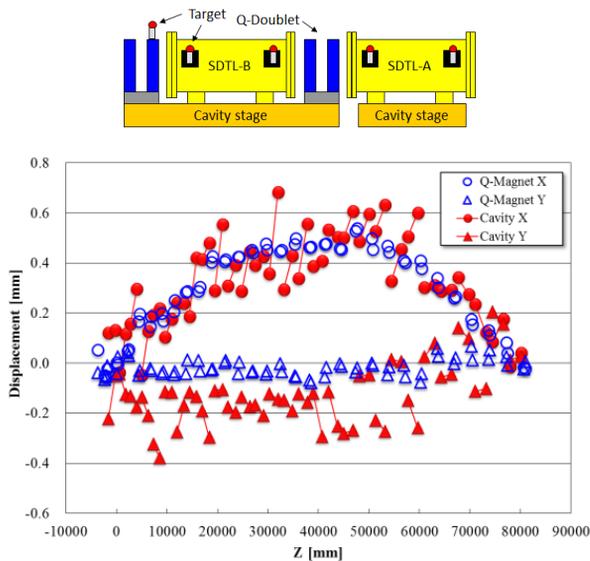
Figure 5: Displacement of the SDTL and the magnet.

Every focusing magnet has a target, and Each SDTL cavity has two targets as with the unit tank of the DTL. A cavity-A (S01A - A15A) is aligned individually. A cavity-B (S01B - S15B) and two doublets (four magnets) are aligned together on the cavity stage. The SDTL and the magnet are aligned smoothly within about 0.6mm from the new beam axis. The measured displacement of the X direction is larger than Y. This reason is an alignment error by the measurement limit of the laser tracker. The

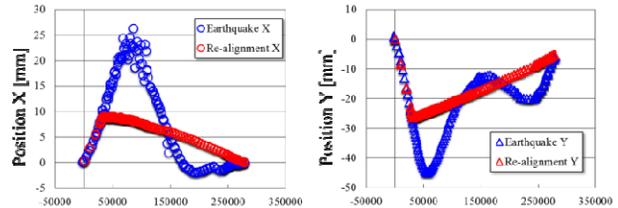
After the vacuum pumps, the beam monitors and so on were attached, the final alignment of the cavity and the magnet was done. Figure 6 shows the result of the final alignment. It may be seen from figure 6 that the DTL and the SDTL is aligned to the different beam axis.

Figure 6: Result of the final alignment.
