OPTICAL INSPECTION OF SRF CAVITIES AT DESY

S. Aderhold#, Deutsches Elektronen-Synchrotron DESY, 22603 Hamburg, Germany

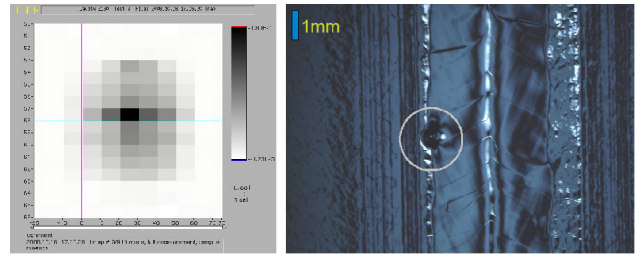
Figure 1: Z130: Hotspot found by T-map during RF-test (left) and defect in optical inspection picture of respective area on inner surface.

In the first vertical RF-test, Z130 was limited by quench at 17.3 MV/m and was therefore cut out of the He-vessel for further investigation. The second test after an additional HPR was carried out with T-map in all nine modes. The π -mode was limited at 16.6 MV/m with quench. The heating spot for the 3/9- and 1/9- π -mode was found on the equator of cell 5 (see left part of figure 1).

Optical inspection was carried out after the second vertical RF-test. A circular pit of about 700 μm was detected at the heating location in cell 5 (right part of figure 1) on the edge of the welding seam.

This defect has been subject to detailed analysis by now. Samples have been cut from Z130 for surface analysis, one of them the above described defect [2]. The profile of the pit shows a difference in height between the highest and the lowest point of more than 150 μm . No foreign material inclusion was detected by EDX measurement.

The analysis of the sample with the defect cut from Z130 indicates that the cause for the quench lies in the geometrical nature of the defect.

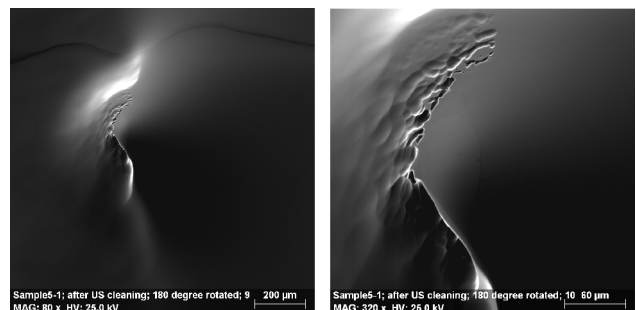
Cutting the sample with the defect from the cavity also allowed taking SEM-pictures with high magnification, as shown in figure 2. At the edge of the defect with its rather large diameter of 700 μm small, sharp structures of the order of less than 10 μm are visible.

Figure 2: SEM-pictures of the defect in Z130: 80x magnification (left) and 320x magnification (right)

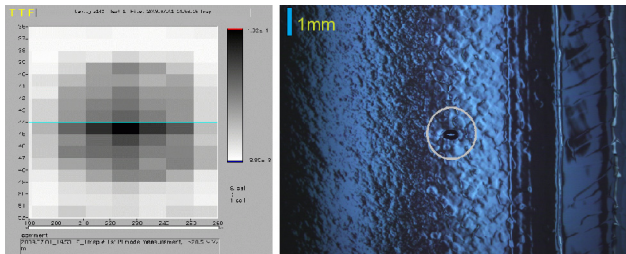
A second, good example for the match between T-map measurement and optical inspection is the cavity Z142. The temperature map recorded during the quench in the π -mode during the first vertical RF-test is depicted in the left part of figure 3.

Figure 3: Quench location found by T-map (left) and optical inspection picture of respective area (right) in Z142

In the π -mode Z142 quenched at 20.6 MV/m without measured field emission and heating was observed near the equator of cell 6. Optical inspection of the respective area after the test revealed a defect in the heat affected zone next to the equator welding seam (right part of figure 3). The defect is a pit of elliptical shape with a semi-minor axis of about 300 μm and a semi-major axis of about 500 μm .

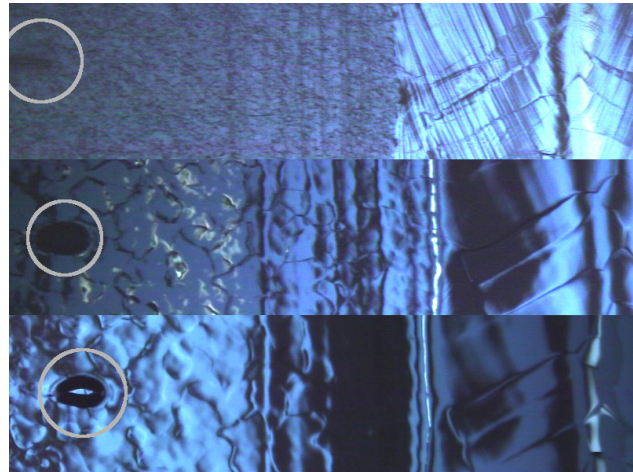
The series of pictures in figure 4 depicts the evolution of the defect in Z142 that was already described in the previous section.

Figure 4: Defect evolution in Z242: Before surface removal (upper part), after main-EP (middle), after final EP and RF-test (lower part)

The upper part of figure 4 shows the surface of Z142 before surface removal directly after the manufacturing. Some millimeters to left of the equator welding seam, one can see a darker spot at the location where the defect is visible later. The middle picture of figure 4 was taken after the bulk surface removal of 108 μm by electro-polishing. Instead of the darker spot an elliptical pit with a semi-minor axis of about 300 μm and a semi-major axis of about 500 μm is clearly visible. The lower picture is the same as in the right part of figure 3, taken after the final EP of 48 μm and the RF-test. The pit has not changed significantly in shape or dimensions with respect to the step before final EP.

In Z142 a defect could be traced through all surface preparation steps from the state “as received” until the RF-test with T-map and confirmation of the defect to be the hotspot.
