HOW TO FIX A THOMSON TH2075 KLYSTRON WITH VACUUM PROBLEMS WITHOUT SPENDING A LOT OF MONEY

M.N. Martins, A.L. Bonini, R.R. Lima, A.A. Malafronte, L. Portante, J. Takahashi, Laboratório do Acelerador Linear, Instituto de Física da Universidade de São Paulo, PO Box 66318, 05315-970 São Paulo, SP, Brazil

This paper documents the repair of a Thomson TH2075 klystron, which was presenting vacuum problems. We detected the leak that was causing the problems, fixed it, and developed a procedure that allowed the introduction of an auxiliary pumping system, without the need to expose the tube to atmospheric pressure. All the work was done at the Laboratório do Acelerador Linear of the University of São Paulo.

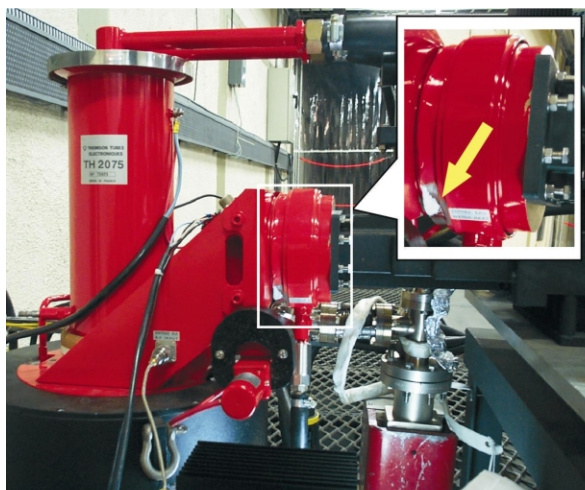
Figure 1: Photograph of the TH2075 klystron, with an enlargement showing the RF output. The leak was detected on the welding between the RF output and the RF output window flange, and fixed with vacuum cement, as shown by the arrow.

We also found out the origin of the vacuum problem. There was a leak on the welding between the RF output and the RF output window flange. The leak was caused by a crack in the welding, which was covered by the painting of the tube. It is important to state that the whole welding is irregular. Figure 1 shows a photograph of the tube, showing in an inlet, the place where the leak was found and fixed with vacuum cement.

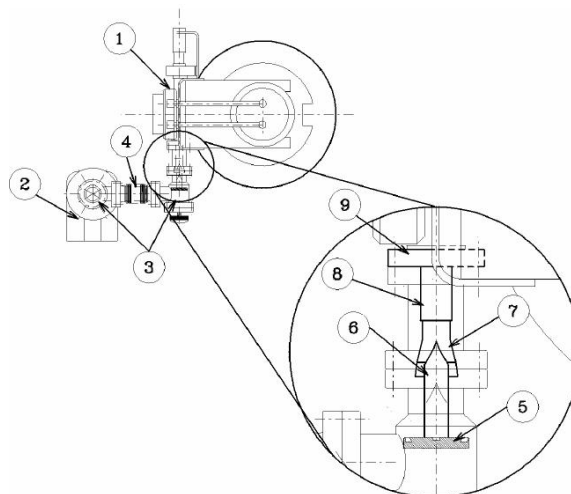
Figure 2: top view of the klystron and the auxiliary pumping system. The inlet shows a detail of the apparatus used to break the vacuum of the tube. 1 – TH2075 Klystron; 2 – Ion pump (30 l/s); 3 – Right-angle valves; 4 – Bellows; 5 – Bonnet; 6 – Stainless steel spike; 7 – Pinch off port; 8 – Support tube; 9 – Special CF40 flange.

The auxiliary pumping system consists of an ion pump (30 l/s), two right-angle manual valves, and connections that allow external pumping to the system, as shown in Figs. 2 and 3.

The first right-angle valve, closer to the pump, is used to open the system to the outside, in order to pre-evacuate the system plus pump and get the ion pump started. The second valve has two functions: the first one was to break

the pinch off port of the tube (see the installation procedure below). The second one is to isolate the tube from the auxiliary system, allowing for maintenance procedures.

was connected to the klystron (1) through the pinch off port (7) of the tube. A special CF40 flange (9) was machined with an internal diameter matching the external diameter of the tube (8) that supports the pinch off port. This flange was then welded to the support tube. A 5-cm diameter tube, with CF40 flanges at both ends was connected to the welded flange, so that the pinch off tube was inside and coaxial to the new stainless steel tube. This tube was coupled to a leak detector, to check for possible leaks at the welding between the flange and the support tube.

A right-angle valve (3) was coupled to the flange of the external tube. Welding a stainless steel spike (6) to the bonnet modified this valve, so that, when the valve was closed, the spike protruded out of the valve towards the pinch off port. The other end of this valve was connected, through a bellows and another right-angle valve, to the ion pump.

After all the parts were fastened together, the whole system was checked for leaks. After that we pumped the system down to 10^{-6} torr with a turbo-plus-mechanical pumping system, closed the right-angle valve that opened the system to the outside, and started the ion pump. After baking, the system reached a final pressure of 2×10^{-9} torr. We were then ready to break the pinch off port seal. This was done by closing the right-angle valve (closer to the tube), so that the bonnet pushed the stainless steel spike through the pinch off port seal, tearing it. The valve was then open again, connecting the body of the tube to the auxiliary pumping system.

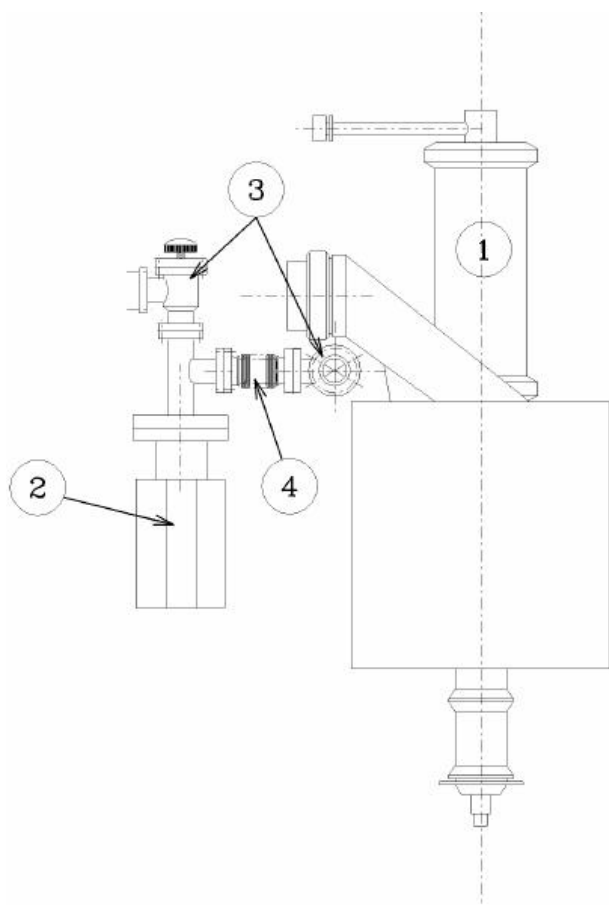
Figure 3: side view of the tube with the auxiliary pumping system. 1 – TH2075 Klystron; 2 – Ion pump (30 l/s); 3 – Right-angle valves; 4 – Bellows.
