RADIATION DAMAGE OF MAGNET COILS DUE TO SYNCHROTRON RADIATION

K. Tsumaki, S. Matsui, M. Ohishi, T. Yorita, JASRI/SPring-8, Hyogo, Japan
 T. Shibata, T. Tateishi, KOBELCO RESEARCH INSTITUTE, INC., Hyogo, Japan

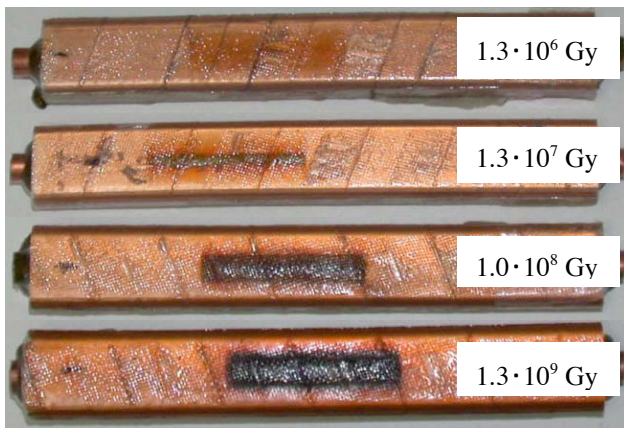
The test pieces after irradiation are shown in Fig. 3. The irradiated part of the test piece was slightly colored in the case of 10^6 Gy irradiation. When the irradiation increased to 10^7 Gy, the center of the irradiated part became white. It became black when the irradiation was greater than 10^8 Gy. The temperature rise in the test pieces during the irradiation was 2°C , so the effect of temperature was negligible. Photographs magnified by a microscope are shown in Fig. 4. We can see the glass cloth vaguely under the milky-white epoxy resin in the non-irradiated test piece. The glass cloth could be seen more clearly under the epoxy resin when the irradiation was 10^7 Gy. With more irradiation, the epoxy resin was carbonized and became black. The irradiated part expanded in volume.

Figure 3: Test pieces after irradiation.

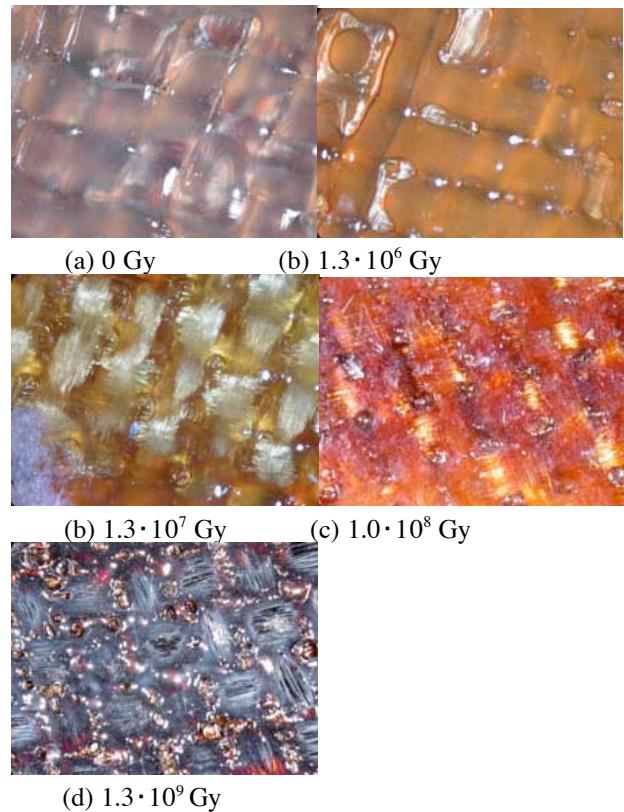
Figure 4: Test piece photographs magnified by a microscope.

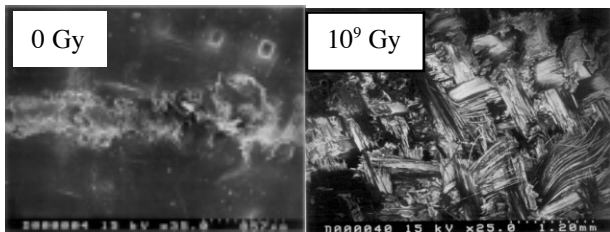
Test results showed almost no difference between the non-irradiated and the 10^7 Gy irradiated test pieces. Above irradiation of 10^8 Gy, the scratch width became wider and the area of damage spread as the radiation dose increased. Photographs of the non-irradiated and irradiated test pieces are shown in Fig. 6. Although the glass cloth of the non-irradiated test piece was not damaged, that of the 10^9 Gy irradiated piece was seriously damaged. That is, the glass prepreg was weakened as the radiation dose increased.

Figure 6: Scratch test results for non-irradiated and irradiated test pieces.

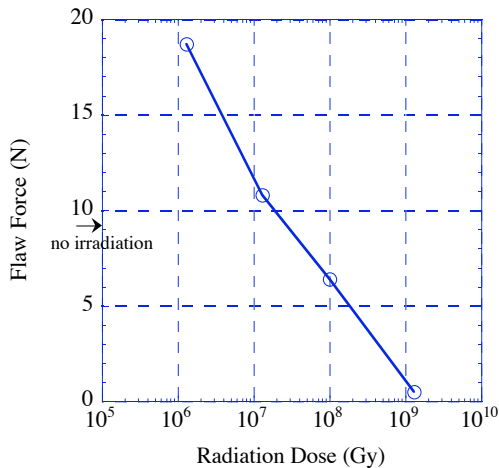
Figure 7: Relation between radiation dose and the flaw force.

When the force was applied, we saw that flaws appeared in the test pieces at certain levels of applied force. We refer to this force as the flaw force. The relation between the radiation dose and the flaw force is shown in Fig. 7. With 10^6 Gy irradiation, the glass prepreg hardened and the flaw force became higher than that for no irradiation. However, the flaw force decreased with increasing irradiation and reached 3 % of the flaw force for 10^6 Gy irradiation at 10^9 Gy. This shows the epoxy resin becomes increasingly fragile with greater radiation exposure.

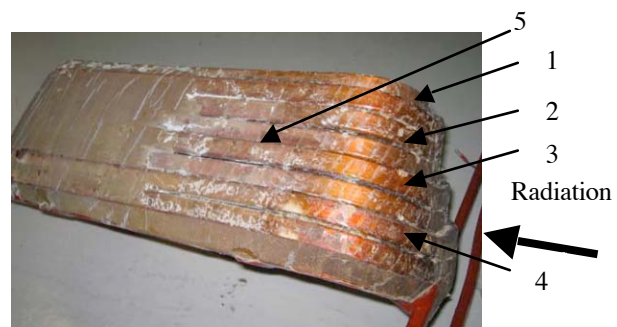
An external view of the removed magnet coil is shown in Fig. 8. The side of the coil was milky-white in color, but the color of the part that had faced the absorber had

changed to brown. We applied the scratch test to five test pieces taken from the coil. (The test pieces were numbered as shown in Fig. 8.) The five flaws arising from the scratch test were similar in appearance to each other and to that of the acceleration test piece exposed to 10^6 Gy irradiation. The measured flaw forces for pieces one to five were 8.5, 13.1, 5.1, 7.5, and 7.1 N, respectively. These values correspond to irradiation of 10^6 to 10^8 Gy (Fig. 7). The resistivity was more than $1 \text{ G}\Omega$. From the above results, we can see that the coil was still able to perform properly. The degree of damage suggested by the external view and scratch test results corresponded to the damage caused by irradiation of 10^6 to 10^7 Gy in the acceleration test. This agrees roughly with the estimated radiation dose of this magnet and shows the validity of the acceleration test results.

Figure 8: External view of the removed magnet coil.
