DEVELOPMENT OF BEAM ABNORMAL STATE MONITORING PROCESSOR ON SSRF STORAGE RING

Authors: <u>Longwei Lai*,</u> Yongbin Leng, Yingbing Yan, SSRF, Shanghai, P.R. China

Abstract

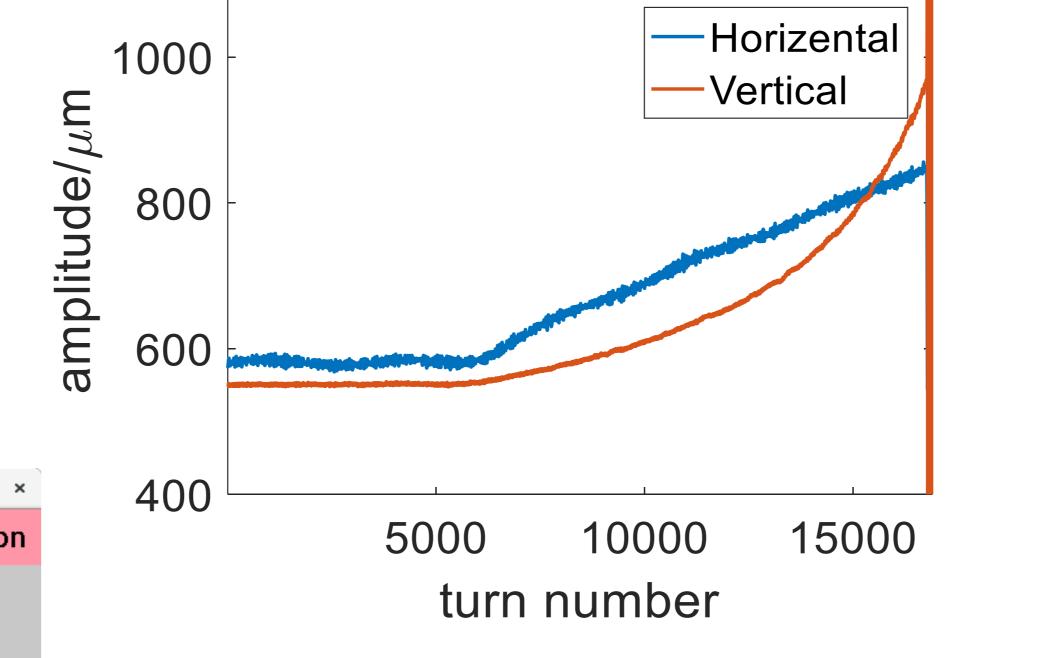
800	2020.04.16 23:23 Temp. alarm interlock						
000		I					
			Horizental

The orbit seems quite normal before the beam lost. Operation log recorded a temperature alarm interlock at that time. It is likely that the temperature interlock system has failed.

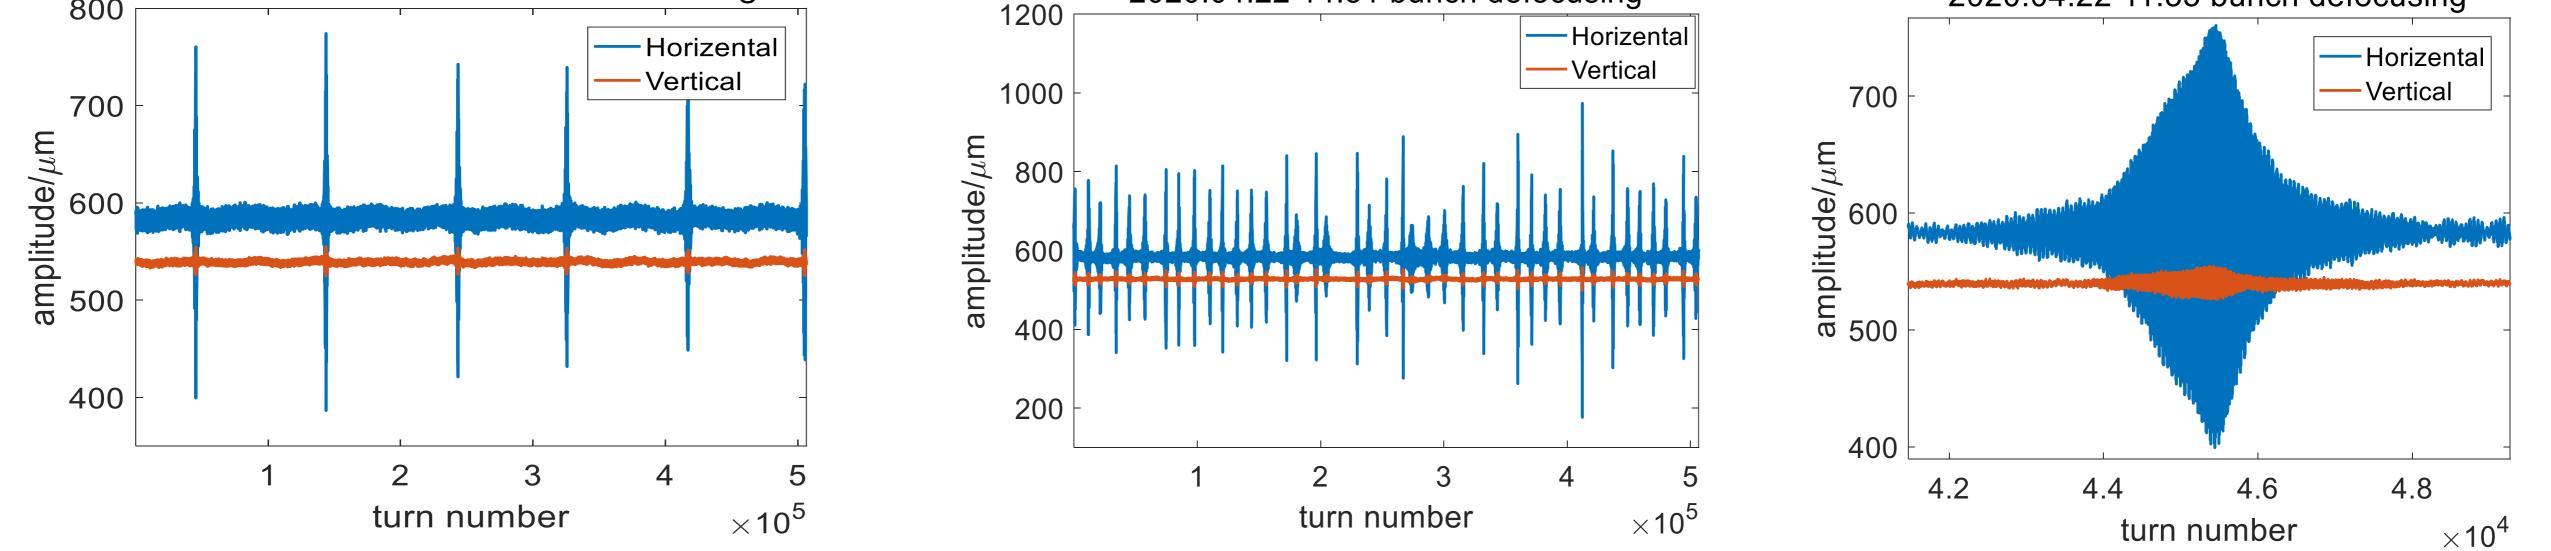
2020.04.22 11:35 bunch defocusing

There was no beam lost, but periodic orbit oscillation can be seen. Checking with the operation log, bunch defocusing was recorded at that time. The beam behavior is consistent with the data.
