PHOTOCATHODE PREPARATION AND CHARACTERISTICS OF THE ELECTRON SOURCE FOR THE VELA/CLARA FACILITY

T. C. Q. Noakes*, D. Angal-Kalinin, L. S. Cowie, F. Jackson, J. W. McKenzie, K. J. Middleman, B. L. Militsyn, M. D. Roper, E. W. Snedden, R. Valizadeh, D. A. Walsh, Accelerator Science and Technology Centre and Cockcroft Institute, STFC Daresbury Laboratory, Warrington, UK

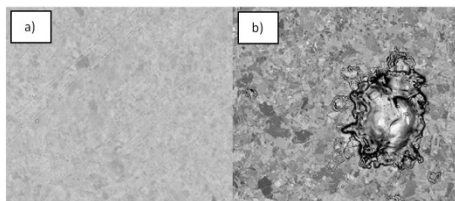
Because of the high dark current seen on cathode '2' during the Spring 2017 run, post analysis of this cathode using scanning electron microscopy (SEM) was carried out. Figure 2 shows two images, the first of an untreated and unused cathode surface and the second of a crater in the surface of the used cathode. It should be noted that the two

images have different magnifications, so the domains visible in image b) are at least 10x larger than those in image a). Growth in domain size during heating is well known and the used sample has been Ar plasma treated, heated to 250°C (as part of the RF cavity baking procedure) and then conditioned using RF power before use in beam generation.

Figure 2: SEM images of Cu photocathode surfaces, a) An unused cathode ($15 \times 15 \mu\text{m}$), b) Cathode '2' after removal from the gun ($150 \times 150 \mu\text{m}$).

The crater seen in Fig. 2b is not caused by ablation from the laser, since the image is taken from a region of the back plate surface which cannot be illuminated by the laser. The origin of this feature is thought to be due to an RF breakdown event either during conditioning or when generating accelerated beam. Similar features have also been seen in the optical microscopy images. Such features could easily act as sites for field emission and contribute to the dark current seen. A series of SEM images was taken every 0.9 mm across the back plate to investigate the spatial distribution of these features. In Fig. 3, the number of features is plotted as a function of radial position across the cathode with the mid-point, where the electrons are extracted, at 42 mm. This data is compared to the distribution of the RF fields present on the back plate during the RF cycle which have been generated using CST Microwave Studio.

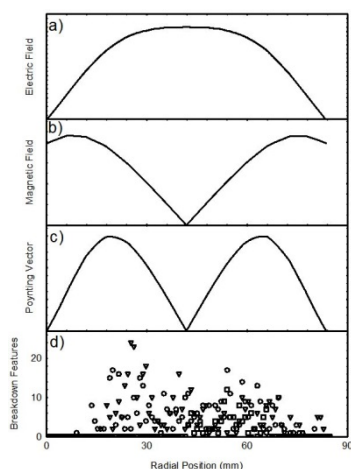
Figure 3: A plot of breakdown features against distance across the back plate compared to the RF fields present. a) Electric Field. b) Magnetic field, c) Poynting vector, d) distribution of breakdown features.

There is some limited evidence of a bimodal distribution of breakdown events across the back plate, with the largest number of events occurring in a ring at about 20 mm radius. This may point to a correlation with the fields present

on the cathode during the RF pulse, specifically the Poynting vector which is a measure of the power dissipation on the back plate.
