LCLS-II CRYOMODULES PRODUCTION AT FERMILAB*

T. Arkan[†], J. Blowers, C. Ginsburg, C. Grimm, J. Kaluzny, A. Lunin, Y. Orlov, K. Premo, R. Stanek, G. Wu, Fermi National Accelerator Laboratory, Batavia, IL, USA

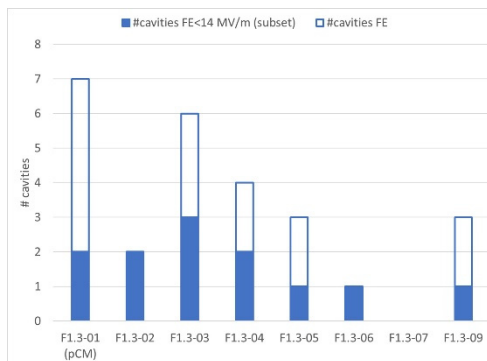
During testing of the F1.3-1 through F1.3-3 at CMTS, we have experienced excessive field emission (FE). The field emission specification requires the onset of measurable field to be above a gradient (Eacc) of 14 MV/m for all cavities. Starting from F1.3-5, we started to increase quality oversight during cavity string assembly in the CAF cleanroom, and the FE problem started to improve significantly. During the F1.3-7 cavity string assembly, the cavity beamline vent procedures were optimized. F1.3-7 is the first cryomodule tested with no measurable FE. During

Figure 1: Field Emission Performance. No FE was measured for F1.3-07.

F1.3-9 cavity assembly, an external expert audit was conducted by Stephane Berry from CEA/Saclay. Audit recommendations (infrastructure and assembly processes improvements) are currently being implemented gradually to achieve consistent FE performance. F1.3-9 is the last cryomodule currently being tested at CMTS. Fig. 1 shows the FE performance of the tested cryomodules at CMTS [2].

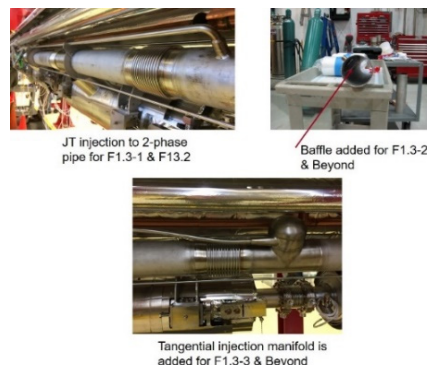
During F1.3-1 testing, microphonics detuning exceeded the specification [3]. Thermal acoustic oscillations (TAO) in the cryogenic valves internal to the cryomodule were found to be the main culprit. Design and assembly modifications to reduce microphonics were immediately introduced during F1.3-2 assembly. During F1.3-2 testing, microphonics problems were reduced but cavity string position #1 still did not meet the requirements of the LCLS-II project. Additional design and assembly modifications were done for F1.3-3 through F1.3-7. These modifications reduced the microphonics detuning. F1.3-7 is the first module where all the cavities met the microphonics requirements [3]. The most significant modifications are shown at Fig. 2 and Fig. 3.

Figure 2: Better Liquid Management and Microphonics Optimization

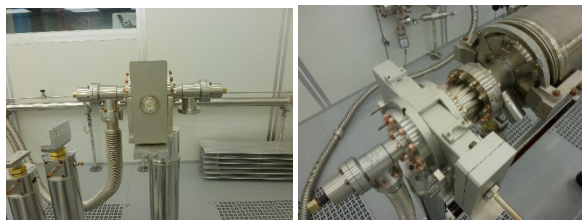
During F1.3-2 final beamline vacuum pump down and leak check (done at the final assembly work station before transporting the module to CMTS for testing), the cold valves were found to be leaking through. Both cold gate valves were installed onto F1.3-2 cavity string in the cleanroom, and the cavity string successfully passed the helium mass spectrometry leak check after installation.

The gate valves were leak tight to air, but the gate does not close properly and this leak through phenomenon cannot be diagnosed with a standard helium mass spectrometry leak check. Corrective actions that were immediately introduced: leak check gate valves and right-angle valves individually before installation onto the cavity string. We started to perform this leak check with F1.3-5. See Fig. 4. The valve vendor was contacted to report this non-conformance, but for schedule and efficiency, the problematic gate valve was not disassembled nor returned to the vendor, and no further action has been taken. No other leak through problems were experienced after F1.3-2.

Figure 4: Valves leak check and Assembly

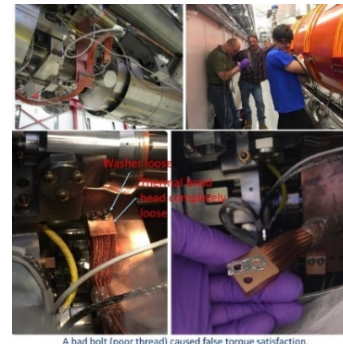
During the testing for F1.3-3, the cavity at string position 3 experienced end group heating [2]. Further diagnosis was done at CMTS after warm-up by accessing the thermal intercepts for the high order mode (HOM) for this end group via using the access ports on the side of the vacuum vessel. There are 7 access ports on the opposite side of the fundamental power coupler (FPC) ports which are designed mainly for tuner access. These access ports have proven to be very useful to repair several other problems and eliminated the needed to pull the cold mass off the vacuum vessel for many repairs. The thermal intercept clamp installed on the HOM connector was installed with indium and torqued to specified value with specified sequence, but a bad thread of the used fastener caused a false torque reading and resulted a loose thermal intercept installation during cryomodule assembly. Corrective actions that were immediately introduced: extra

Figure 5: Thermal intercept repair

QC steps such as checking the assembled thermal intercepts by wiggling the clamp, sink and giving more attention to the torqued fasteners by peers, lead techs and the responsible engineer.

Fig 5 shows the repair done in-situ at CMTS while F1.3-3 was warm but still on the test stand.

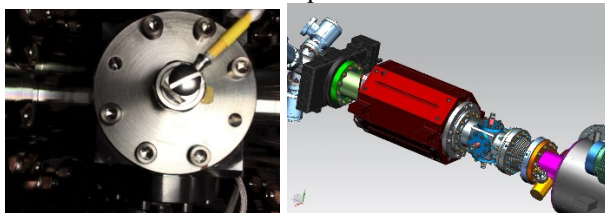
After the testing of F1.3-3, during warm-up, a beamline leak developed. This cryomodule is disassembled at CAF for further diagnosis and to pinpoint the leak location. The leak was located at beam position monitor (BPM). 3 of the 4 electrical feedthrough flange connections to the BPM body developed leaks. Fasteners which were torqued to 12 N-m specification during string assembly were loose. After the fasteners were tightened to 12 N-m, two flanges stopped leaking. Other still leaking flange was torqued to 16 N-m and the leak was eliminated. Based on the findings, the root cause of the BPM leak was deemed to be insufficient torque on the fasteners and loosening of the fasteners after thermal cycle. Corrective actions that were immediately introduced: increase the torque for the BPM electrical flanges from 12 N-m to 16 N-m and introduce a formal torque specification for all the cavity string fasteners. Starting from F1.3-7, travelers are revised to specify the torque values and torque wrench use.

During incoming quality control checks, it was found that the beamline vacuum integrity was compromised. Further investigation showed that the BPM electrical feedthrough flange which faces down lost 2 out of 8 fasteners. One fastener was fully disengaged and fell; the other fastener was hanging in only by a thread. See Fig. 6. Tuner access ports were used to determine that some fasteners from the cavity string position 1 tuner and cold mass upper assembly got loose and fell during cryomodule shipping. The LCLS-II project halted cryomodule production immediately to start a formal investigation for the root cause of this catastrophic failure.

Figure 6: BPM
