OPERATING EXPERIENCE AND RELIABILITY IMPROVEMENTS ON THE 5 KW CW KLYSTRON AT JEFFERSON LAB

R. Nelson, S. Holben, Thomas Jefferson National Accelerator Facility, 12000 Jefferson Avenue,
Newport News VA USA 23606

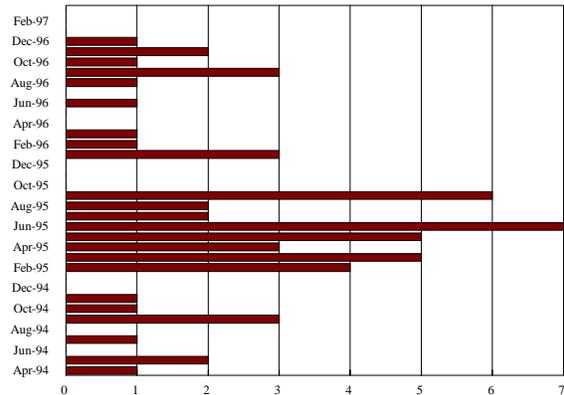
As could be expected, klystrons failed. To date, some 83 have died. As tubes failed, the few spares originally purchased dwindled and additional tubes were purchased to supplement the 350 originals. Concurrent with the purchase of spares, a vendor was also selected to repair and rebuild the failed klystrons. Both contracts were the result of a competitive bid process. New tubes would be supplied by Litton Electron Devices, while a startup company, Pendulum Electromagnetics (PendEI) in Raleigh NC, would handle all the repairs and rebuilding.

The spec requested tubes with at least 20-25k hours life. Overall, even with a high number of early failures, the MTBF was around 22k hours by 1994. Currently, the hours/failures ratio shows about 90K hours of filament operation and 67k hours of HV operation average. None of the failures so far has been from normal wear out, that is, cathode depletion. Instead, catastrophic failures have ranged from open heaters to external arcing.

Figure 1 - Klystron Failures by Month

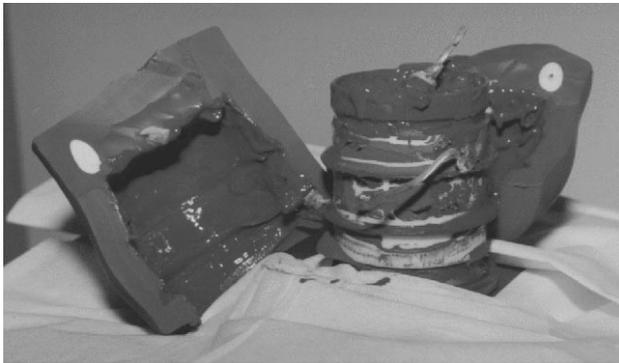
The largest number of failures were the result of *external* arcs across the ceramic of the gun assembly. The gun assembly is potted with a silicone RTV to prevent problems with dust and humidity. In many cases, the RTV closest to the gun reverted to either a thick soup of silicone oil and solids or a dry and crumbling material. While the RTV was rated at 250 °C [2] and measured surface temperatures according to data provided were well below that point, silicone supplier GE Silicone felt the material was being exposed to temperatures too high.

Figure 2 - Gun assembly showing degraded potting

Recognizing that we couldn't consistently spot bad potting or predict failures, a decision was made to repot all the tubes in the machine. This time the RTV was Stycast 5952 from Emerson & Cuming., a product with higher thermal conductivity [3] and one that didn't require stage curing.

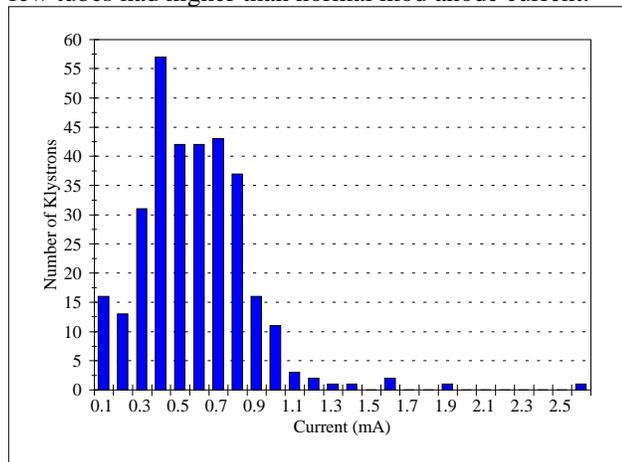
not mod anode current. As a test, a metering panel was assembled on a clear acrylic panel and mounted in spare rack space on the HPA. As predicted, we found that a few tubes had higher than normal mod anode current.

Figure 3 - Mod Anode Current Distribution

Original specs required mod anode intercept to be < 1% of beam current, which equated to <13 mA. Assuming that most of the current intercepted by the modulating anode was dissipated by the metal and ceramic through the potting material, we simulated additional heat on our thermocouple equipped tube by increasing heater power. The temperature reached 250 °C with another 30 watts input. So while 12 mA of intercept would fall within the specs, it would also generate 139 watts of heat. The gun would fracture well before that point. In fact, at least three tubes have suffered that fate, so it's convincing that excessive mod anode current was probably a major contributor to potting failures.

We had lowered the cathode voltage but kept the heater setting at the nameplate value. Running a curve of cathode emission vs. filament voltage, we found that most tubes would operate satisfactorily with about 75% of the rated voltage. Running cathodes hot had resulted in excessive barium boil off and internal contamination. Since resetting individual filament voltages based on emission curves, the failure rate has dropped noticeably.

Because mod anode current was found to be a critical measure of the tube's health and an indicator of impending failure, permanent monitoring has been

installed on all klystron positions. This parameter is now remotely monitored, and can be logged or trip the power supply if a preset threshold is exceeded.
