TRANSFER LINE DAMAGE DURING HIGH INTENSITY PROTON BEAM EXTRACTION FROM THE SPS IN 2004

B.Goddard, CERN, Geneva, Switzerland.

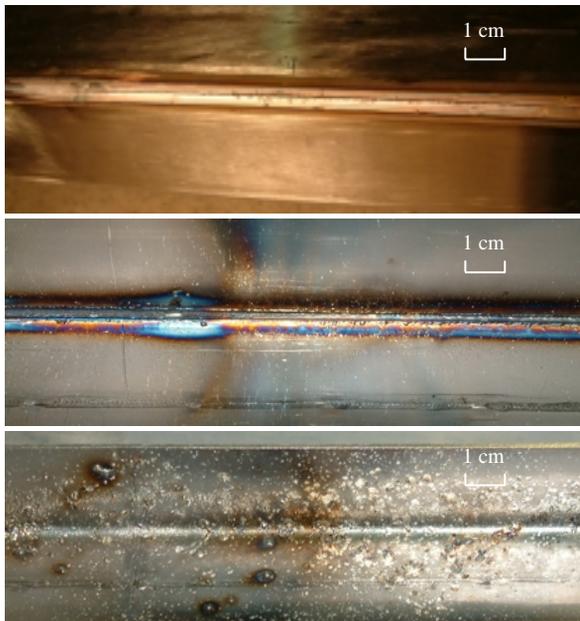
The extraction from SPS LSS4 [1] into TT40 of nominal intensity LHC injection beams was required in 2004, for robustness tests of the prototype LHC collimator, for CNGS target rod tests and for materials tests to benchmark energy deposition simulations [2,3]. During the test, the beam was extracted with a wrong trajectory, due to a switch-off of the extraction septum (MSE). A downstream magnet vacuum chamber was severely damaged [4], Figs. 1-3. A cut approximately 25 cm long was visible about 70 cm from the start of the chamber. When the chamber was cut open the beam impact side was confirmed to be consistent with insufficient MSE deflection. A groove approximately 110 cm long where the chamber material had been removed was visible, and on the non-impact side, the wall was covered with condensed drops of steel.

Figures 1-3. Vacuum chamber damage observed on the outside (top), inside at the beam impact area (middle) and inside opposite the beam impact (bottom).

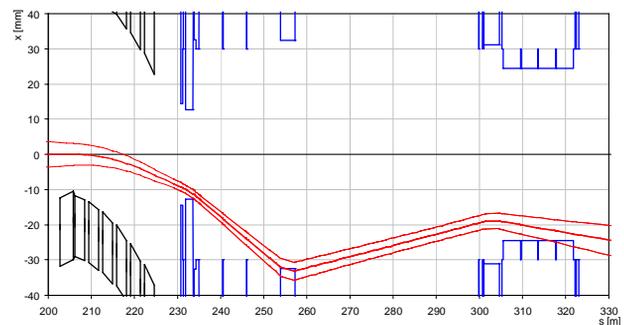
The probable trajectory of the badly extracted beam was reconstructed by varying the MSE kick and constraining the beam position to be those measured by the BPMs and BTVs. An impact at the QTRF4002 vacuum chamber was imposed. The resulting trajectory is shown in Fig. 4. The MSE error was constrained to be -5.1%, and the impact angle about 0.6 mrad. The beam σ at this location is 0.7 mm in both planes.

Figure 4. Reconstructed trajectory with MSE kick at 5.1% below nominal (H plane, $\pm 3.5 \sigma$ beam envelope).

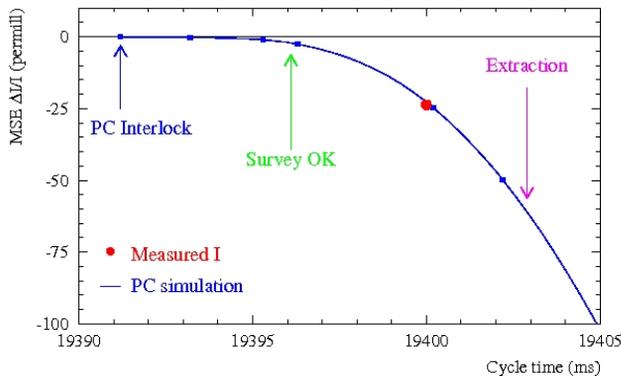
The 23 ms time constant of the MSE circuit means that the current decays very rapidly when the power convertor is switched off. The current was surveyed by software in the front end, with a ‘slow’ response time of about 7 ms. A simulation of the power supply current was made, Fig. 5:

- 13 ms before extraction, the power supply tripped;
- 7 ms before extraction, the surveillance saw a -0.5% error, which was still in tolerance;
- 3 ms before extraction, the logging gave -2.5%;
- At extraction, the current had decreased to -6%.

Figure 5. Simulation of the MSE current. The current at the extraction time is predicted to be -6%.

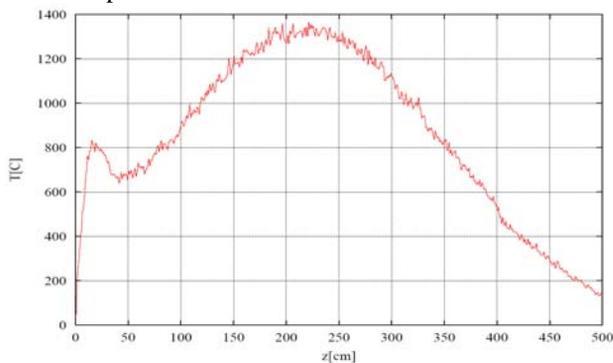
With the impact parameters known, a FLUKA model was made to check if the observed damage profile could be reconstituted. Fig. 12 shows the energy deposition profile obtained, for a test geometry with a 5 m long chamber equipped with entrance flange only. The maximum temperature reached in the peak of the energy deposition in the pipe, made of stainless steel 314L, is only 1350°C, Fig. 6, compared to the melting point of 1400°C. It was very difficult to reconstitute the observed physical damage in a simulation with limited knowledge of the input conditions.

Figure 6. FLUKA simulation results of ΔT in chamber.
