EXPERIENCE OF THE EROSION-CORROSION PROBLEMS IN THE MAIN RING COOLING WATER SYSTEM AT THE KEK-PS

Hikaru Sato, Tomio Kubo, Katsumi Marutsuka, Yoshio Saito, Masashi Shirakata and Noboru Tokuda
 Accelerator Laboratory, High Energy Accelerator Research Organization (KEK),
 Oho 1-1, Tsukuba-shi, Ibaraki-ken 305-0801, Japan

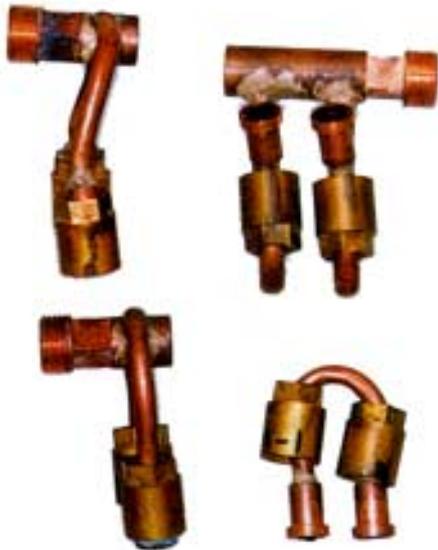
Figure 2: Old small piping parts for the quadrupole magnet cooling loop.

A main ring quadrupole magnet has four water cooling loops, and they are concentrated to one pipe to connect the main cooling loop. Then, four types and ten small piping parts are equipped at the end of the quadrupole magnet. Figure 2 shows three type old parts (two of lefts are same type). They were replaced new ones as shown in Fig.3. These parts are made of copper pipe of 6 mm of outer diameter and 0.6 mm of thickness and brass. Pinhole leaks occurred on these pipes for recent years. Microscopic inspection the small piping parts indicates clearly the trace of erosion. The pipe wall became very thin and is 0.05 mm at the thinnest position. These phenomena indicate a possibility of erosion. Figure 4 shows a typical broken part. It is impossible to inspect the inner surface of these parts by cutting, since it is highly radioactivated. Therefore we inspected the same type parts of a field monitor magnet in the power supply building. We found an erosion trace (black colored copper oxide coat is stripped off) in most of the parts as shown typically in Fig. 5, 6. The flow speed of water is estimated as 6 m/s in these pipes, and erosion is a matter of course.

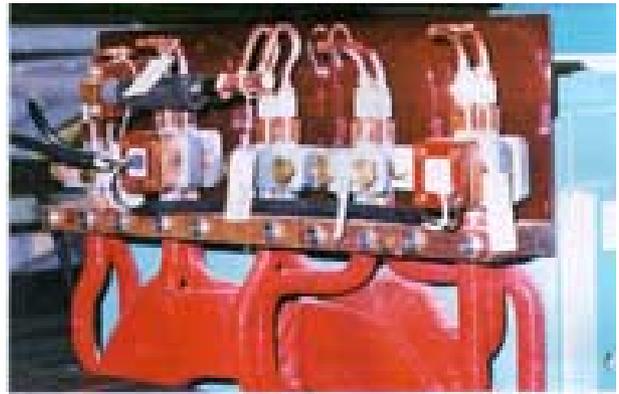
Figure 3: Replaced small piping parts at the upper half of the quadrupole magnet.

Three quarters of these parts (especially in high radioactive area) were replaced during the summer shut down in 2000, as shown in Fig. 3. The remained parts will be replaced during the summer shut down in this year.

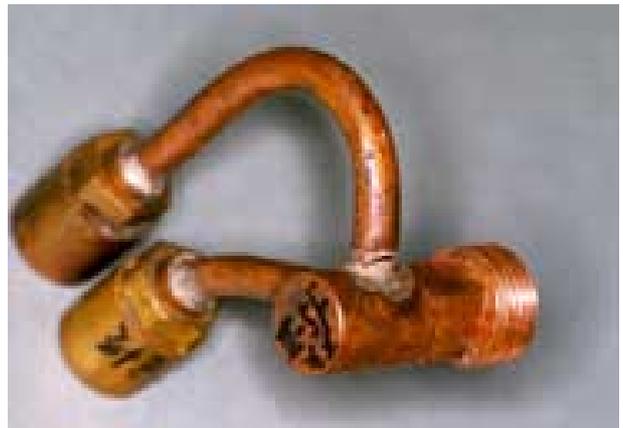
Figure 4: Broken small piping part.

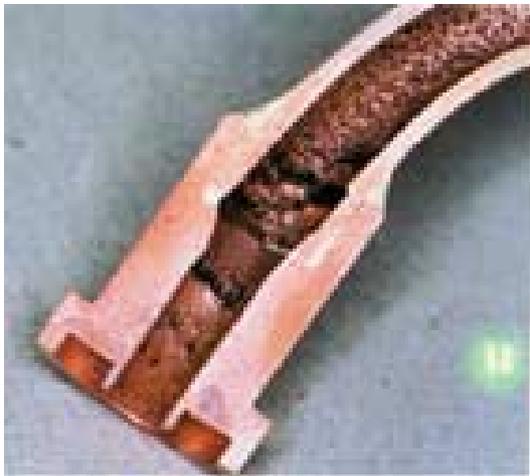
Figure 5: Original step at the welding position becomes too smooth. Water flows from upper to bottom.

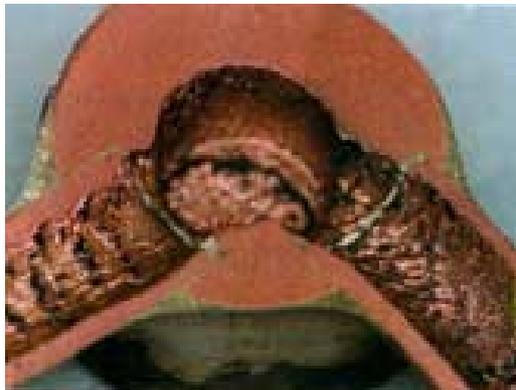
Figure 6: Evidence of the erosion by cavitation. Water flows from right to left.

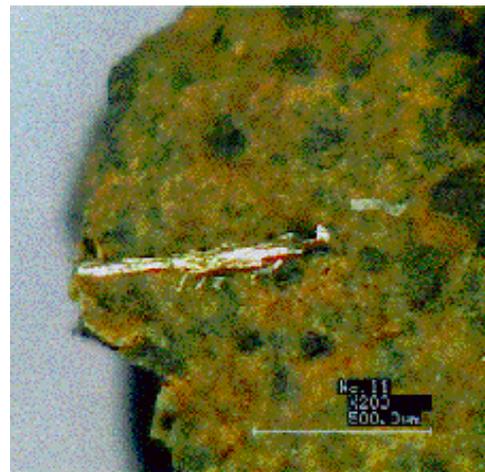
Rubber tubes for the main ring power supply cooling system have been replaced twice in the past because of the insulation resistance drop. During the summer shut down in 2000, the rubber tubes for the field monitor-bending magnet were replaced. Since these parts were not activated, we could inspect them by chemical and spectrum analysis. Figure 7 shows an inner surface of this rubber tube. Adherent brown material was identified to waterweed, iron, copper, chromium, silver, zinc, nickel, lead and their oxide. The white luster material was identified to iron, copper, zinc, nickel and cobalt. We estimate that these are from various materials in the piping parts by erosion-corrosion and adhered on the surface of rubber.

Figure 7: Inner surface of the rubber tube for the field monitor bending magnet.
