OPERATIONAL EXPERIENCE AT THE INTENSITY LIMIT IN COMPACT CYCLOTRONS

G. Cojocaru and J. Lofvendahl, TRIUMF

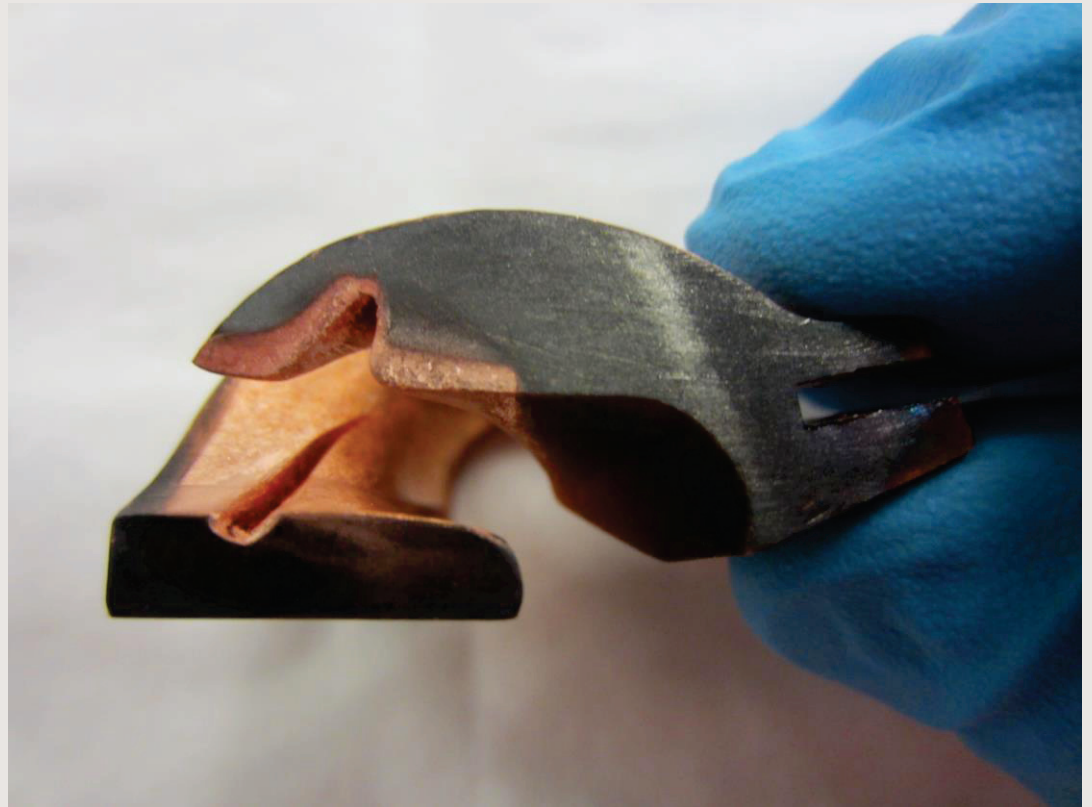
- A failure rate of about once/year on both machines
 - 4 days maintenance and recovery:
 - Cool-down
 - Replacement
 - Vacuum recovery
 - Inflector conditioning and tuning
 - Tank RF conditioning
- Affects **only uptime**, not beam amplitude before and after the change

TR30-2 beam eroded inflector

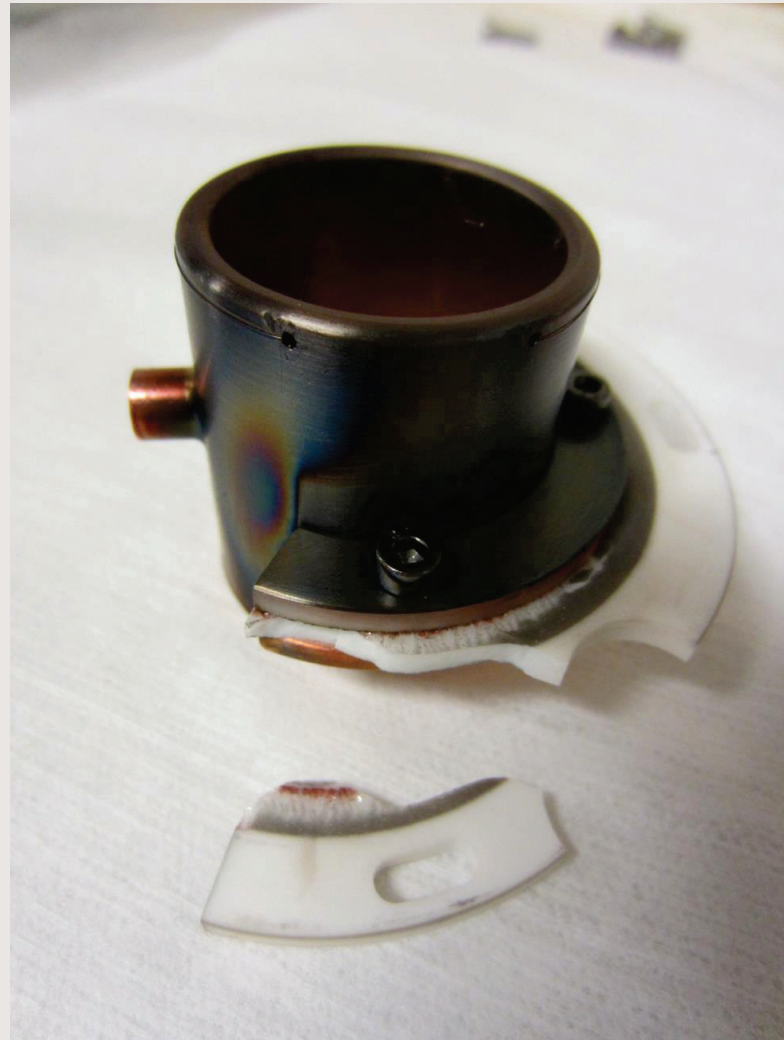
- A failure rate of about once every 3 years on TR30-2 (less on TR30-1)
- Preceded by amplitude beam deterioration
- 2 days maintenance and beam recovery

Affects both **beam amplitude** and **uptime**

TR30-2 damaged buncher

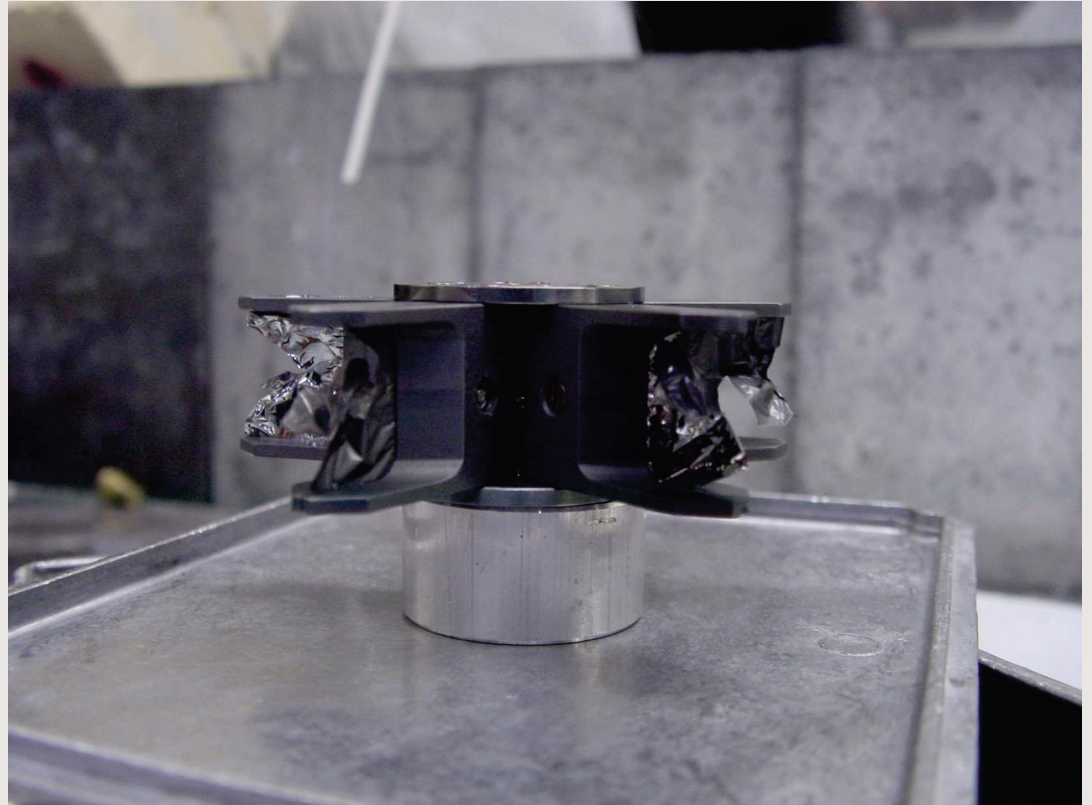
- There is typical beam deterioration during the lifetime of an individual foil due to its physical depreciation, which could be compensated by beam tuning and higher extracted beam
- New foil needs additional beam tuning, eventually a new carousel is necessary
- 5 hours to complete a carousel replacement
- Work is followed by tank RF conditioning
 - Affect both **beam amplitude** before and after the changes and **uptime**

Used foils on extraction carousel

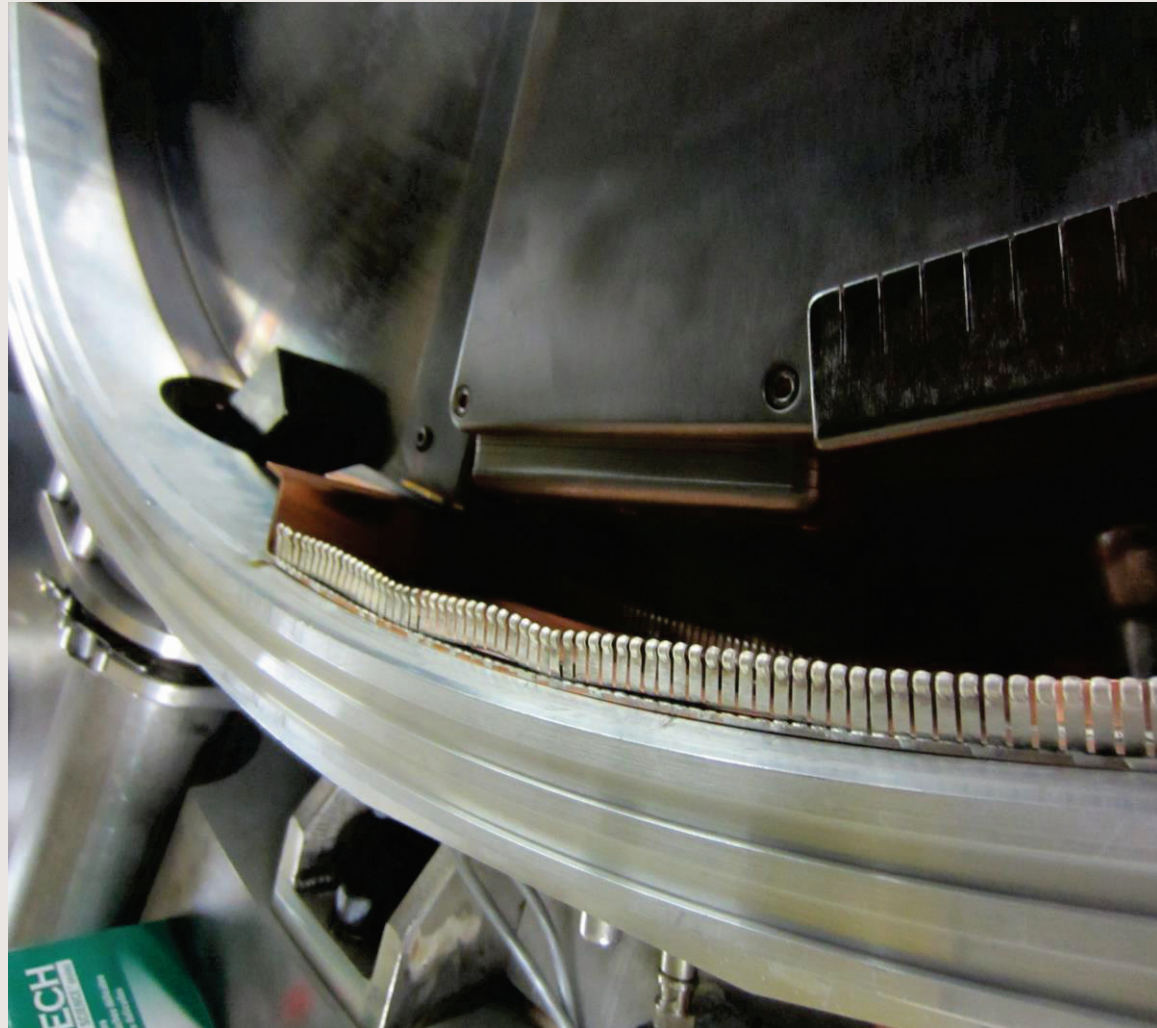
- We have experienced a peak in TR30-1 RF failures after 20 years of quasi continuous operation.
- Dees and RF liners developed water leaks and soldering fractures.

TR30-1 liner with fractures in soldering

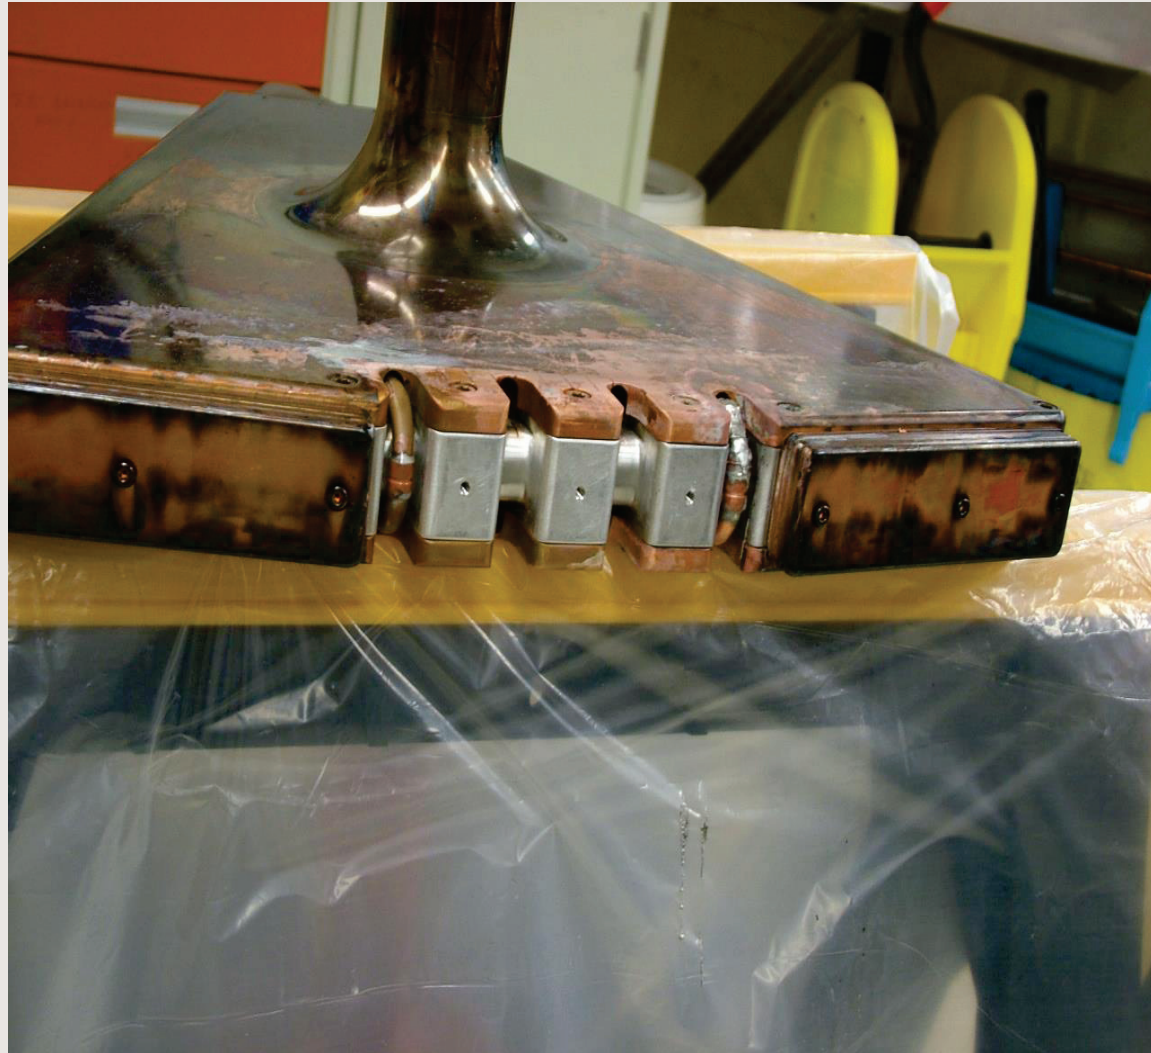
TR30-1 Dee out for fixing a leak in a water cooling line

Dees were replaced with new ones in the following year

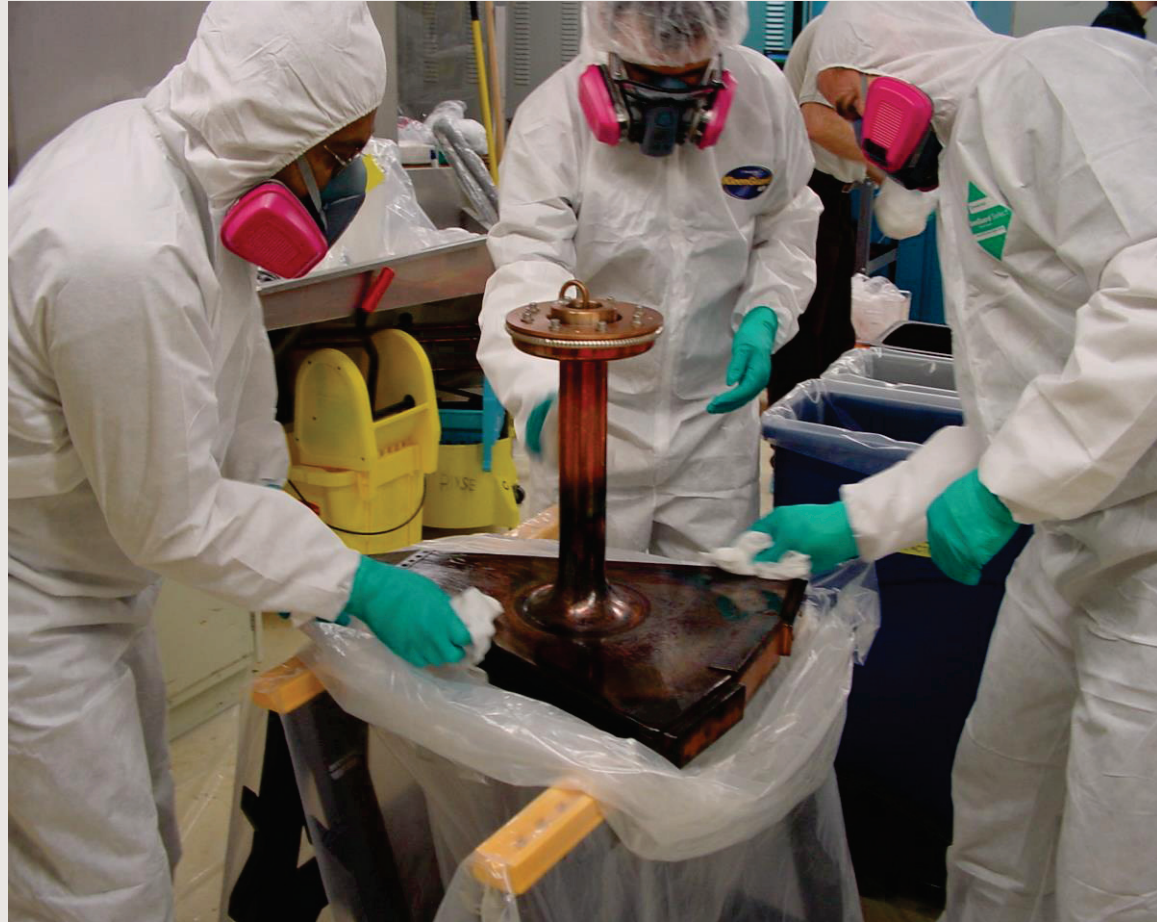
TR30-1 Dees repair:

- Radiation fields
- Contaminated parts

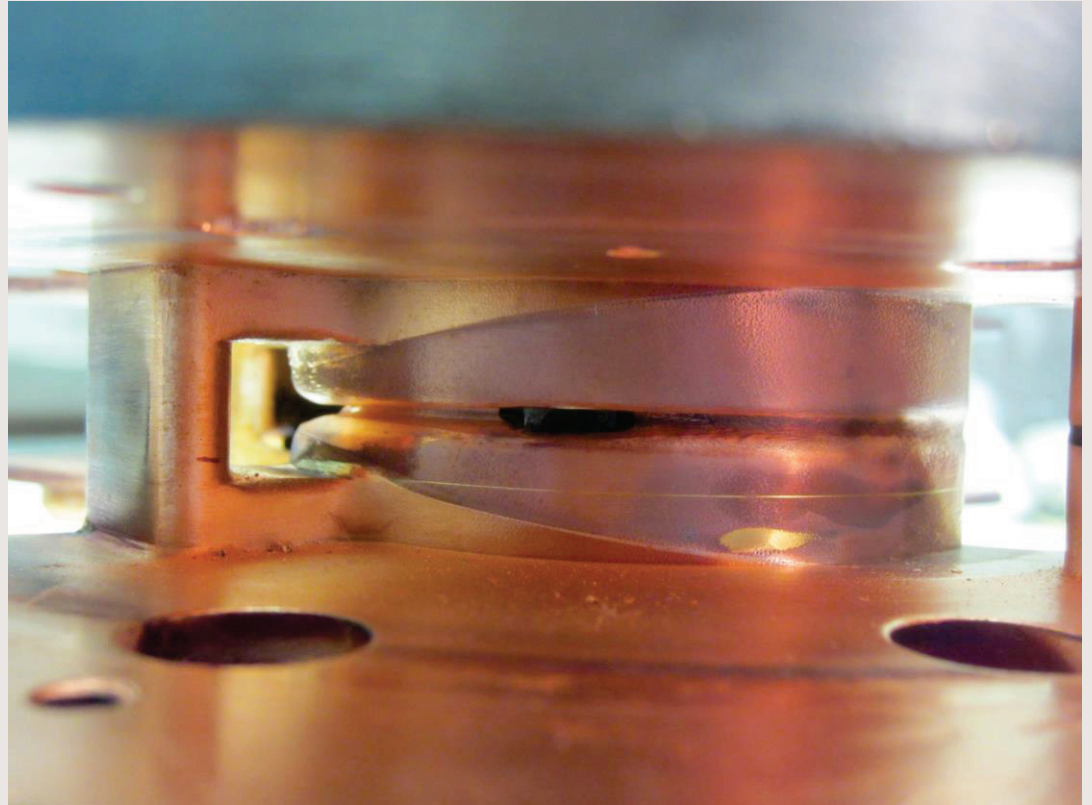
TR30-2 Centre Region after 10 years of beam

- Sputtering of metal surfaces is evident with its detrimental consequences in this area
- Beam stability, RF stability are affected
- Beam amplitude is eventually affected
- Misalignment during this process, and possible after maintenance due to conditions in the tank will further contribute to overall transmission deterioration
- Maintenance and beam recovery take about a week
 - Cool-down (high radiation fields and contaminated parts)
 - Complex work, alignment involved in a difficult space
 - Vacuum recovery
 - RF conditioning

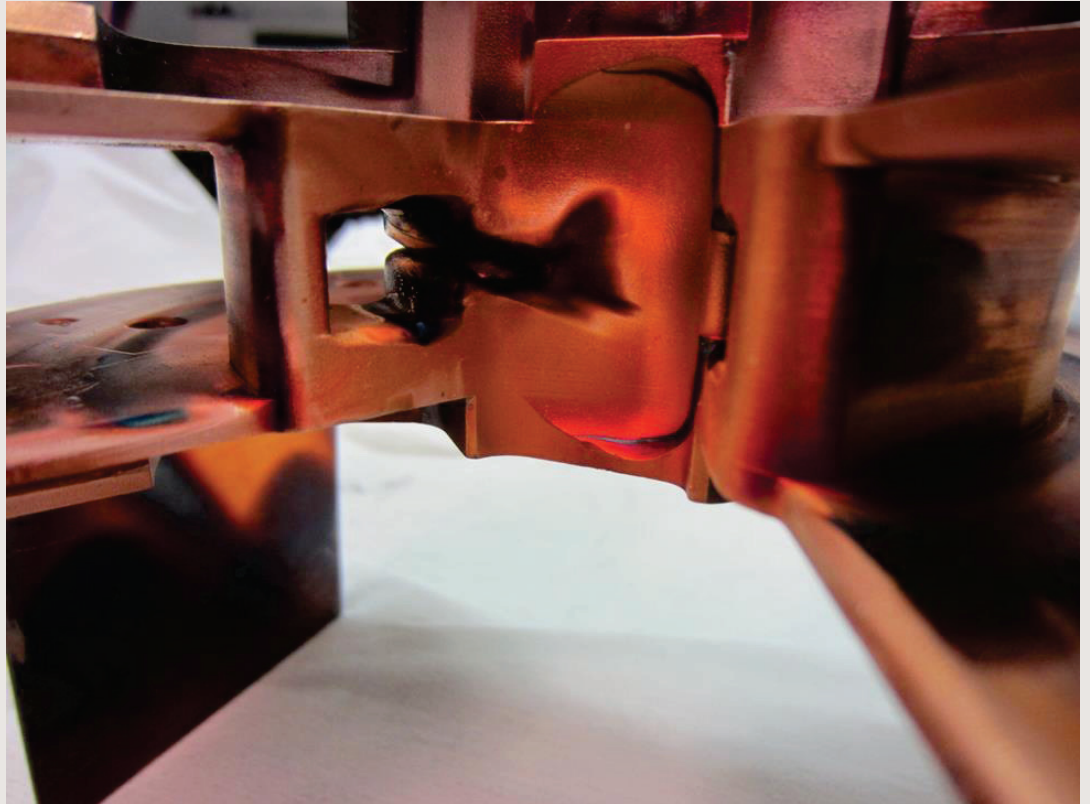
TR30-2 Centre Region
deterioration

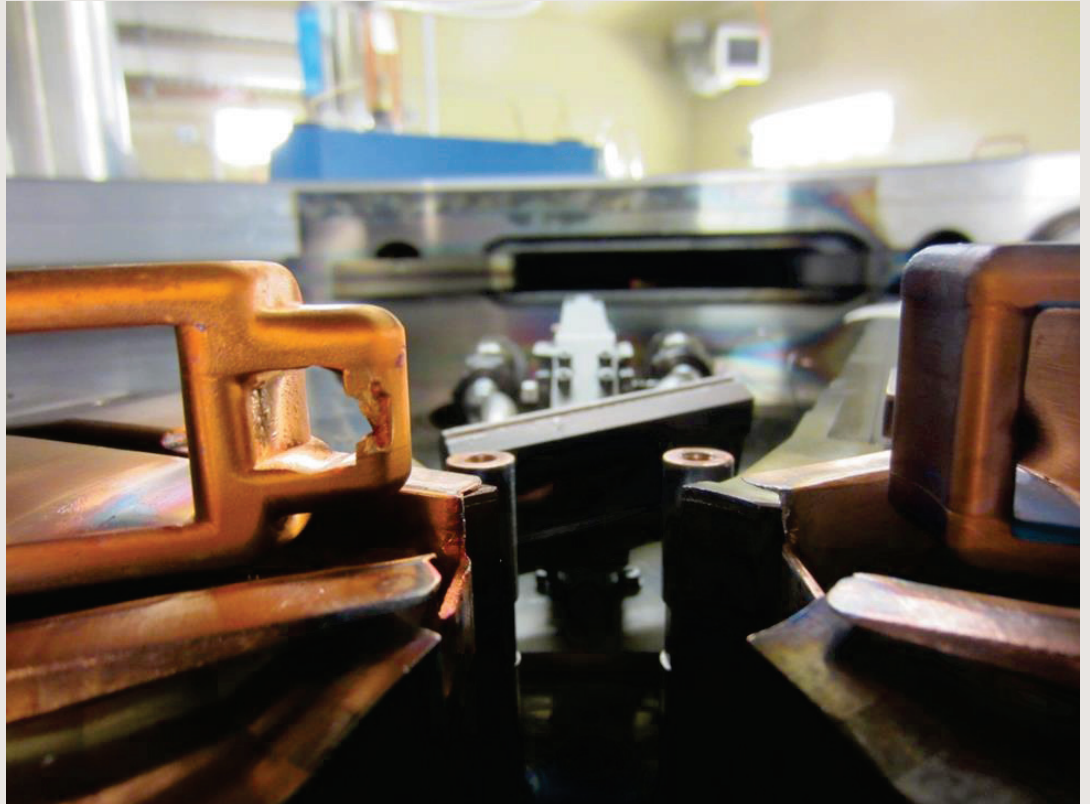
Dee tip - same machine

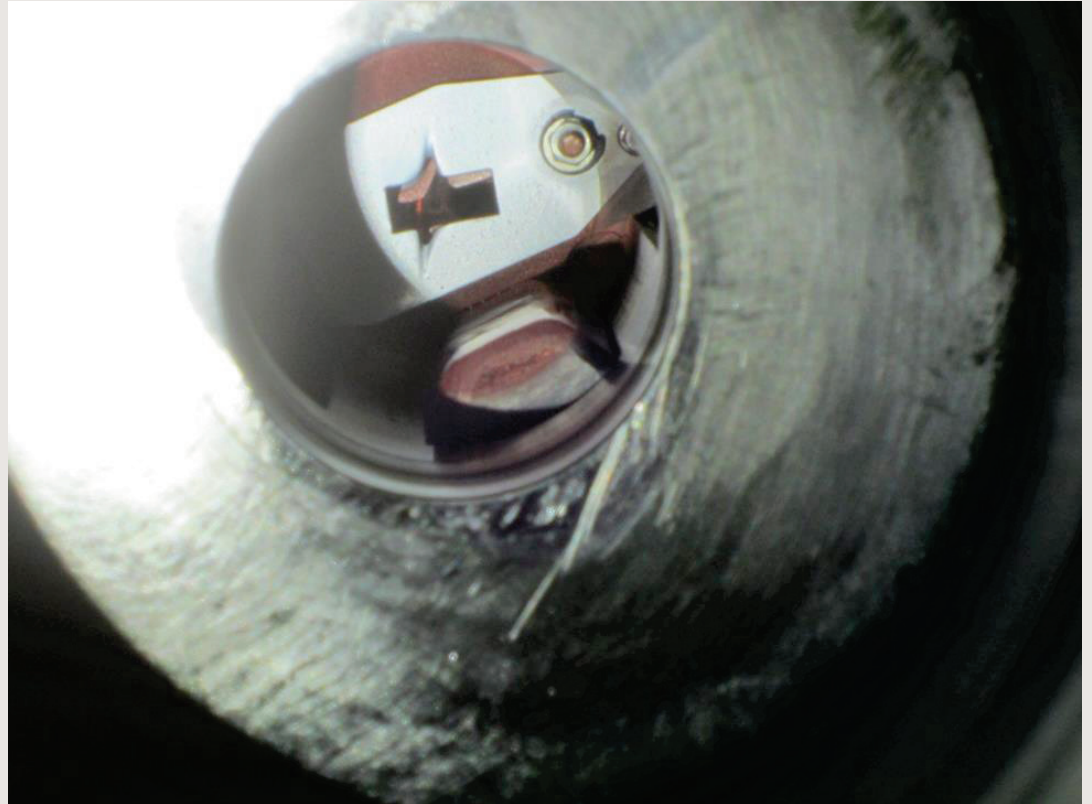
Same inflector with its
collimator seen from the
injection line side
