RADIATION DAMAGES AND CHARACTERIZATION IN THE SOLEIL STORAGE RING

N. Hubert[#], N. Béchu, P. Brunelle, L. Cassinari, C. Herbeaux, S. Hustache, J-F. Lamarre, P. Lebasque, F. Marteau, A. Nadji, L. S. Nadolski, Synchrotron SOLEIL, Gif-sur-Yvette, France

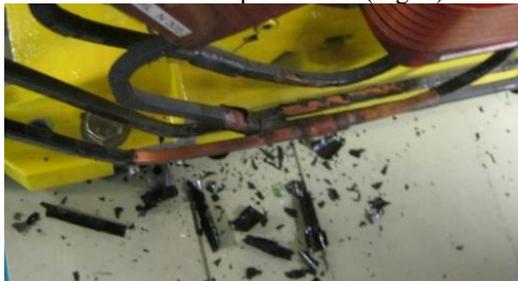
- Insulator of some sextupole cables (Fig. 1)

Figure 1: Insulating layer of some sextupole magnets has become brittle due to radiation.

Deterioration of cable insulators poses of course a risk to the machine reliability (short circuits) and they have been quickly repaired either by replacing the insulator itself (sextupoles) or the cables (correctors). BPM cable insulators have not been damaged enough to have any consequences on the position measurement quality. To avoid additional damage requiring an expensive replacement, disposable pigtailed cables have been inserted between original cables and BPMs (Fig. 4).

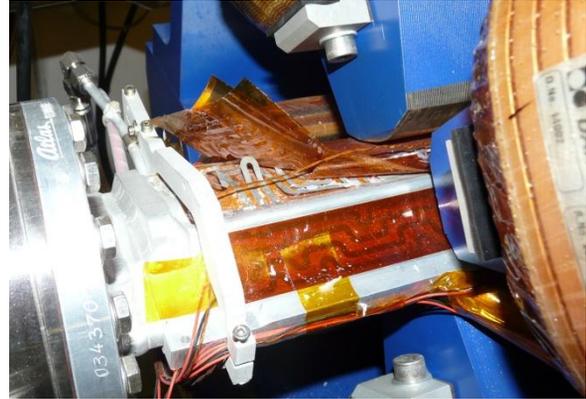
Figure 2: Glue that sticks together different kapton foils of some baking out films is damaged by radiation.

Nevertheless the most concerning issue is the damage of the baking out films. All the SOLEIL quadrupole VCs are coated with Non Evaporable Getter (NEG) to reduce photon stimulated desorption rate [2]. This NEG layer needs to be activated at 180°C. To perform this baking out, thin films made of resistors stick between kapton foils have been glued on those VCs. In that way, baking out can be done in-situ without opening and removing quadrupole and sextupole yokes installed around the chambers.

Thereby replacing damaged and unusable films is a tedious and very time demanding task that will be done only if necessary. Moreover with nominal operation at 430 mA, new films are damaged rather quickly (less than 2 years), so preventive replacement is not an option.

A study is on-going to find new glue material more radiation hardened than the present one.

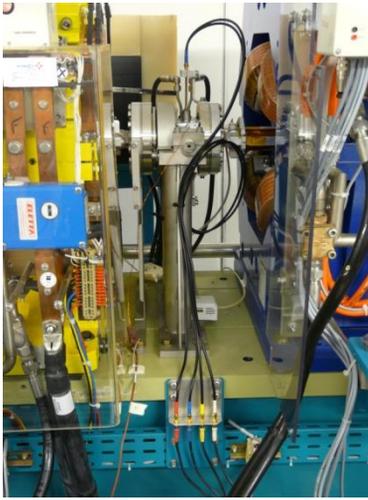
Figure 4: Insertion of disposable pigtails between BPM and its cables to avoid damages of the long and expensive cables.

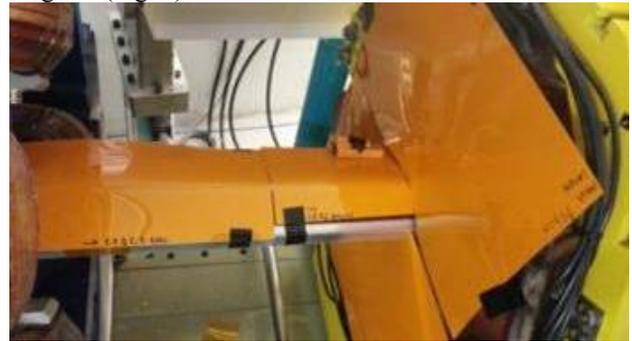
Figure 6: Gafchromic films installed on the VC and against a sextupole magnet in cell C08 (before exposition).

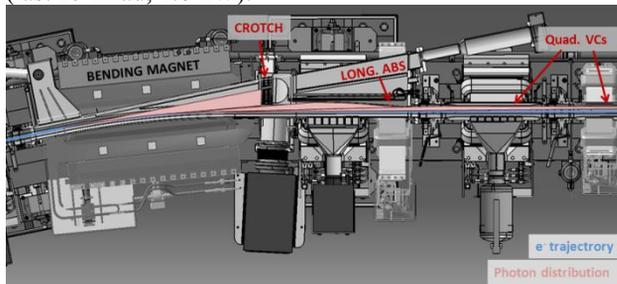
When going through each of the 32 dipole magnets, the electron trajectory is bent by an angle of 196 mrad; therefore photons are produced within that angle in the horizontal plane. A large part of those photons is absorbed by three different elements: the crotch absorber (first 102 mrad, 7.6 kW at 500 mA), the longitudinal absorber (following 69 mrad, 5.1 kW) and by the quadrupole VCs (Fig. 8) installed downstream the dipole (last 25 mrad, 1.8 kW).

Figure 8: Photons produced in the dipole magnets are absorbed by one of the following elements depending on their emission angle: crotch, longitudinal absorber or quadrupole VC (top view).

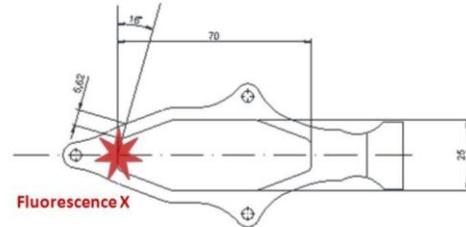
Under the effect of the incident photon beam produced by the upstream dipole, materials of the VC and the NEG coating fluoresce and emit X-rays isotropically (Fig. 9). Depending on their energy, those X-rays are then possibly absorbed by the material (VC, air...) encountered during their diffusion.

Figure 9: Cross section of a quadrupole VC. Minimum thickness is 3 mm. Upstream dipole synchrotron radiation is intercepted by the chamber inducing X-ray fluorescence of its materials.

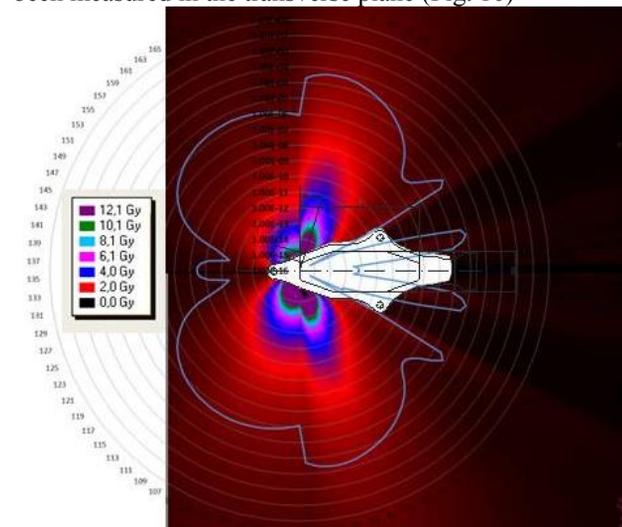
Dose distribution measured with Gafchromic films in the transversal plane shows lobes with very high dose (~12 Gy) and area with low dose (<0.1 Gy) even at the contact of the VC. Fluorescence X-rays go through a thickness of aluminium determined by their angle of emission. Transmission coefficient calculation, depending on the emission angle (and thus the crossed Al thickness) is perfectly correlated to the dose distribution that has been measured in the transverse plane (Fig. 10)

Figure 10: Correlation between the dose distribution measured with Gafchromic films and the calculation of 15 keV X-ray transmission factor (blue curve) as a function of the crossed Al thickness (transversal plane).

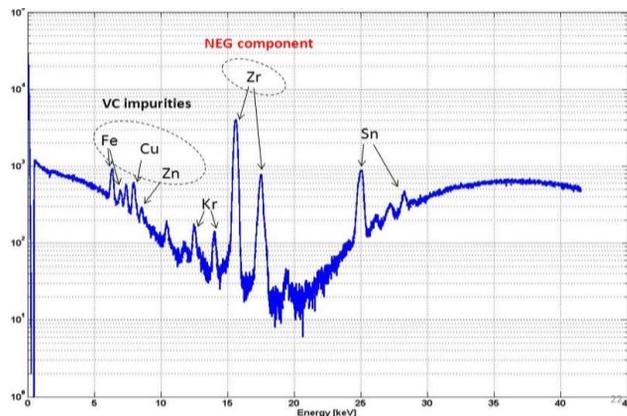
- Fe (0.7%), Cu (0.15-0.4%) and Zn (0.25%) are impurities in the aluminium VC. Their spectrum lines are respectively at 6.4 keV (K α) and 7.06 keV (K β), 8.05 keV (K α) and 8.64 keV (K β).
- Zr is one of the three NEG coating components (Zr, Ti, V), with fluorescence lines at 15.78 keV (K α) and 17.67 keV (K β).

Detected Kr fluorescence lines may be residuals from NEG coating process (done under Kr atmosphere). The origin of Sn spectrum lines is not yet understood.

Fluorescence from other main components such as Al (VC, 96%), Ti and V (NEG-coating) have not been detected. Indeed their fluorescence lines are at lower energy: respectively 1.49 keV, 4.51 keV and 4.95 keV, and probably attenuated by the VC (see next paragraph).

Figure 11: X-ray spectrum analysis acquired with a silicon drift detector. Measurement confirms the fluorescence of NEG coating material (Zr) and of some impurities in the Aluminium of the VC (Fe, Cu and Zn).

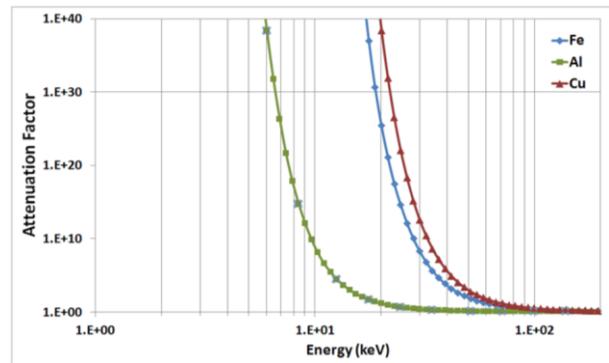
A comparison with other materials as Cu or Stainless Steel (SS) usually used for the VC manufacturing shows that Al is the one with the poorest “shielding effect”. In particular X-rays in the 10 to 30 keV energy range are well attenuated by 3mm of Cu or SS whereas they are not

by 3 mm of Al (Fig. 12). Typically Zr (NEG coating) fluorescence X-rays at 15 keV are attenuated by a factor 3.10^2 with 3 mm thick Al VC (to be compared with an attenuation factor of 6.10^{53} for the same thickness of SS).

Figure 12: Attenuation factor applied to X-rays crossing 3 mm of Al (green), Fe (blue) or Cu (red) depending on their energy.

SOLEIL experience shows that NEG coated aluminium vacuum chamber is not a relevant solution in case this one has to intercept part of the upstream synchrotron radiation. The use of stainless steel or copper with NEG coating is probably a more appropriate combination to limit fluorescence radiations and damages on equipment. Such quadrupole vacuum chambers will be tested in the next months as a dedicated experiment on the machine.
