# CONDITION OF MA CORES IN THE RF CAVITIES OF J-PARC SYNCHROTRONS AFTER SEVERAL YEARS OF OPERATION

M. Nomura\*, A. Schnase, T. Shimada, H. Suzuki, F. Tamura, M. Yamamoto, JAEA/J-PARC, Tokai-mura, Ibaraki, Japan

## Abstract

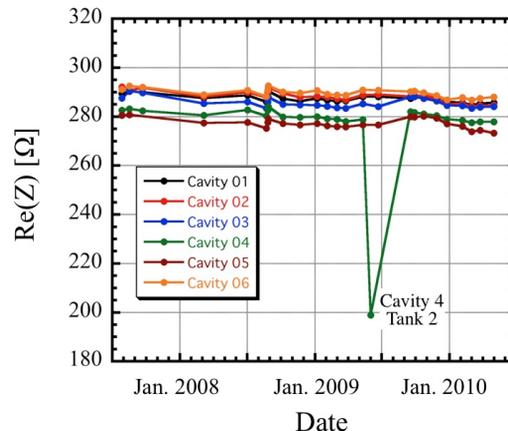
We detected the impedance reduction of cavity 7 in January 2009 [3] and January 2010 and of cavity 4 in June 2009. The results of impedance measurements of RF cavities in RCS are shown in Figs. 1 and 2.

Figure 1: The result of impedance measurements of RF cavity 1 to 6 in RCS.

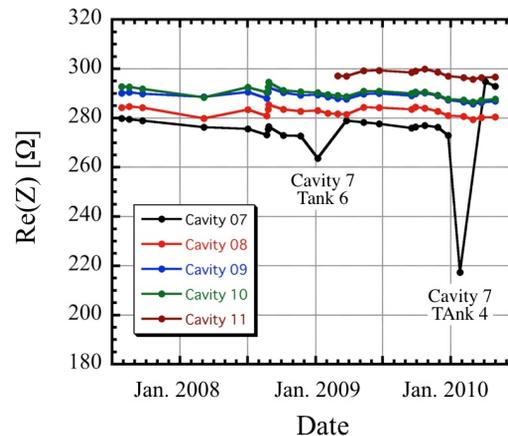
Figure 2: The result of impedance measurements of RF cavity 7 to 11 in RCS.

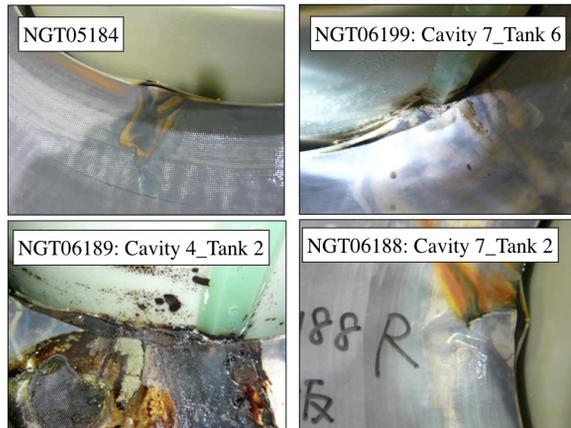
Opening the cavities 3, 4, 5, 6 and 7 to examine the MA core conditions, we found that 26 cores out of 90 in total showed buckling. Most of the buckling sizes are small like NGT05184 in Fig 3. The cores with small buckling caused no impedance reductions. The cores with small buckling are still used and the impedances are monitored carefully. On the other hand, the cores with large buckling, NGT06199, 189 and 188 in Fig 3, caused impedance reductions. Those three buckled cores were damaged by the large buckling. Fig. 4 shows the photograph of the buckling area after removing the epoxy coating on the core surface. The buckling part is

deformed by the pressure due to the buckling part pushing against the column of the FRP inner cylinder and the MA core was torn by the buckling.

Figure 3: Photos of MA core buckling. The MA core NGT05184 shows small buckling and the other three cores show large buckling.

In the case of MA core buckling, it is basically caused by the thermal stress of the cavity operation. The local core temperature rise is inverse proportional to the core radius. In operation, the temperatures inside the core, 17.5 mm from the core surface, of the inner and outer radius are about 110 and 43 degrees Celsius, respectively. This temperature difference makes a compressive stress along the circumferential direction around the inner radius. From the correlation between the occurrence of core buckling and core coating type, we figured out that the MA core buckling was caused by the thermal stress that was enhanced due to the impregnation with epoxy resin [4]. The core without the impregnation of epoxy resin has small spaces, about few  $\mu\text{m}$ , between ribbon layers, and hence the ribbons can release the stress from the thermal expansion by spreading outward in the small spaces. On the other hand, the core with the impregnation of epoxy

resin has almost no space to release the stress from the thermal expansion.

In March 2010, we replace with MA cores without the impregnation of epoxy resin in one RF cavity and have been observing its impedance carefully.

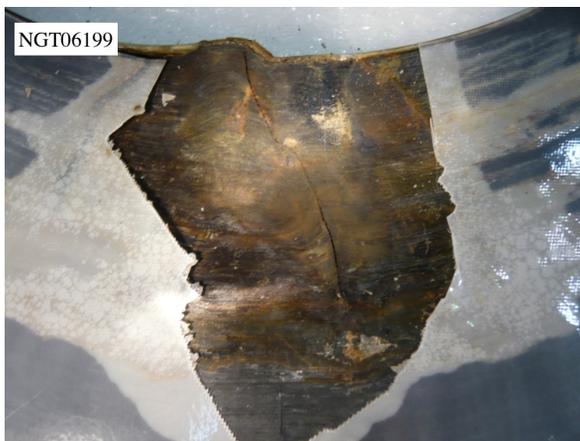
Figure 4: The photo of the buckling area of NGT06199 after removing the epoxy coating.

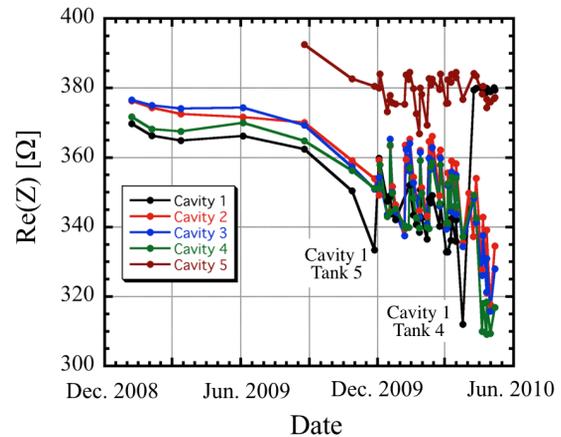
The impedance of all RF cavities in MR started to decrease from October 2009. The result of impedance measurements is shown in Fig. 5.

Figure 5: The result of impedance measurements of RF cavity 1 to 5 in MR. The RF cavity 1 was replaced in April 2010.

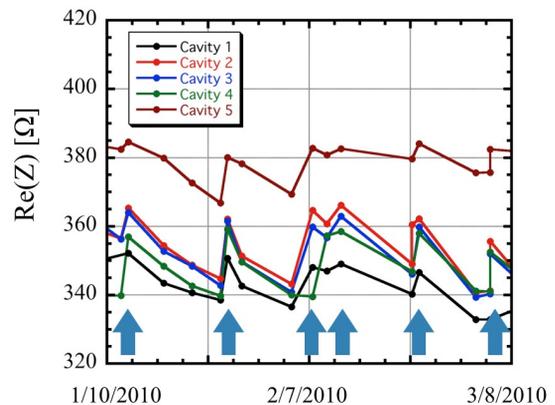
First of all we explain the impedance fluctuation from December 2009. When we opened the RF cavity 1 to see the core condition in November 2009, we noticed that the cavity impedance recovered to some extent by draining off the cooling water from the RF cavity. We also found that the recovery did not occur if draining off water with nitrogen gas. This recovery of the impedance might be caused by the change of the conductivity of the cutting surface by oxidation.

Figure 6: The change of the impedance by exposure to air. The arrows show the date of exposing the cutting surface by draining off the cooling water.

From December 2009, we regularly expose the cutting surfaces to air by draining off the cooling water from the RF cavity in order to recover the impedance as much as possible (See Fig. 6).

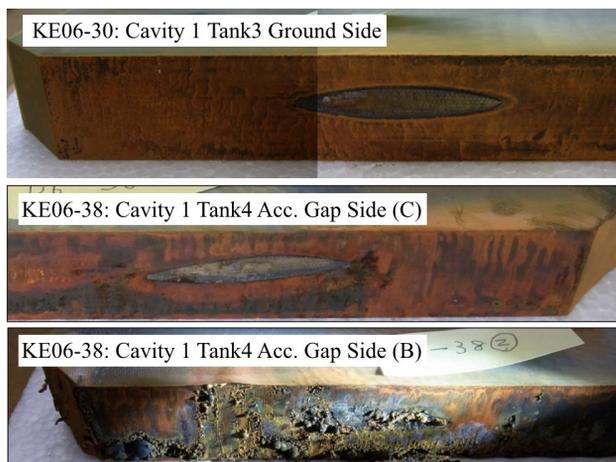
Next, we describe the MA core condition in RF cavity 1. Opening the Cavity 1, we found that the cutting surfaces of all cores were rusted like KE06-30 in Fig. 7. The cutting surface of the core, KE06-38 Acc. gap side B in Fig. 7, was damaged, and it might be caused by the high RF field. The slow impedance reductions were caused by the corrosion. However large reductions were caused by the damage of the cutting surface.

Figure 7: Photos of cutting surfaces.

To solve the issue of cutting surface corrosion, we have two different approaches. One is improving the cooling water quality by adding filters and separating the cooling system of RF cavities from the main magnets. Another is coating of cutting surfaces to prevent rusting. We have been developing the coating on the cutting surface with an inorganic polymer to prevent the corrosion.

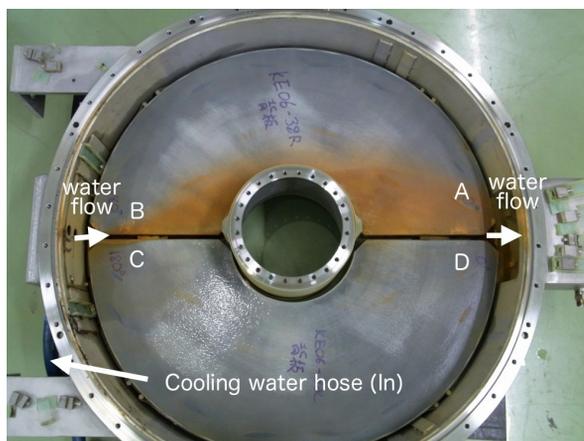
Fig. 8 shows the core KE06-38 in the water tank 4. From the rust color in Fig. 8, it is found that the flow of cooling water was not symmetrical. This asymmetry was caused by the position of the cooling water hose. The cutting surfaces that face the flow of cooling water, in this case cutting surface B, were damaged. It is noteworthy that CuO was detected on the damaged cutting surface.

Figure 8: Photo of the core KE06-38 in the water tank 4.

For the following circumstances, we speculate that the copper ions or colloids in the cooling water accelerate the corrosion process.

- (1) The MR cooling water contains copper ions and colloids.
- (2) From October 2009 when the impedance started to decrease, the duty of MR was increased, and accordingly copper ions or colloids in cooling water from copper hollow conductors of the main magnets (B, Q) is thought to be increased.
- (3) The cutting surfaces that face the flow of cooling water were damaged.
- (4) The CuO was detected on the damaged cutting surface.
