SNS STRIPPER FOIL FAILURE MODES AND THEIR CURES*

M. Plum, J. Galambos, S. Kim, P. Ladd, C. Luck, C. Peters, Y. Polsky, R. Shaw,
Oak Ridge National Laboratory*, Oak Ridge, TN, USA
R. Macek, Los Alamos National Laboratory, Los Alamos, NM, USA
D. Raparia, Brookhaven National Laboratory, Upton, NY, USA

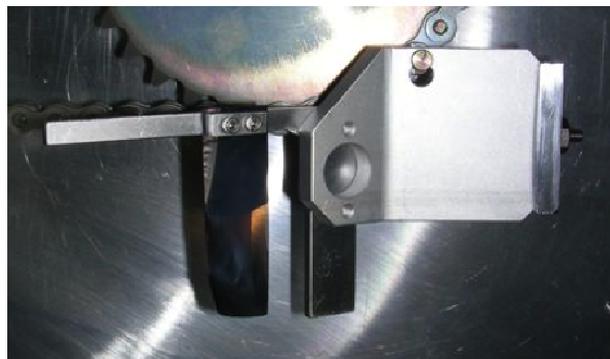
Figure. 1. A first generation foil bracket mounted on the foil-changer mechanism. The long arm and leg of the L-shaped bracket are designed to stretch carbon fibers across the span to support foils if needed (not used in this case).

The first failure mechanism is simple – the lower portion of the L-shaped bracket was too close to the foil, so the convoy electrons struck the bracket on their first revolution around the magnetic field lines. It should be stressed that this failure mechanism is actually a bracket failure, not a foil failure. A photo of a second generation bracket (the type in use at the times of the first set of failures) is shown in Fig. 2. An example of a failed bracket is shown in Fig. 3. The bottom-left corner of the bracket shows the melting that occurred from the convoy electrons striking the bracket. The large melted area on the lower right shows where a counterweight was attached before the material around the mounting hole melted, causing the counterweight to fall off.

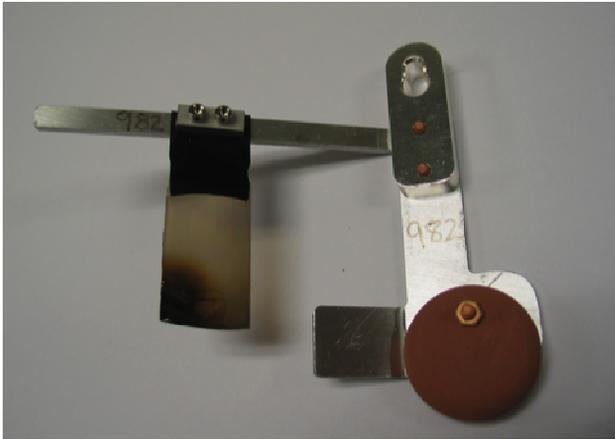
Figure 2. A used second-generation foil bracket. The beam power in this case was only 400 kW, so this foil and bracket show very little damage.

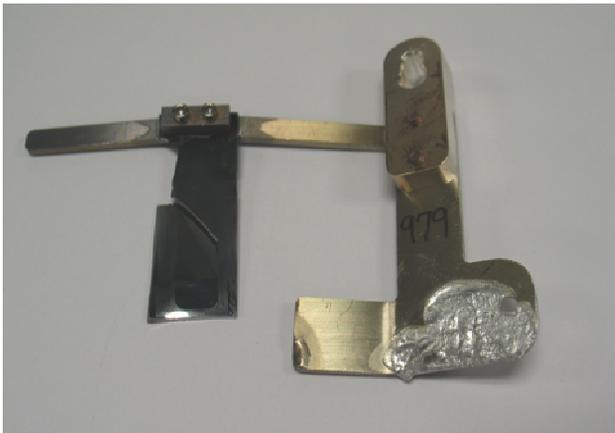
The second failure mechanism is reflected convoy electrons. If the electrons are not properly captured by the electron catcher, some may reflect back up into the vacuum chamber and strike the foil and/or the bracket. The electron catcher material is a carbon-carbon composite (since carbon has a relatively low reflection coefficient), with angled undercut faces where the electrons are supposed to hit in order to aim any reflected electrons in the downward direction.

Figure 3. A failed second-generation foil and bracket. This foil lasted for a few hours at a beam power of ~840kW.

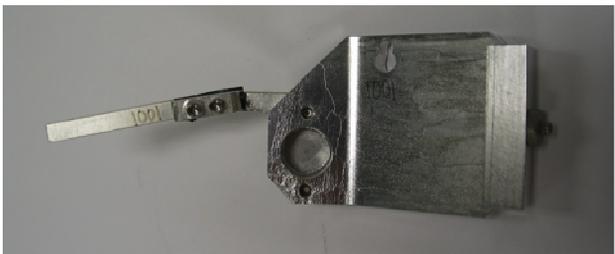
Figure 4. A used third-generation foil bracket

However, some electrons can hit the upward-facing surfaces of the electron catcher and reflect back up toward the foil and bracket. Figure 4 shows a third-generation foil and bracket. The lower leg on this bracket was removed so that the convoy electrons would not hit it as they travel down to the electron catcher, yet it still shows melting damage on the lower left corner, and the arm of the bracket has also softened enough to allow the arm to droop down. We believe that the melting on the lower left corner is due to reflected convoy electrons. Although some of these reflected electrons also strike the foil and the bracket arm, they cannot explain all the damage to this part of the bracket.

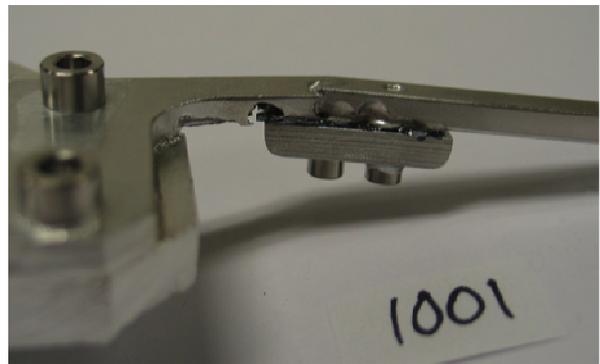
The third failure mechanism is cathode-spot in-vacuum breakdown. This form of electrical breakdown can take place in a perfect vacuum. To initiate the breakdown, the anode (foil) first develops a positive electrical charge due to secondary electron emission. If the foil is hot enough, thermionic electron emission can further charge the foil. The next step is evaporation of sharp points on the cathode (bracket) that become hot from field emission due to the strong electric field between the bracket and the foil. The evaporated cathode material then provides the gaseous environment needed to sustain the breakdown. Each breakdown event creates a small crater in the bracket, and over time large holes develop. Figure 5 shows a close up photo of the same bracket as in Fig. 4. Several holes can be seen where the foil substrate was clamped to the bracket. One hole passes completely through the bracket arm. The top of the bracket also shows similar material erosion at locations where the foil substrate had sharp edges that helped initiate the vacuum breakdown events.

Figure 5. A close-up view of the foil clamp for the bracket shown in Fig. 4.

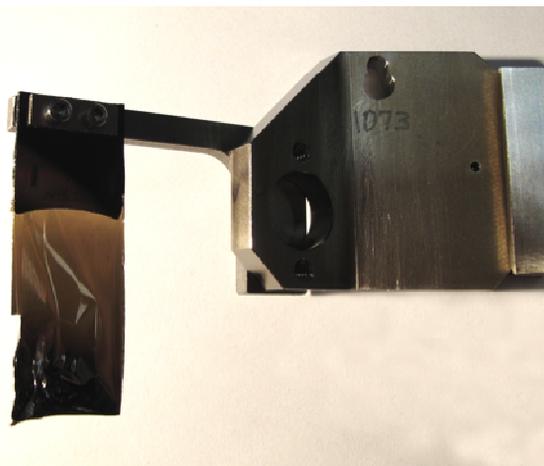
A new set of foils, half with the gold foil mounting and half without, were installed for the September to December 2009 run cycle. The first foil selected was one with the gold foil mounting method, and it lasted the entire run cycle, even after increasing the beam power to 1 MW. The total charge delivered to the target using this foil was 4820 C, to be compared to the previous high-power record of 978 C. The used bracket shows no signs of damage, although there is an unknown coating on the upstream side of the bracket and foil substrate that is not understood at this time. The foil itself is blackened, twisted, and wrinkled, but it was still performing well at the end of the run cycle. A photograph of this foil, taken after it was removed in February 2010, is shown in Fig. 6. For the present February to June 2010 run cycle, we are using a foil mounted without gold, and to date it has also functioned well.

Figure 6. Photo of the foil and bracket that lasted the entire Sept. – Dec. 2009 run cycle at high beam power.

During the summer of 2009 several modifications were made to the foil and the bracket. The bracket material was changed from aluminium to titanium, since the thermal expansion coefficient of titanium is much better matched to that of silicon. Also titanium has a relatively high melting point, good electrical conductivity, and it is lightweight. However, the radioactivation properties are not as good as aluminium due to its high atomic number. The bracket and clamp are machined flat, and before clamping the foil to the bracket, both the bracket arm and the clamp are carefully polished to remove any sharp points that can contribute to cathode-spot in-vacuum breakdown. Some of the foils we installed in September

2009 were also sandwiched between layers of gold foil ~0.025 mm thick to help improve the large-area electrical contact between the foil and the bracket. The foils were also moved 1 cm further out on the arms of the brackets to improve the clearance for the circulating convoy electrons, and the arms and legs of the brackets were made as short as possible to remove any excess material that could be struck by beam halo or reflected convoy electrons. Note that some additional length will need to be added to both the arm and the leg in order to mount fiber-supported foils.

The foil itself was modified to have up to a 35-mm free-standing length (shorter silicon substrate) to prevent beam halo and reflected convoy electrons from striking the substrate.
