# *Beam Commissioning Status of Superconducting Crab Cavities in KEKB*

MOOCMH03  
(May/2010)

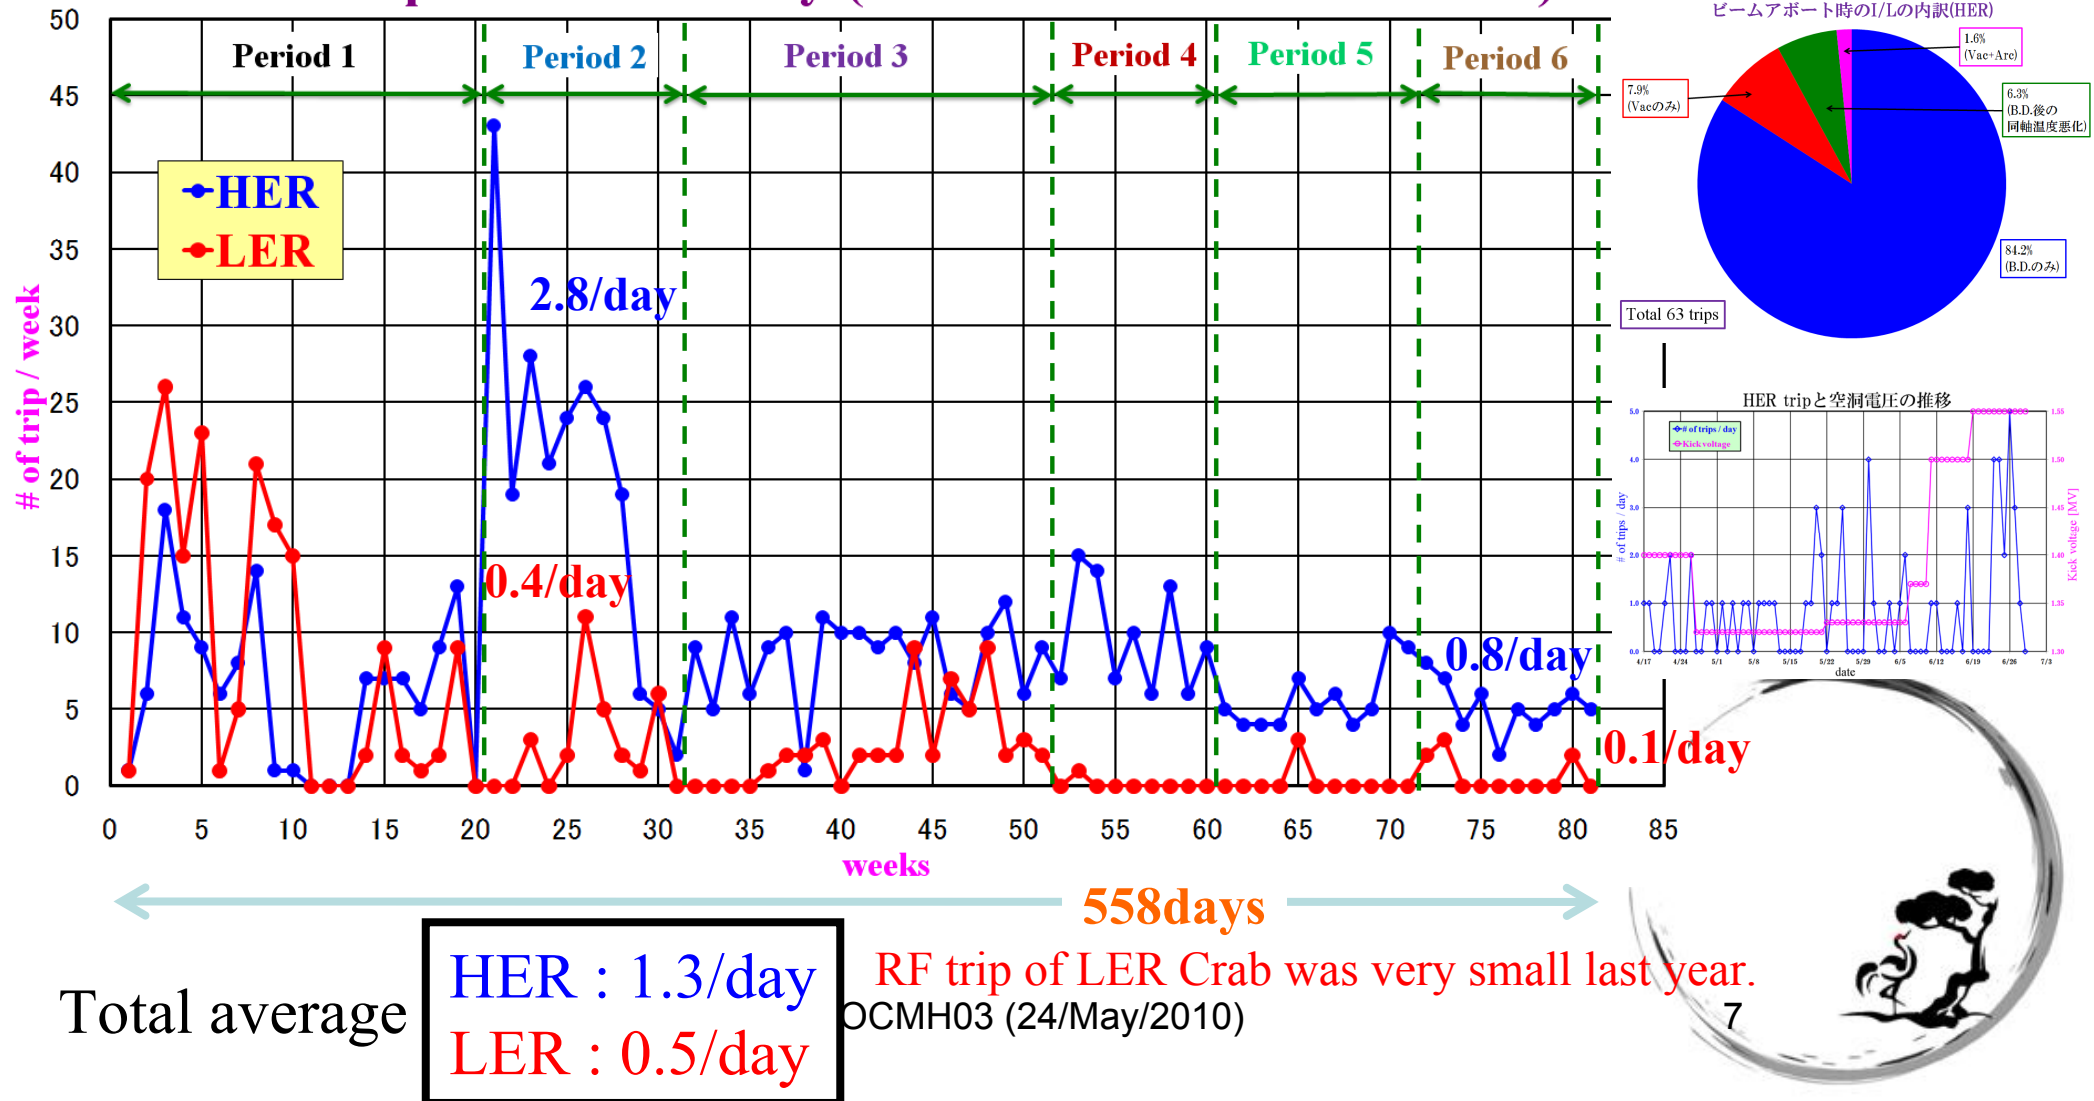
## RF Trip of Crab Cavity (13/Feb/2007~24/Dec/2009)

Period 1 : Feb/2007~Jun/2007, Period 2 : Oct/2007~Dec/2007, Period 3 : Feb/2008~Jun/2008

Period 4 : Oct/2008~Dec/2008, Period 5 : Apr/2009~Jun/2009, Period 6 : Oct/2009~Dec/2009

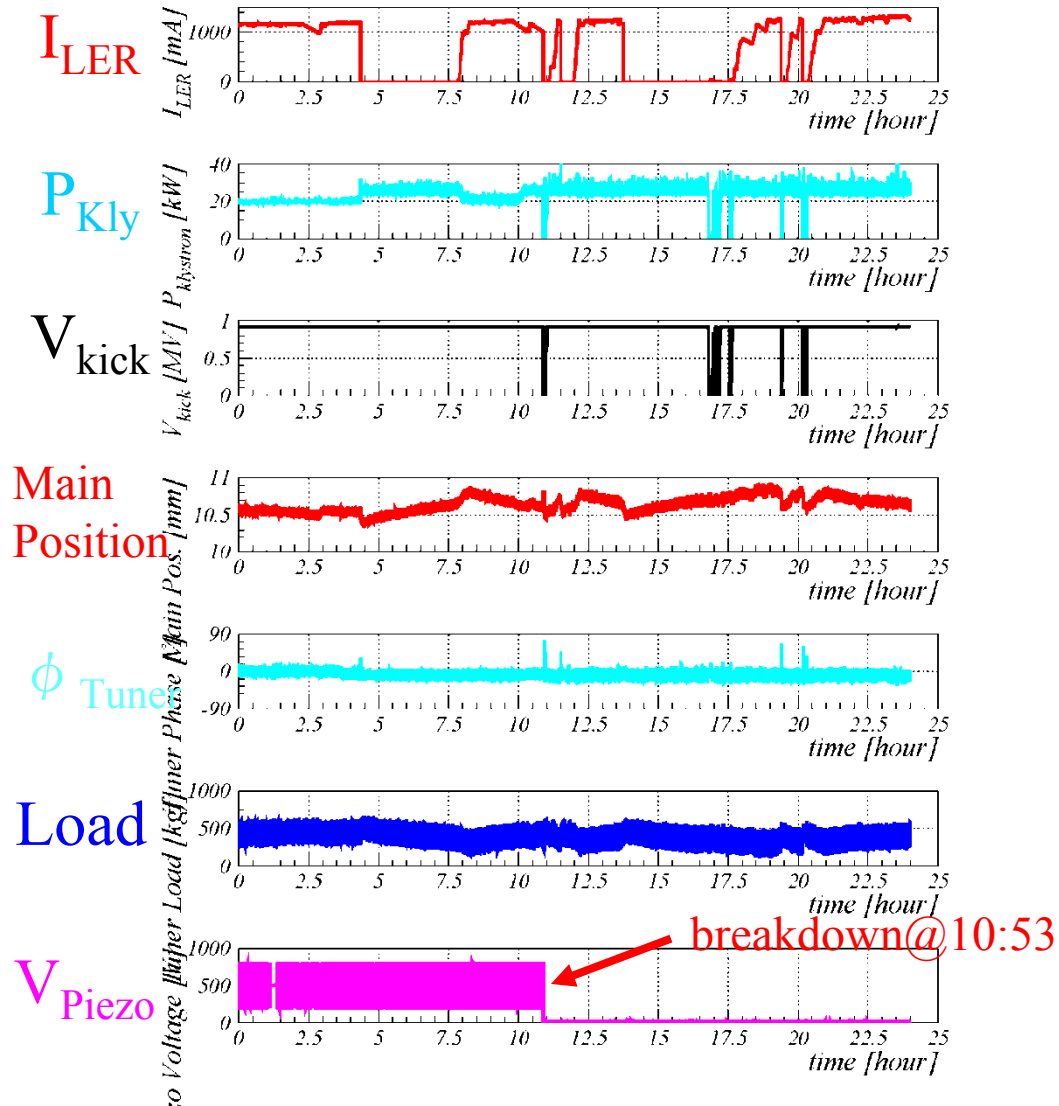
Commissioning for LER Crab Cavity ('07/6/23)

# Piezo actuator breakdown

Low level feedback system can control Crab cavity without Piezo.

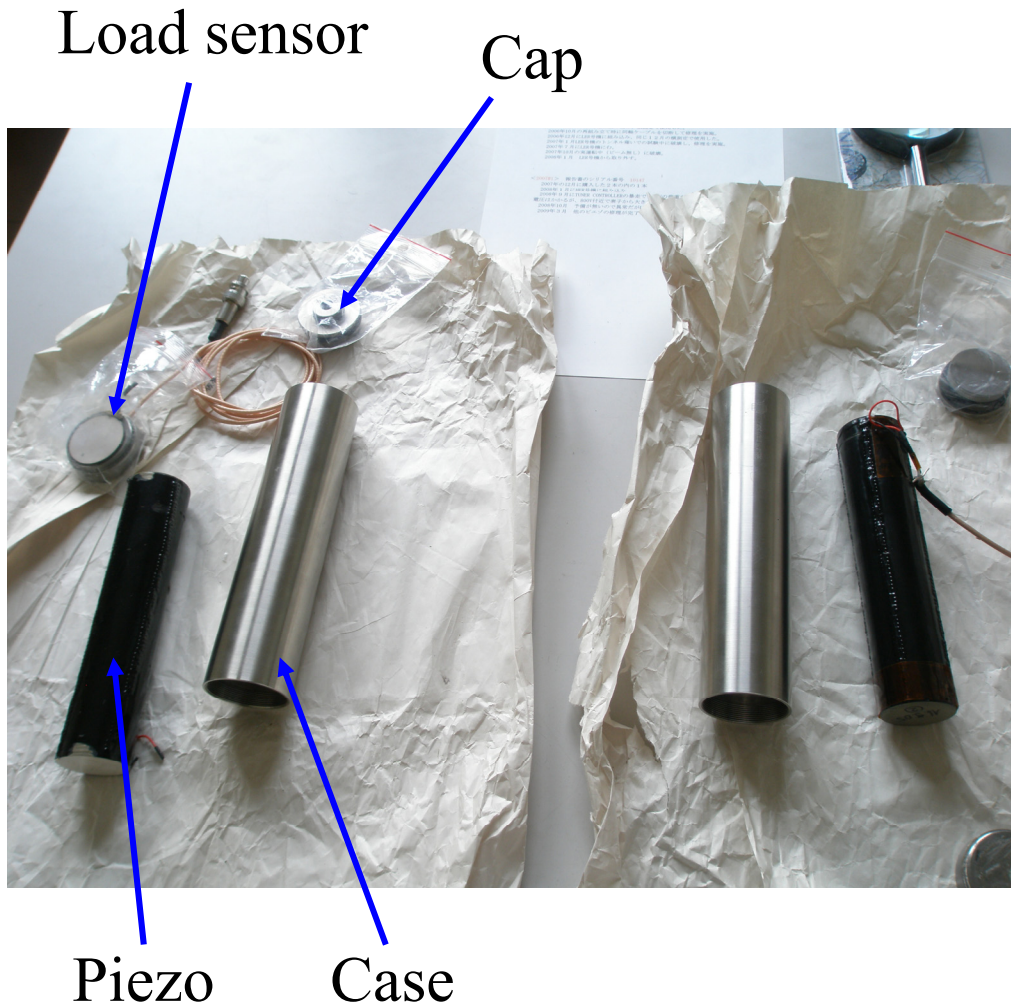
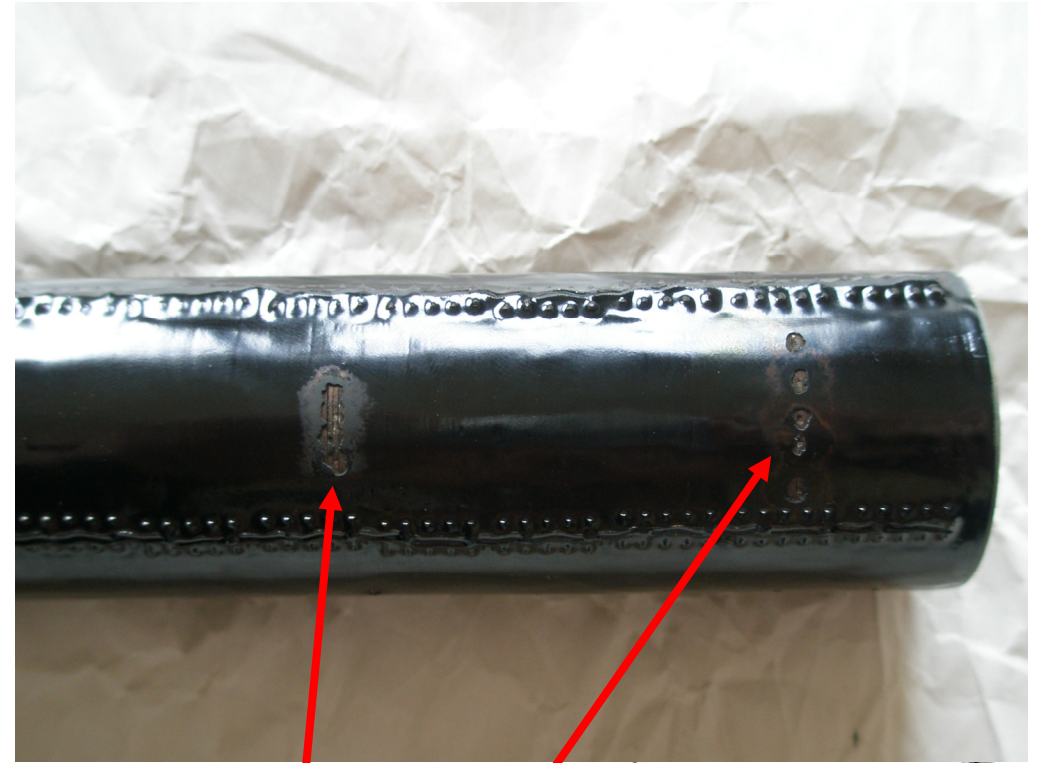
discharge traces

We observed so many discharge traces on Piezo surface.  
This problem may be caused by adding an over-load to Piezo horizontally.

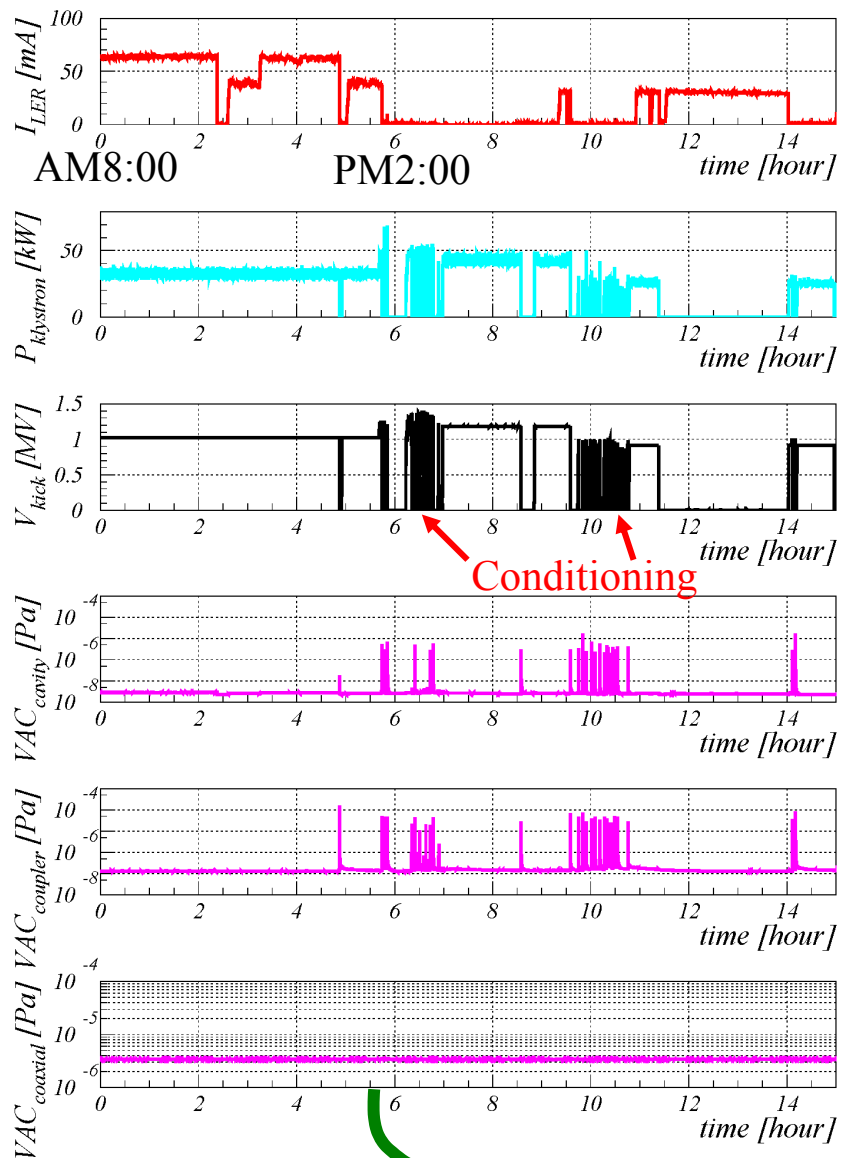
Commissioning for LER Crab Cavity ('07/3/17)

Cavity voltage of LER Crab was better than HER at horizontal test.  
But, after installation to beam line, it dropped gradually.  
And, it dropped suddenly from 1.3 to 1.0MV in Mar/17/2007.

# What occurred on “black day”?

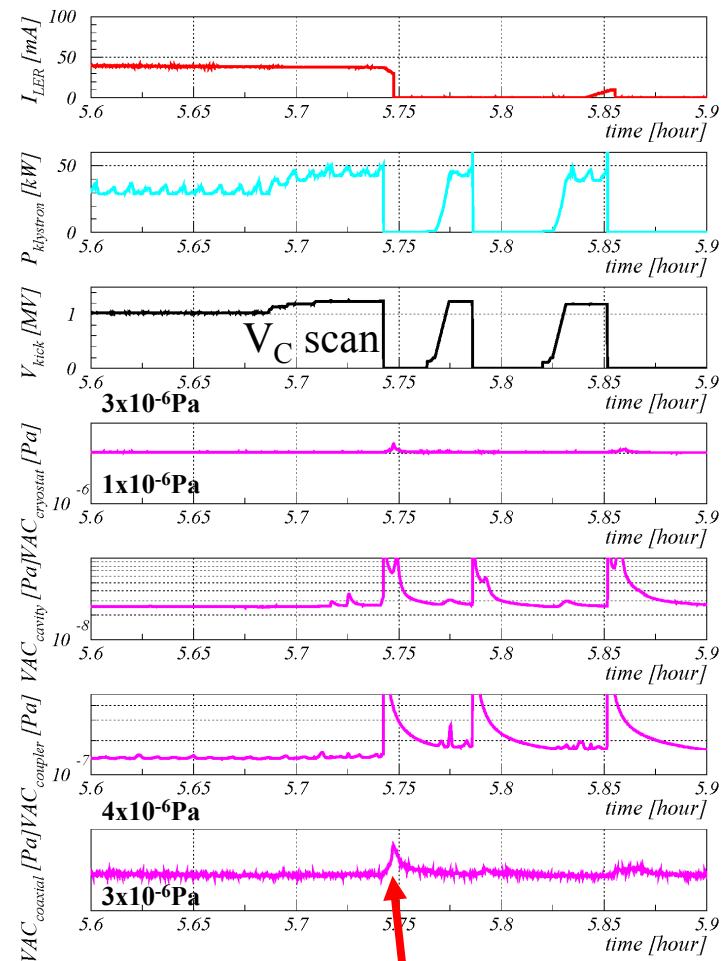
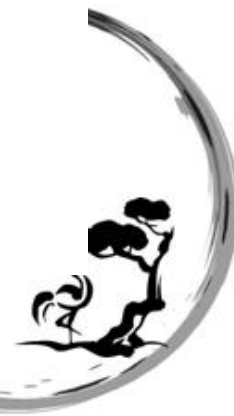
Commissioning for LER Crab Cavity ('07/3/17)

abnormal vacuum burst!

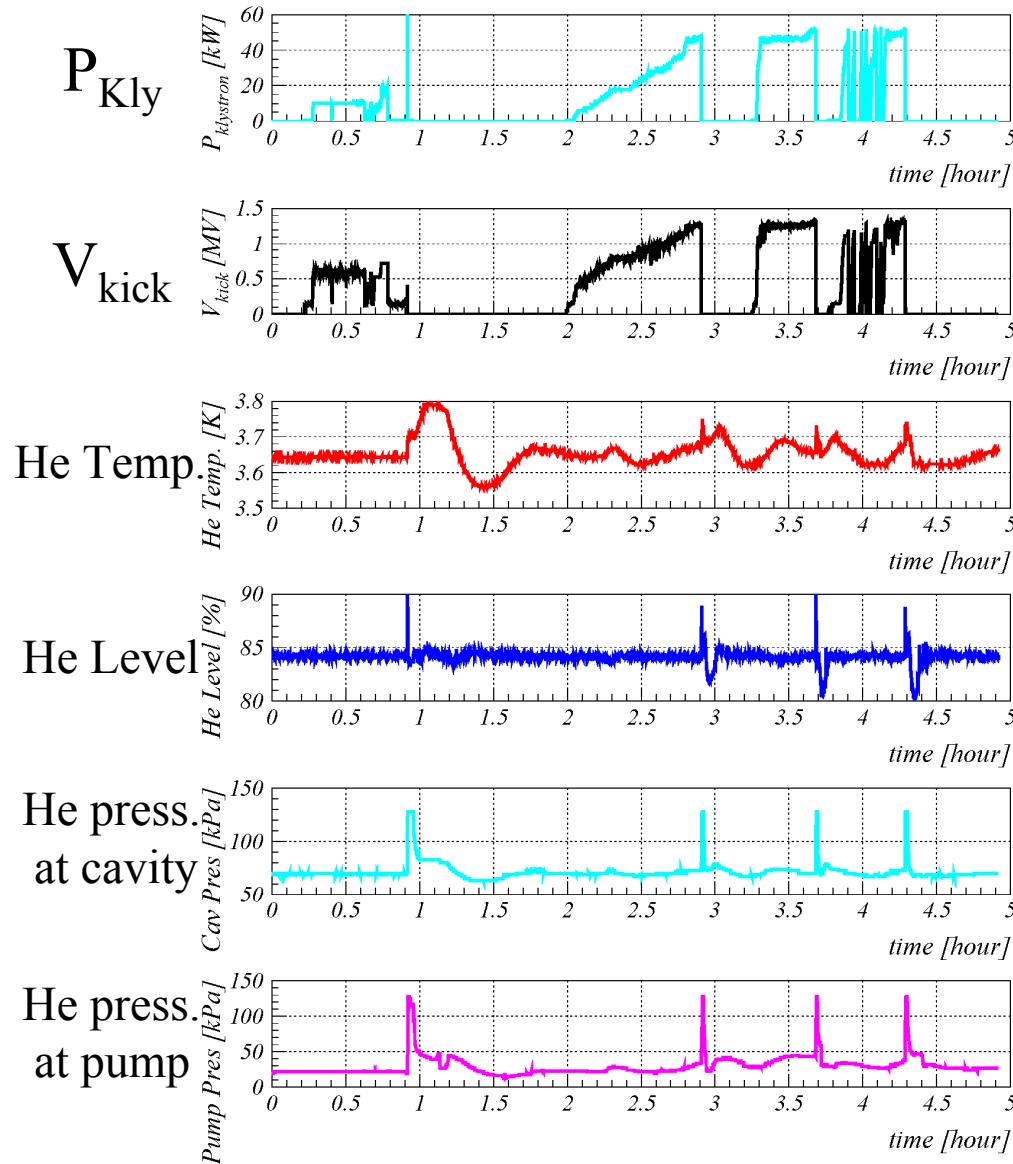
Commissioning for LER Crab Cavity ('09/4/6)

Hosoyama-san's group tried lower temperature operation than 4.2K.

**Lower temperature operation was successful!**  
**The operation was stable around 3.6K.**

But, performance of LER Crab cavity was not recovered.

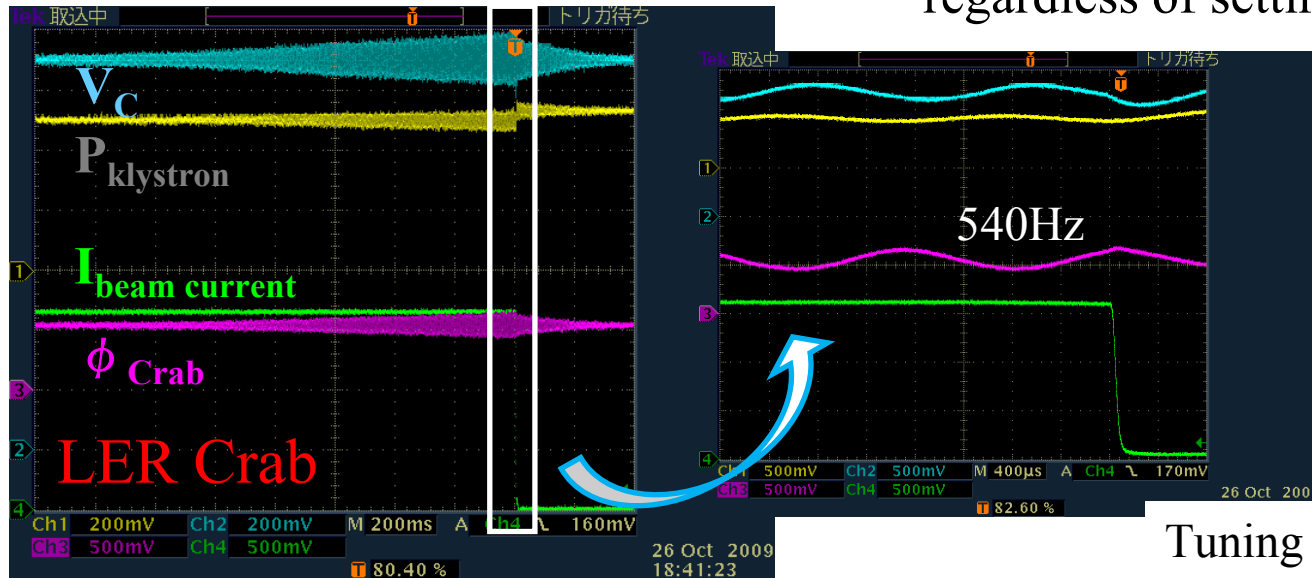
Oscillation occurred again in autumn/2009, regardless of setting same values as previous.

Tuning phase offset :  $+15^\circ$  (HER)  
 $-10^\circ$  (LER)

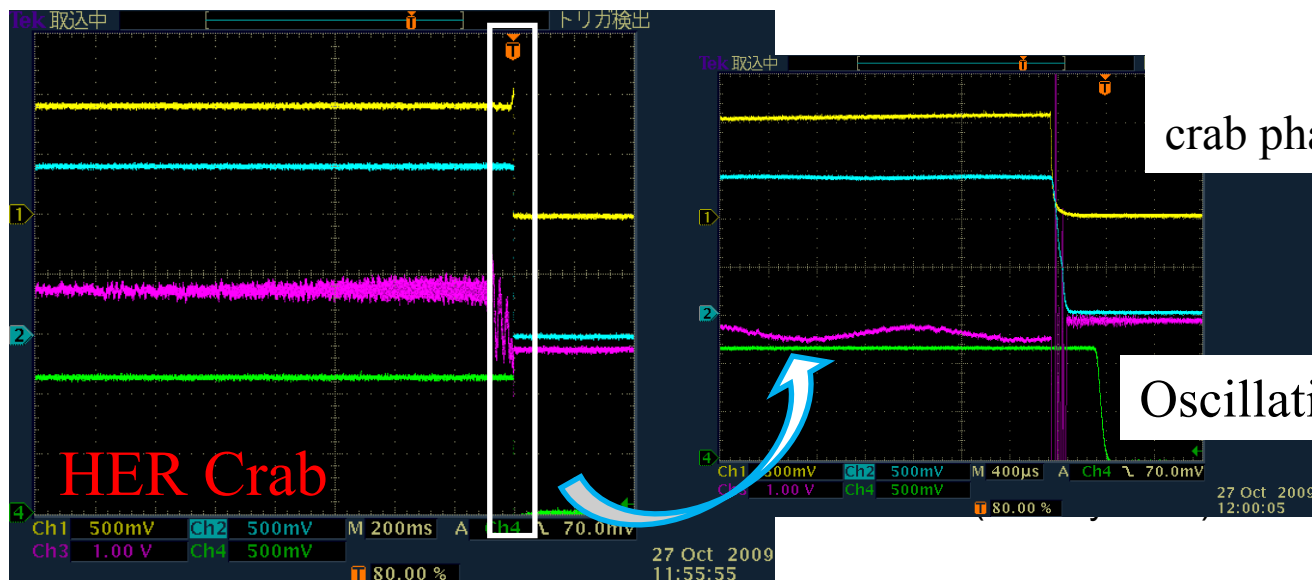
Oscillation is suppressed again!

crab phase :  $\sim +19^\circ$  (HER/LER)
