ANALYSIS OF KICKER NOISE INDUCED BEAM EMITTANCE GROWTH*

W. Zhang[#], J. Sandberg, L. Ahrens, M. I. Blackler, J.M. Brennan, M. Blaskiewicz, W. Fischer, H. Hahn, H. Huang, N. Kling, M. Lafky, G. Marr, K. Mernick, J. Mi, M. Minty, C. Naylor, T. Roser, T. Shrey, B. van Kuik, A. Zelenski, BNL, Upton, NY 11973, USA

Over the last few years, physicists have occasionally observed the presence of noise acting on the RHIC beams leading to emittance growth at high beam energies. While the noise was sporadic in the past, it became persistent during the Run-11 setup period. An investigation diagnosed the source as originating from the RHIC dump kicker system. Once identified the issue was quickly resolved. We report in this paper the investigation result, circuit analysis, measured and simulated waveforms, solutions, and future plans.

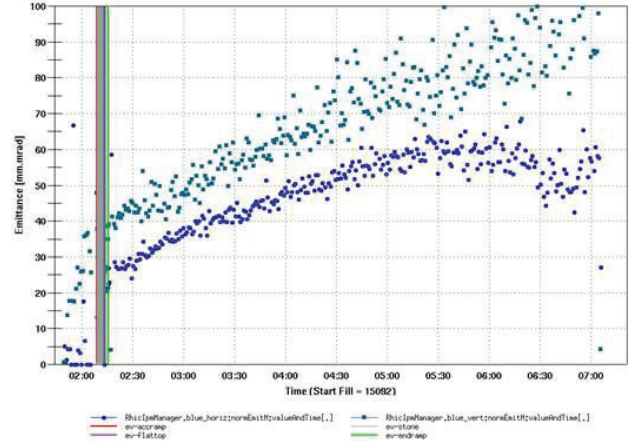
The Blue ring beam emittance growth was intermittent at first, and then became persistent. The figure below shows that the emittances were blown up in both planes. In about three hours, the beam emittance would approximately double as shown in Figure 1, which prevented operation. It suggests as a possibility that the source has high power and is generated by a magnetic dipole field with a random component or impulse excitation. Beam diagnostics clearly identified the source as being in the horizontal plane with excitations present also at injection energy.

Figure 1: RHIC Blue beam emittance growth measure by IPM in fill #15092.

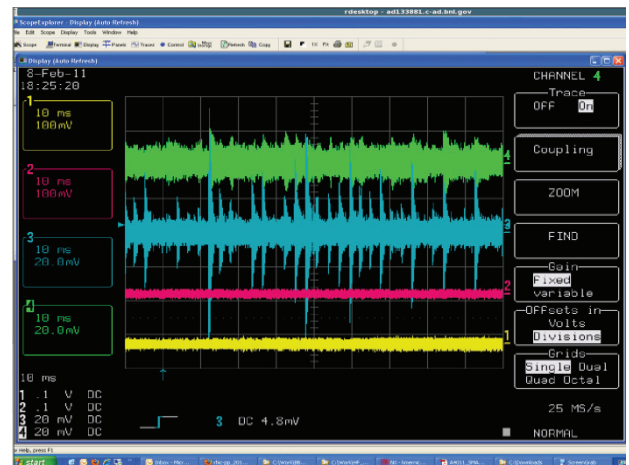
The blue traces in Figure 2 and Figure 3 show the noisy Blue beam waveforms measured by base-band tune meter (BBQ) system. In comparison, the yellow trace is the Yellow beam signal.

Figure 2: The blue trace is the Blue difference signals of the base-band tune meter; and the yellow trace is the Yellow difference signals of the base-band tune meter. The horizontal scale is 10 ms per division.

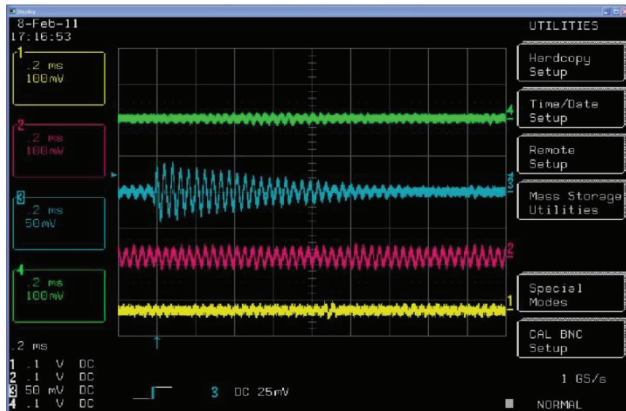
Figure 3: The blue trace is the Blue difference signals of the base-band tune meter; and the yellow trace is the Yellow difference signals of the base-band tune meter. The horizontal scale is 0.2 ms per division, much more expanded than in Figure 2.

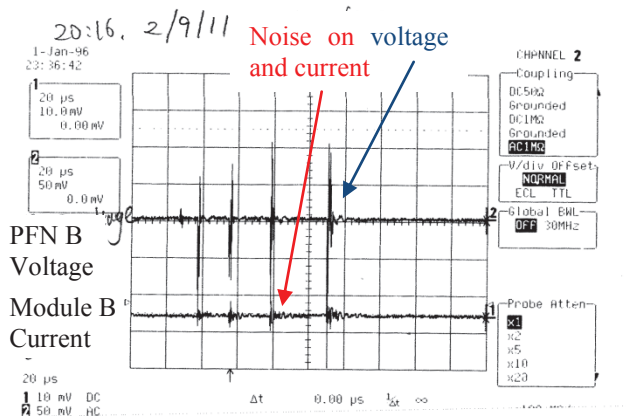
noise signal, we removed all attenuators and adjusted the scope to near maximal signal resolution. It enabled us to find the noise current in one of the pulse modulators, Blue module B. The noise signals on module B PFN voltage and charging current waveforms are shown in Figure 4.

Figure 4: Noise on PFN voltage monitoring signal and magnet current monitoring signal.

In the following days, we observed that the noise signature was random and intermittent. It behaved like a dynamic spark gap discharging at random voltage level. Its damped oscillation waveform with random oscillating frequency suggested a parallel circuit of varying capacitor and resistor. The channel 1 in Figure 4 was the noise current detected by the current transformer without attenuators. The vertical scale is 10 mV per division and 0.01 V per ampere. From the picture, the noise current was of order 10 mA. The noise current oscillation usually damped out in several 10s of ms.

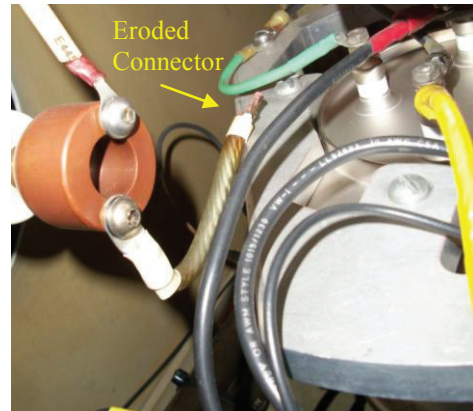
Eventually, an eroded connector inside a wire lug was found. It was mounted beneath the thyatron base plate and not visible from the front, as shown in Figure 5. The repair was easy and fast, although the investigation took days.

Figure 5: The eroded connector being placed on the thyatron base plate.

The discovery of the eroded connector prompted us to replace similar connectors in all ten modulators. The erosion of the connector could be the result of a combination of several factors, such as improper construction technique, high current induced metallic migration, and radiation induced metal erosion, etc.

We plan to routinely check current signals during start up and replace high current connectors when necessary to ensure the operation reliability of the system.

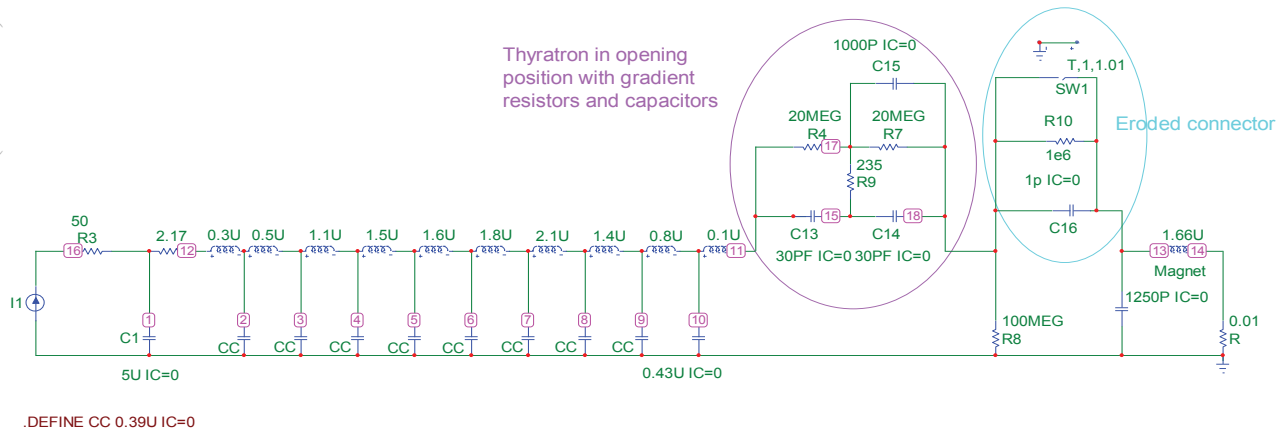
eroded connector was in between the thyatron cathode and the magnet high voltage lead. There was a small bypass capacitor across the magnet feed-through. We modelled the eroded connector by a switch (SW1), a capacitor (C16), and a resistor (R10) in parallel. This was to simulate a connection with random air gap.

Figure 7: The enhanced circuit model of beam dump kicker for noise analysis.

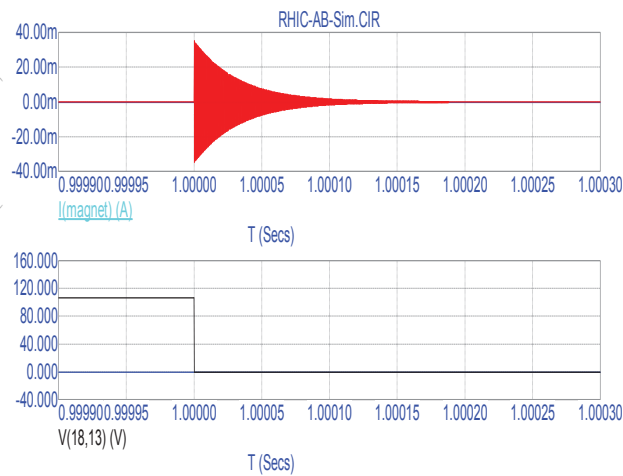
The capacitor slowly charged up during initial PFN charging and tracking, and suddenly discharged by the switch representing a spark gap. The simulated leakage current through the magnet is shown in Figure 8.

Figure 8: The upper trace is the leakage current of the kicker and the lower trace is the voltage across the nodes of the dynamic circuit model representing the eroded connector.

The simulated noise current is about 40 mA in amplitude with an oscillatory waveform similar to some of the measured noise signatures. This noise current is about a few millionths of the peak discharge current and well below the resolution of the normal monitoring capability.
