A REVIEW OF 14 YEARS OF OPERATION OF HELIOS 2 AT SSSL*

Li Zhiwang, Diao Cao Zheng, Miao Hua, Chew Eh Piew, Alaric Wong, Mark B H Breese
Singapore Synchrotron Light Source (SSLS), National University of Singapore
5 Research Link, Singapore 117603

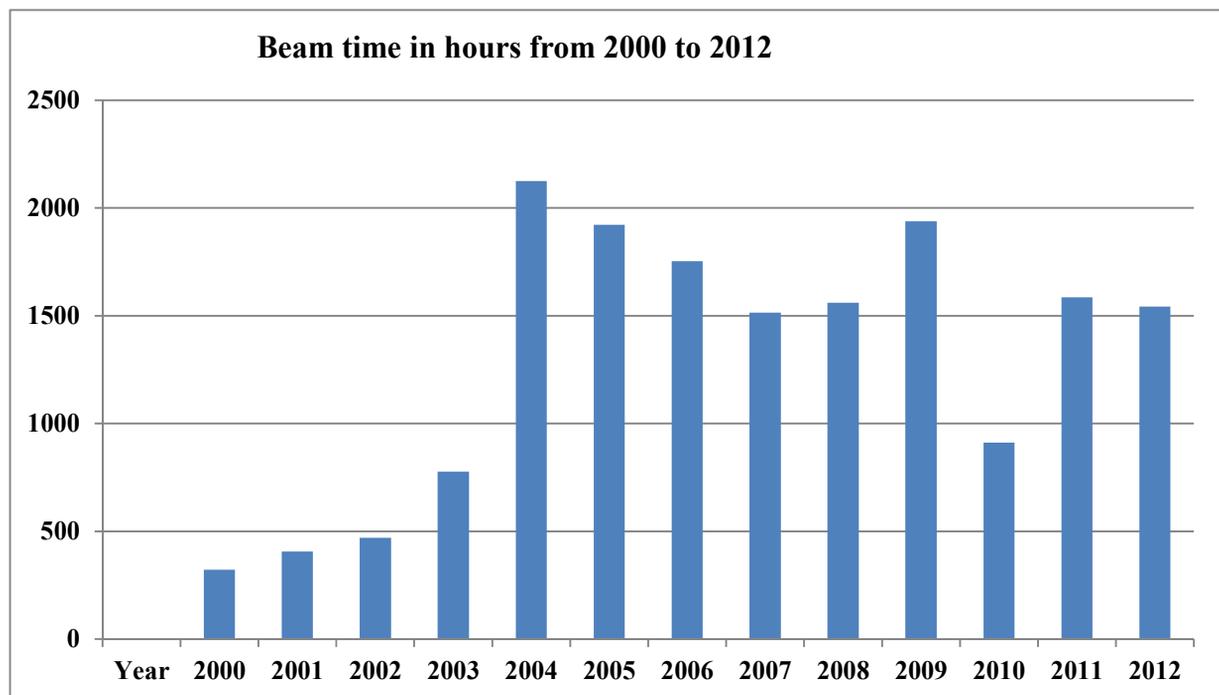
Figure 1: SSSL beam hours for each year.

Helios 2 was manufactured by Oxford Instruments, and delivered to Singapore in 1999. The first beam was injected and stored in the ring in June of 2000. During the last 14 years, we have encountered a variety of problems related to Helios 2. Table 2 lists the major problems each year from 2000 to 2013. Despite many technical problems, we have been able to provide 1000 to 2000 hours per year. Fig.1 shows a graph of SSSL beam hours delivered for each year. The low beam hour from 2000 to 2003 was due to the fridge losing its cooling capacity, and the relatively lower beam hour delivered in 2010 was due to a ring gate valve and an air regulator became faulty.
