# 1<sup>ST</sup> YEAR OPERATION OF THE ALBA SYNCHROTRON LIGHT SOURCE

F. Perez on behalf of the Accelerator Division,  
CELLS - ALBA, Cerdanyola del Valles, Barcelona, Spain.

ALBA is a 3 GeV, 3<sup>rd</sup> generation, synchrotron light source located in Cerdanyola del Vallès, near Barcelona (Spain), which started users operation in May 2012.

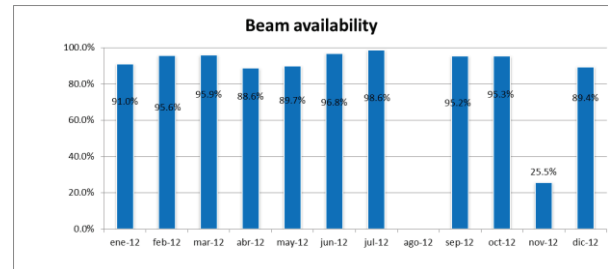
Figure 2 shows the availability along the eleven runs of 2012. The average beam availability has been 94 % without taking into account the run in November, when as a consequence of a large vacuum incident the operation was stopped for two weeks. The Mean Time Between Failures (MTBF) for 2012 has been 21 h.

Figure 2: Beam availability per month along 2012.

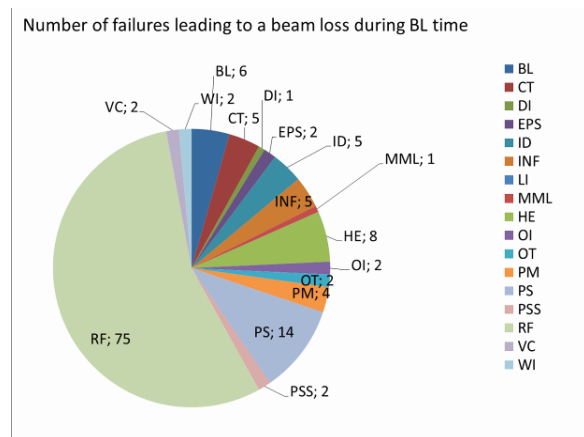
Figure 3 shows the number of trips per main sub-system and figure 4 indicates the down time due to each sub-system excluding the vacuum incident, which as a single incident accounted for 57% of the total down time in 2012.

Figure 3: Number of trips per sub-system along 2012.

Analysis of figures 3 and 4 tells us that the main sub-systems causing problems are the RF and the power supplies (PS). The RF system has many failures with a short recovery time, while the power supplies have less failures but produce longer down times. This time has been reduced by improving the protocols dealing with power supplies replacement after a PS trip. The vacuum incident, the analysis of the RF failures and some additional problems faced during 2012 are described in the following paragraphs.

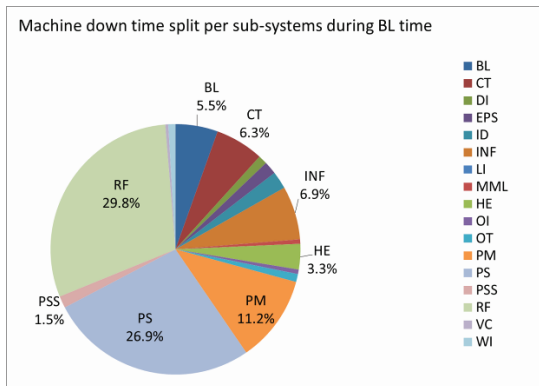
Figure 4: Down time for each sub-system, excluding the vacuum incident.

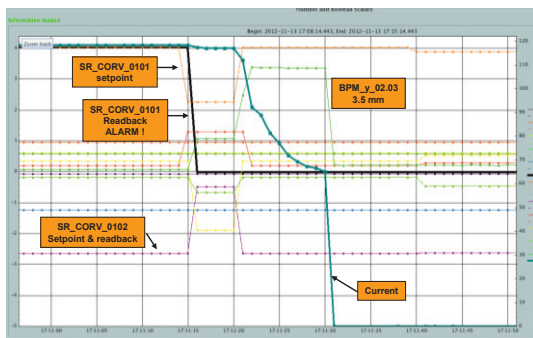
The vacuum incident took place on November 13th. The previous week had been a shut down week in which, among other maintenance tasks, there have been functional tests on the FOFB system and internal parameters on the SR corrector power supplies had been exchanged and unfortunately not replaced.

In parallel there is an attempt to bring the orbit to the um level. At this moment, 21 vertical correctors went off because the internal parameters were not correct. The orbit correction applied is removed because it is observed that the orbit has increased. Since there are 21 correctors off, the orbit does not return to the initial value but keeps getting away from the nominal.

Figure 5: SR\_CORV\_0101 With the first change applied the corrector (setpoint=thin orange line) enters in alarm, and switches off (thick black line). The orbit (green line) moves to +1 mm, and when the correction is removed the orbit jumps to 3.5 mm on this specific BPM.

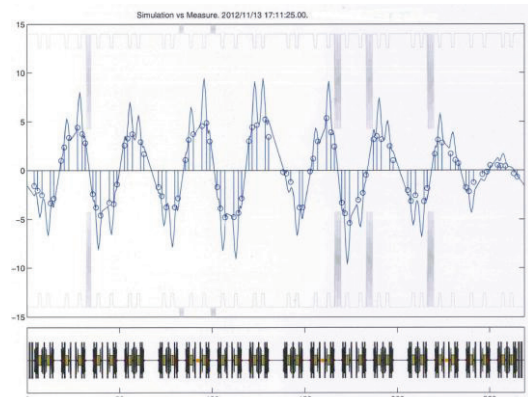
There are excursions up to  $\pm 10$  mm in the vertical plane, the beam scrapes the vacuum chamber and immediately after five sectors in the SR indicate pressures in the  $10^{-3}$  mbar range.

Figure 6: Maximum orbit distortion during the incident: Lines show the simulation and circles are the measurements at the BPMs. In grey the machine minimum vertical apertures are shown.

The day after systematic leak detection is performed around the SR. Leaks are “only” found in the VAT seal of the flange downstream of the dipoles. Having checked

that there are enough spares, a systematic program to replace 13 damaged seals starts. One week later there is a first injection in the SR of 1 mA. It is confirmed that no further damage is present. After that an intensive schedule for vacuum cleaning is established, figure 7 shows the recovery of the product lifetime x current. Two weeks after the incident, 100 mA were provided to the BLs.

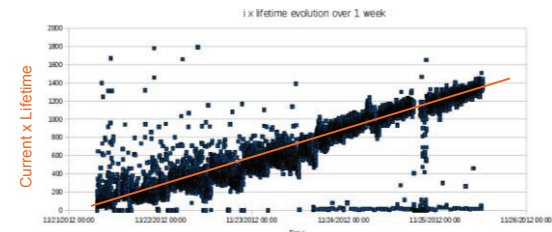
Figure 7: Recovery of the current x lifetime product after the vacuum incident.

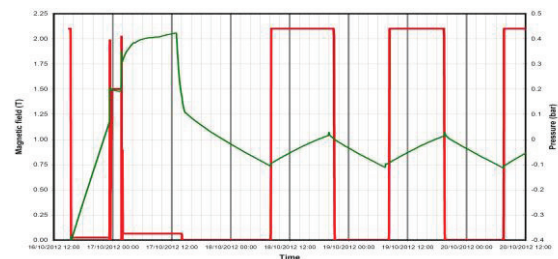
The most severe incident with an ID happened in October 16th. The exit condenser bridge of one power supply of SCW30 was burned, leading to an increase of electrical output noise. This induced extra heating in the wiggler coils, through eddy currents, that the cryocoolers were not able to extract. Because of that, the SCW30 could only be operated during half a day, needing the next half day for cooling. This situation affected RUN #9 and lasted for two weeks. It was solved during the shutdown period right after the run, by replacing the burned condenser bridge.

Figure 8: Evolution of internal pressure (green line) and magnetic field (red line) in the superconducting wiggler during the October incident showing the 12 h on/off sequence.
