VACUUM BRAZING OF THE NEW RFQ FOR THE J-PARC LINAC

T. Morishita*, Y. Kondo, K. Hasegawa, JAEA, Tokai, Japan

Abstract

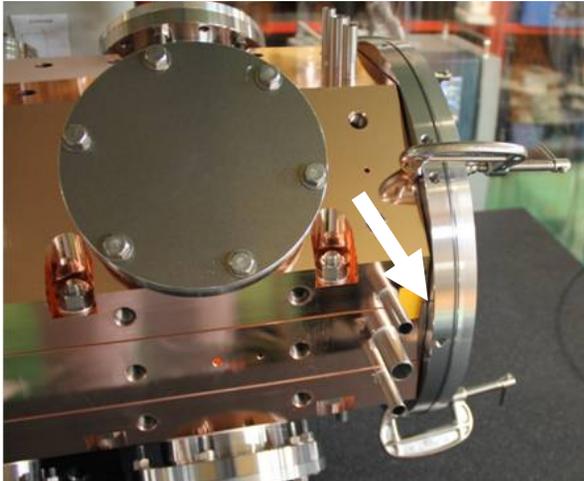
Figure 2: The vacuum leak at the stainless-steel flange.

We found the vacuum leak at the stainless-steel flange location indicated in Fig. 2. We speculate that nonuniform heating during the brazing was the cause. The heating speed of the vacuum furnace was set to be 300 degrees C/h from the room temperature up to 600 degrees C. This heating speed may have been too fast for uniform heating of the vanes. Figure 3 shows the measured temperature

We think that the leaking flange was pushed out by the unequal differential thermal expansion of the vane and then brazed at a mismatched position. We tried re-brazing by putting additional brazing alloy near the leak, however, the vacuum seal failed. We then removed the stainless-steel flange with a dry-cutting method and re-brazed. The method of securing the stainless-steel flange was changed from the staking to bolting with a compression spring. The spring is made of a carbon fiber composite. The strength of this spring is constant in a temperature range up to 1000 degrees C.

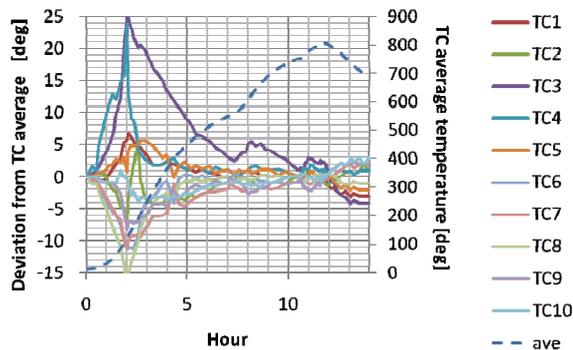
Figure 3: Temperature distribution during the brazing. Dashed line (right scale) is the average temperature of all TCs. The other lines (left scale) are the deviation of each TC from the average temperature.

from the TCs set on the cavity. The dashed line is the average temperature of all the TCs; the other curves are the deviation of each TC from the average temperature. The temperatures measured by TC3 and 4 (the bottom major vane) are momentarily higher by about 40 degrees C over the other vanes at the beginning of the brazing.

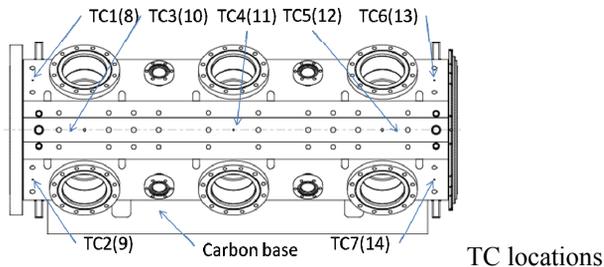
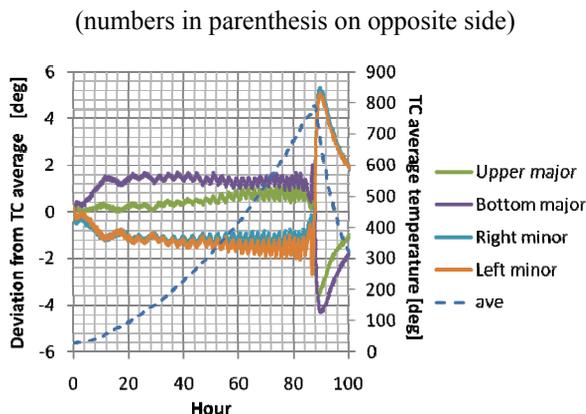
Figure 5: Temperature distribution during the second unit brazing process. Dashed line (right scale) is the average temperature of all the TCs. The other lines (left scale) are the deviation of the vane temperature from the average.

During the heating, the maximum temperature deviation was typically 5.5 degrees C. The heating speed of the furnace was made as slow as 10 - 50 degrees C/h while the temperature was less than 600 degrees C, however, the deviation increases during the heating. Then, the heating speed was manually controlled. The comb-like

fluctuation is coming from the furnace temperature control. The largest deviation was about 9 degrees C at the cooling phase just after the final heating.

During the second unit brazing, a clear tendency in the temperature differences between vanes can be seen in Fig. 5. The temperatures of the minor vanes are lower than those of the major vanes. The ratio of the outer surface area to the volume of the minor vanes is smaller than that of the major vanes. Therefore, this could cause the rate of temperature increase to be different between the major and minor vanes. Based on this assumption, we will try to put heat absorbers on the minor vanes to speed up their rate of temperature increase. In addition, the temperature of the lower major vane is slightly higher than that of the upper major vane, so that we will enhance the thermal shield for the carbon base.

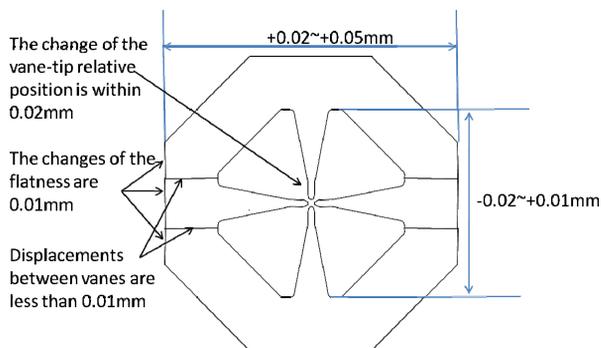
Figure 6: Deformation after the brazing. Inner height is measured at the both ends of the unit cavity.

After the brazing, it is confirmed that the vacuum seal was good. The deformation and the displacement are in the tolerable range. Figure 6 shows the deformation after the brazing as measured by CMM. Displacements between vanes are less than 0.01 mm. The deformation of the major vane is about 0.05 mm. The change of the vane-tip relative position is within 0.02mm, which is mainly due to the deformation of the major vane.
