OVERVIEW OF RECENT STUDIES AND MODIFICATIONS BEING MADE TO RHIC TO MITIGATE THE EFFECTS OF A POTENTIAL FAILURE TO THE HELIUM DISTRIBUTION SYSTEM *

J. Tuozzolo, D. Bruno, A. Di Lieto, G. Heppner, R. Karol, E. Lessard, C.J. Liaw, G. McIntyre, C. Mi, J. Reich, J. Sandberg, S. Seberg, L. Smart, T. Tallerico, Y.R. Than, C. Theisen, R. Todd, R. Zapasek, BNL, Upton, NY 11973, U.S.A.

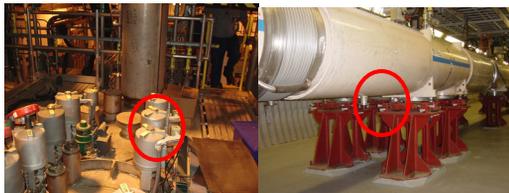
The magnets cryostats, the vacuum jacketed helium transfer pipes between magnets, and the cryostats for the valve boxes in the service buildings are equipped with safety relief devices. Unfortunately, these reliefs vent locally in the tunnel or the service buildings (see Fig. 3). An arc failure of the magnet bus at full current could release up to 70 MJ of energy which could breach the 4.2K helium line in the insulating vacuum volume. In addition, gas cooled leads for the main magnet bus and for corrector magnet systems are located in both the tunnel and the power supply buildings.

Figure 3: Vacuum Volume Pressure Reliefs, Service Building (left) and Tunnel (right).

- The valve box vacuum vessel relief system was upgraded and piping for external venting was added.
- The gas cooled lead feedthrough electrical insulators on the valve boxes were upgraded and plexiglass covers was added over the lead area to direct gas flow up and away from the personnel access walkways in the event of a failure.
- The gas cooled lead feedthrough assemblies were upgraded with improved heater systems and thermal

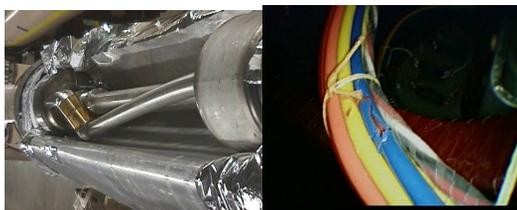
- (2000) During commissioning, a bellows restraint on the magnet line failed in multiple locations as the result. The magnet bus within was not damaged.
- (2002) Chaffed wire insulation occurred because the expansion joint for cooldown and warm-up did not provide enough travel. (Fig. 4).
- (2005) Corrosion on ceramic feedthroughs resulted in minor helium leaks at the valve boxes.
- (2008) High resistances as the result of poor solder joints repaired in the high current quadrupole bus.
- (2009) Insulators for the high current (up to 6000A) bus lead feedthroughs began to deteriorate. Fortunately, none of them caused high value damage or resulted major release of helium. But it was recognized that there is potential for an arc flash or helium release.

Figure 4: Left side, (2000) failed bellows restraint. Right side, (2002) damaged electrical insulation.

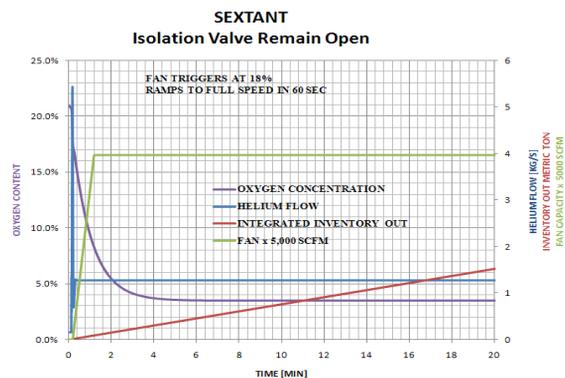
Those two factors taken together indicated a higher level of risk for workers in the tunnel and service buildings while the RHIC cryogenic system and magnets were on. Without a system to detect and isolate helium from the adjacent sectors in RHIC and the refrigerator itself, they could introduce a large volume of helium gas into the tunnel or a service building. Detailed calculations were done to quantify this effect and found that oxygen levels could fall to as low as 4% after a catastrophic failure into the insulating vacuum (Fig. 5).

Figure 5: ODH Calculation Result for Unchecked Helium Release into the RHIC Tunnel

Immediately, the personnel access rules were changed. The RHIC tunnel and service buildings were reclassified as ODH 1 areas. The following changes were made:

- All workers entering the tunnels and service buildings needed ODH 1 training and needed to carry personal protection equipment for ODH 1: a personal oxygen monitor and an oxygen bottle escape pack.
- To reduce the probability and energy in an arc flash failure, magnets in RHIC were no longer ramped above injection current with personnel in the tunnel.

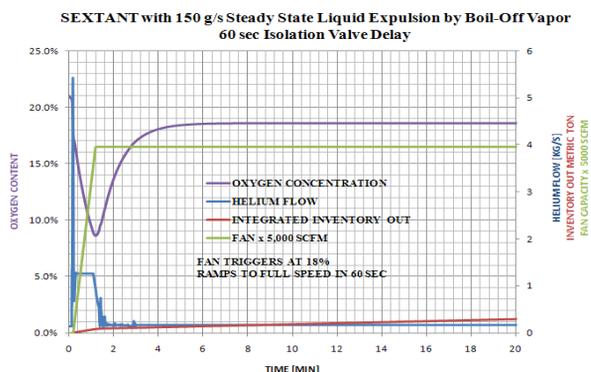
Figure 6: ODH Calculation Result for Helium. Release into the RHIC Tunnel with Intervention

In 2009, sector isolation tests which closed off the distribution lines and the refrigerator supply to the ring with existing cryogenic valves were performed in the RHIC tunnels. Now the cryogenic control room can monitor indicators and implement this intervention when personnel are in the tunnels for maintenance and repair. As shown in Fig. 6, with a 60 second delay in implementing isolation, the oxygen level in the tunnel

reaches 9% but quickly recovers to safe levels as the exhaust fans start and the helium loss rate diminishes.
