THE OAK RIDGE ISOCHRONOUS CYCLOTRON REFURBISHMENT PROJECT*

A.J. Mendez[#], J.B. Ball[†], D.T. Dowling[‡], S.W. Mosko[§], B.A. Tatum[✧], ORNL, Oak Ridge, TN 37831, U.S.A.

Abstract

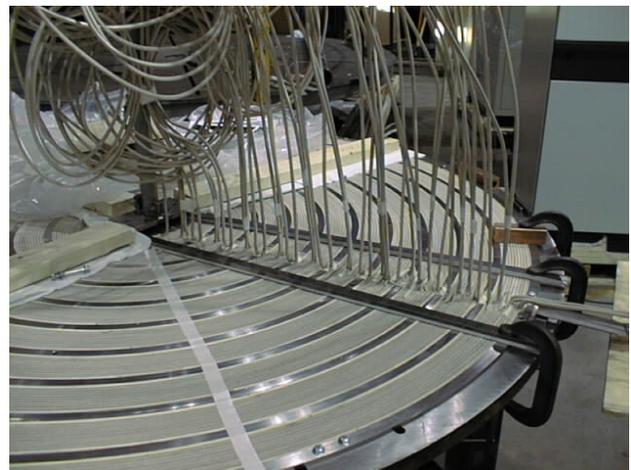
This new set of trim coils was fabricated (see Figure 1) that year and placed in storage, where they sat for the next ten years, awaiting the need to be installed.

Figure 1: Photograph of single trim coil assembly taken during winding of the 10 concentric coils, prior to vacuum canning.

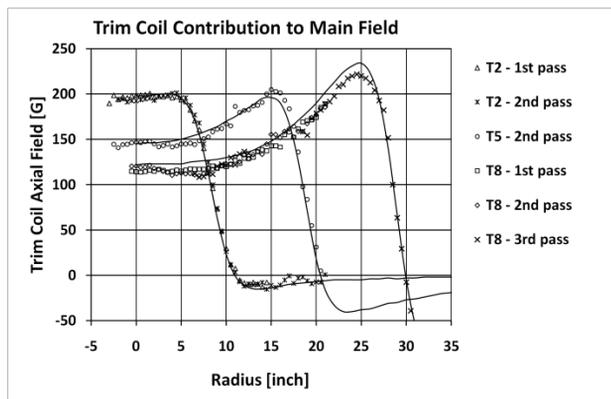
Figure 2 shows the results of scans for three of the 10 trim coils. The solid curves are data extracted from the ORIC setup codes based on field mapping done in the 70’s, when the ORIC was being converted to a booster for the Holifield tandem accelerator. The measurements are in close enough agreement with the values in the setup code to give confidence that the coils were correctly installed

Figure 2: Radial trim coil profiles. Solid curves are profiles as calculated in the setup codes. Symbols are measured values, obtained by subtracting the field profile with the trim coil off from the profile with it on.

and nearly identical to the prior set. During initial ORIC operation following the refurbishment period, very close agreement between the experimental values for the trim coil currents and those predicted by the setup codes was observed.

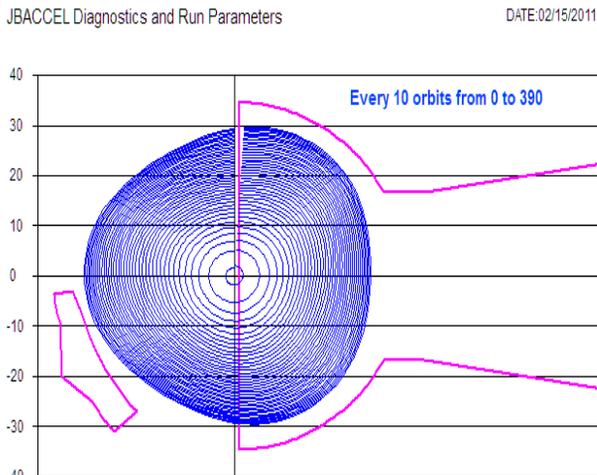
A set of orbit codes has been maintained since the 70's and has currently been updated to run on Windows-based PC's. Results from the most recent machine setup calculation are given in Figures 3-5, which illustrate the orbits in the machine, both in terms of particle path and orbit center path. In Figure 3, the beam orbits counterclockwise in a vertical plane, with the 0° azimuth being to the right in the figure. Extraction begins near 90° at the top of the machine as the beam enters the deflector. The entrance to the last extraction element (shown in the figure) is near 180°.

Figure 3: Output from the ORIC setup calculation. Dimensions are in inches. The outline of the dee and the lower magnetic channel are shown, along with the path of every 10th orbit.

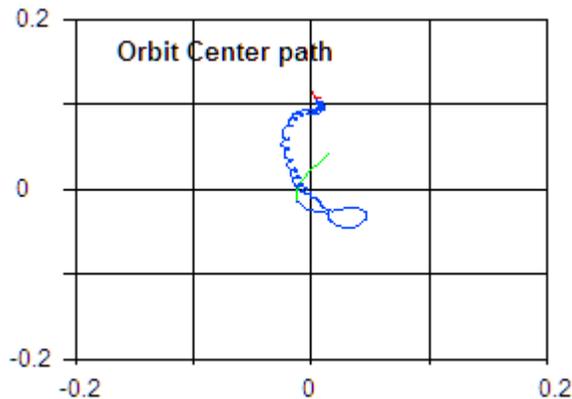
Figure 4: An x-y plot of the motion of the center of the orbit in the median plane. The maximum excursion of just over 0.1" occurs as the beam enters the deflector.

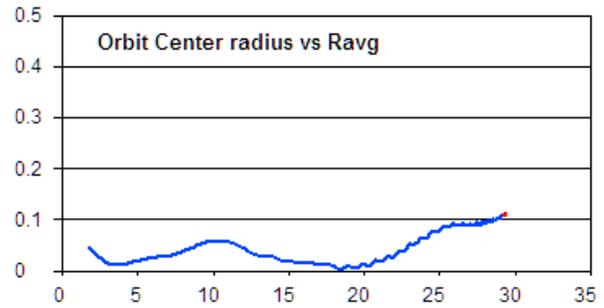
Figure 5: A plot of the radial position of the center of the orbit as a function of beam average radius, showing that the center of the orbit moves the beam toward the deflector as the beam approaches extraction radius.
