## CM2, SECOND 1.3 GHZ CRYOMODULE FABRICATION AT FERMILAB\*

CM2 is the second 1.3GHz Cryomodule assembled at the Cryomodule Assembly Facility (CAF) in Fermi National Accelerator Laboratory. The string has a corrector coil magnet, a beam position monitor and eight cavities. All cavities are qualified at  $\geq 33$  MV/m gradient at the Horizontal Test Facility (HTS) before assembly. The dressed cavities were outfitted with magnetic shielding, blade tuner. The cold mass was assembled based on the Tesla TTF Type III+ cryomodule design. CM2 is currently being installed into the test stand in NML where it will be cooled down and high power tested. CM2 will also be the first cryomodule to be tested with an electron beam at the NML facility. This paper describes the assembly steps, the quality assurance methods and the challenges experienced during assembly and qualification at CAF.

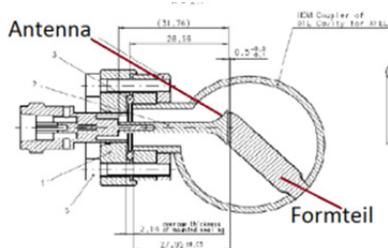
During the electrical quality assurance checks of CM2 cryomodule, electrical shorts were found in three cavities at the high order mode (HOM) feedthrough connectors. An investigation of component dimensional tolerance stack up was undertaken to determine the cause. As it can be seen from Figure 9, the design distance between the antenna tip and the formtail is 0.5 mm. Taking into account that the antenna is assembled on the connector with a press-fit method in the cleanroom prior to the assembly of the feedthrough flange to the cavity, a tolerance stack up due to out of spec dimensions of individual components might cause an electrical short when the tip of the antenna touches the formtail.

Figure 9: HOM Antenna assembly to the HOM coupler.

It was deemed that this problem will not be a critical issue for CM2 operations. However, all components in inventory were measured and the antenna tips were trimmed appropriately. It was also decided to conduct capacitance measurements on feedthrough flanges after these are assembled on the cavity in the cleanroom to ensure that there are no shorts.
