# INVESTIGATION OF SAMPLES SEPARATED FROM PROTOTYPE CAVITIES OF THE EUROPEAN XFEL

X. Singer, S. Aderhold, A. Ermakov, D. Reschke, W. Singer, K. Twarowski, (DESY, Germany)  
M. Hoss, D. Watzal (Heraeus, Germany)

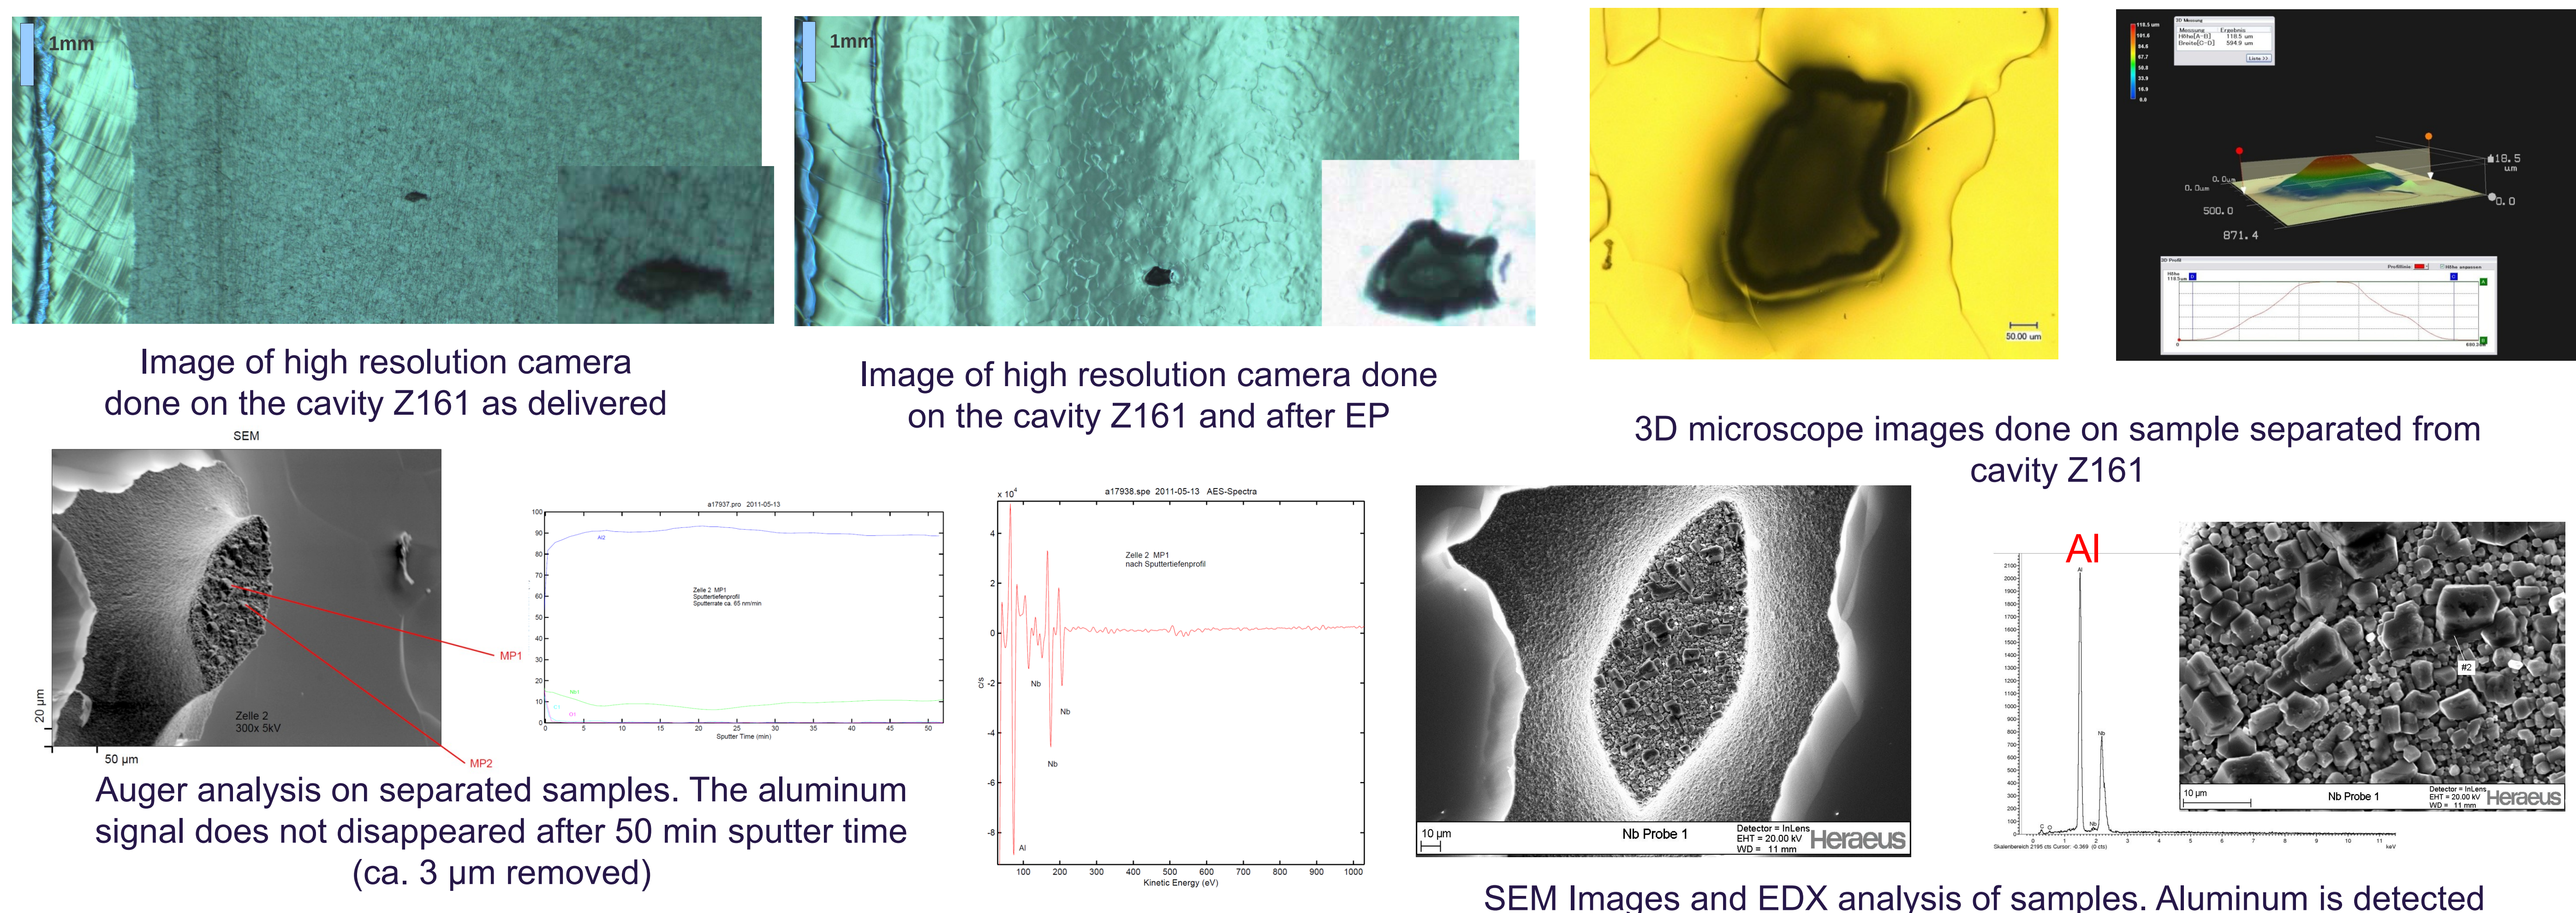
## Detected foreign elements (Aluminium): Cavity Z161, Cell2, 128°. Quench in $\pi$ -mode at 13,7 MV/m

- Aluminium detected in the black spot of cavity Z161, cell 2 caused quench according T-map. Another spots with Al also detected. Defects with Al are protruded.

- Defects with Al of cavity Z161, cell 2 investigated by Auger has a thickness at least more than 3  $\mu\text{m}$  (not a thin layer)
- It was found out (P. Michelato) that tools used for cavity EB welding can produce Al particles during cavity assembly. Probably some Al particles are adhered on the surface and partially melted during EB welding

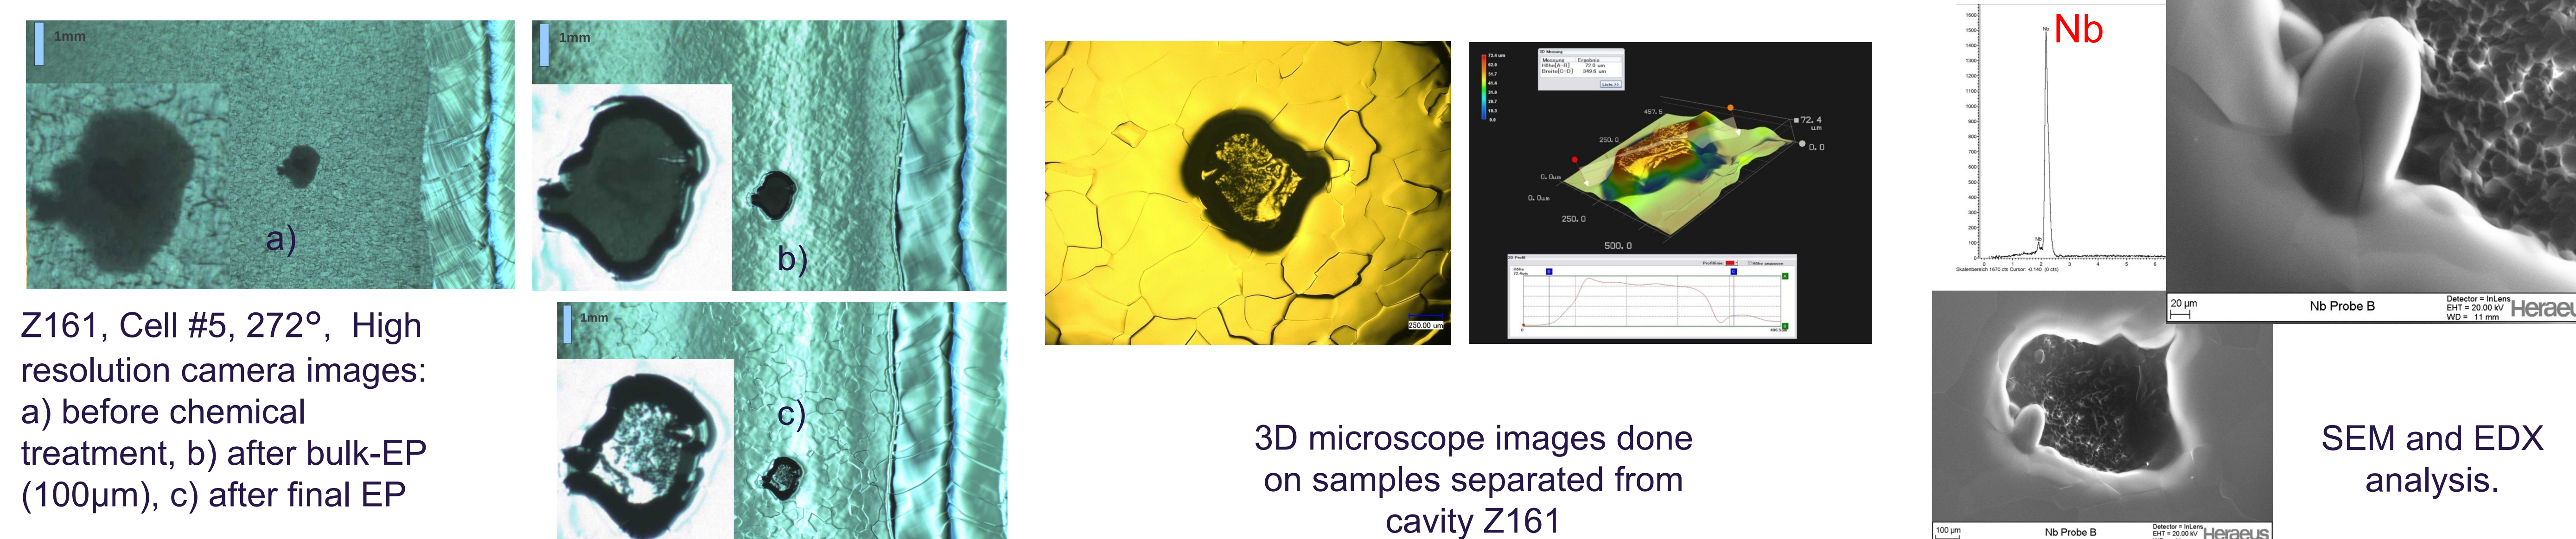
## Cavity Z161, Sample B: Quench in 7/9-, 5/9- and 1/9- $\pi$ -mode, 21 MV/m, cell 5, Tmap: 280°. Topographical defect (no foreign inclusions)

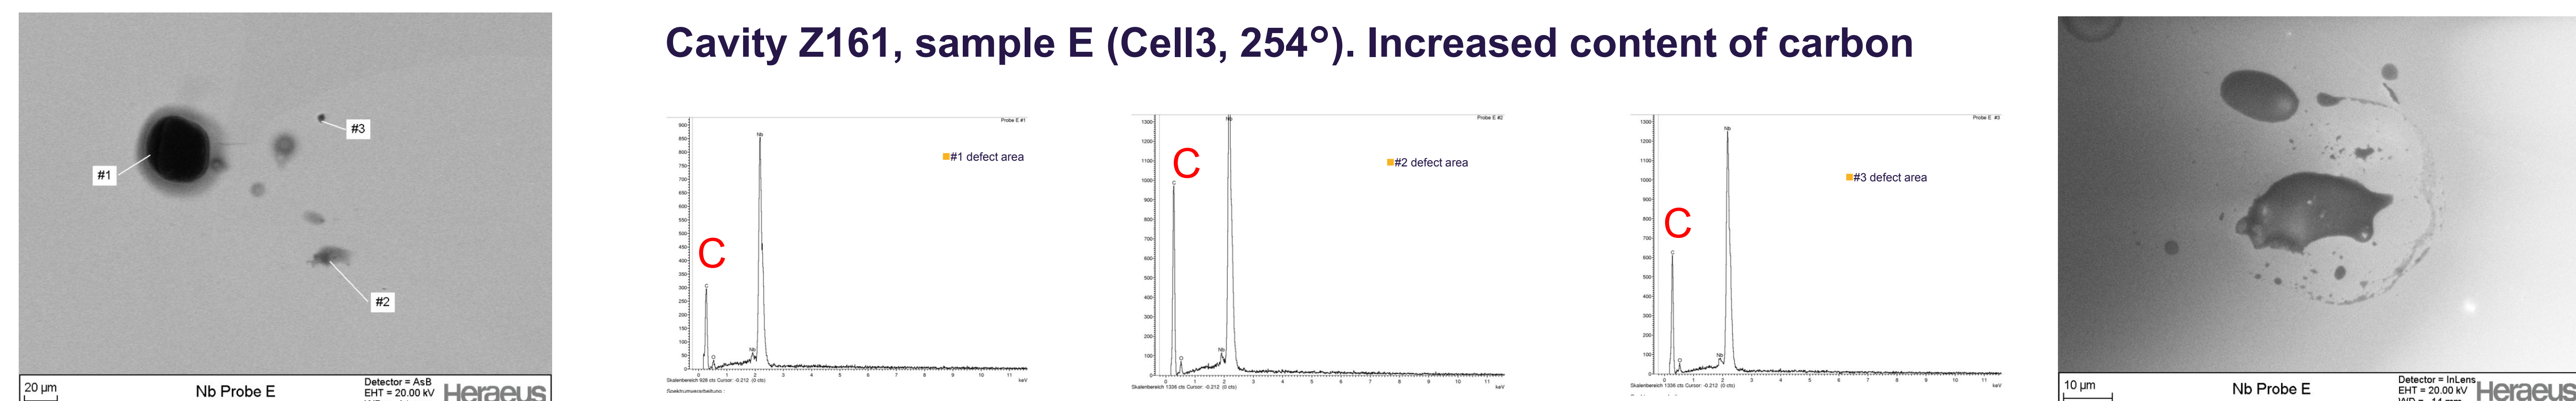
## Cavity Z161, sample E (Cell3, 254°). Increased content of carbon

- Spots with increased content of carbon have been detected by EDX in cavity Z161. Similar spots have been observed earlier in samples separated from cavities Z111 and Z130

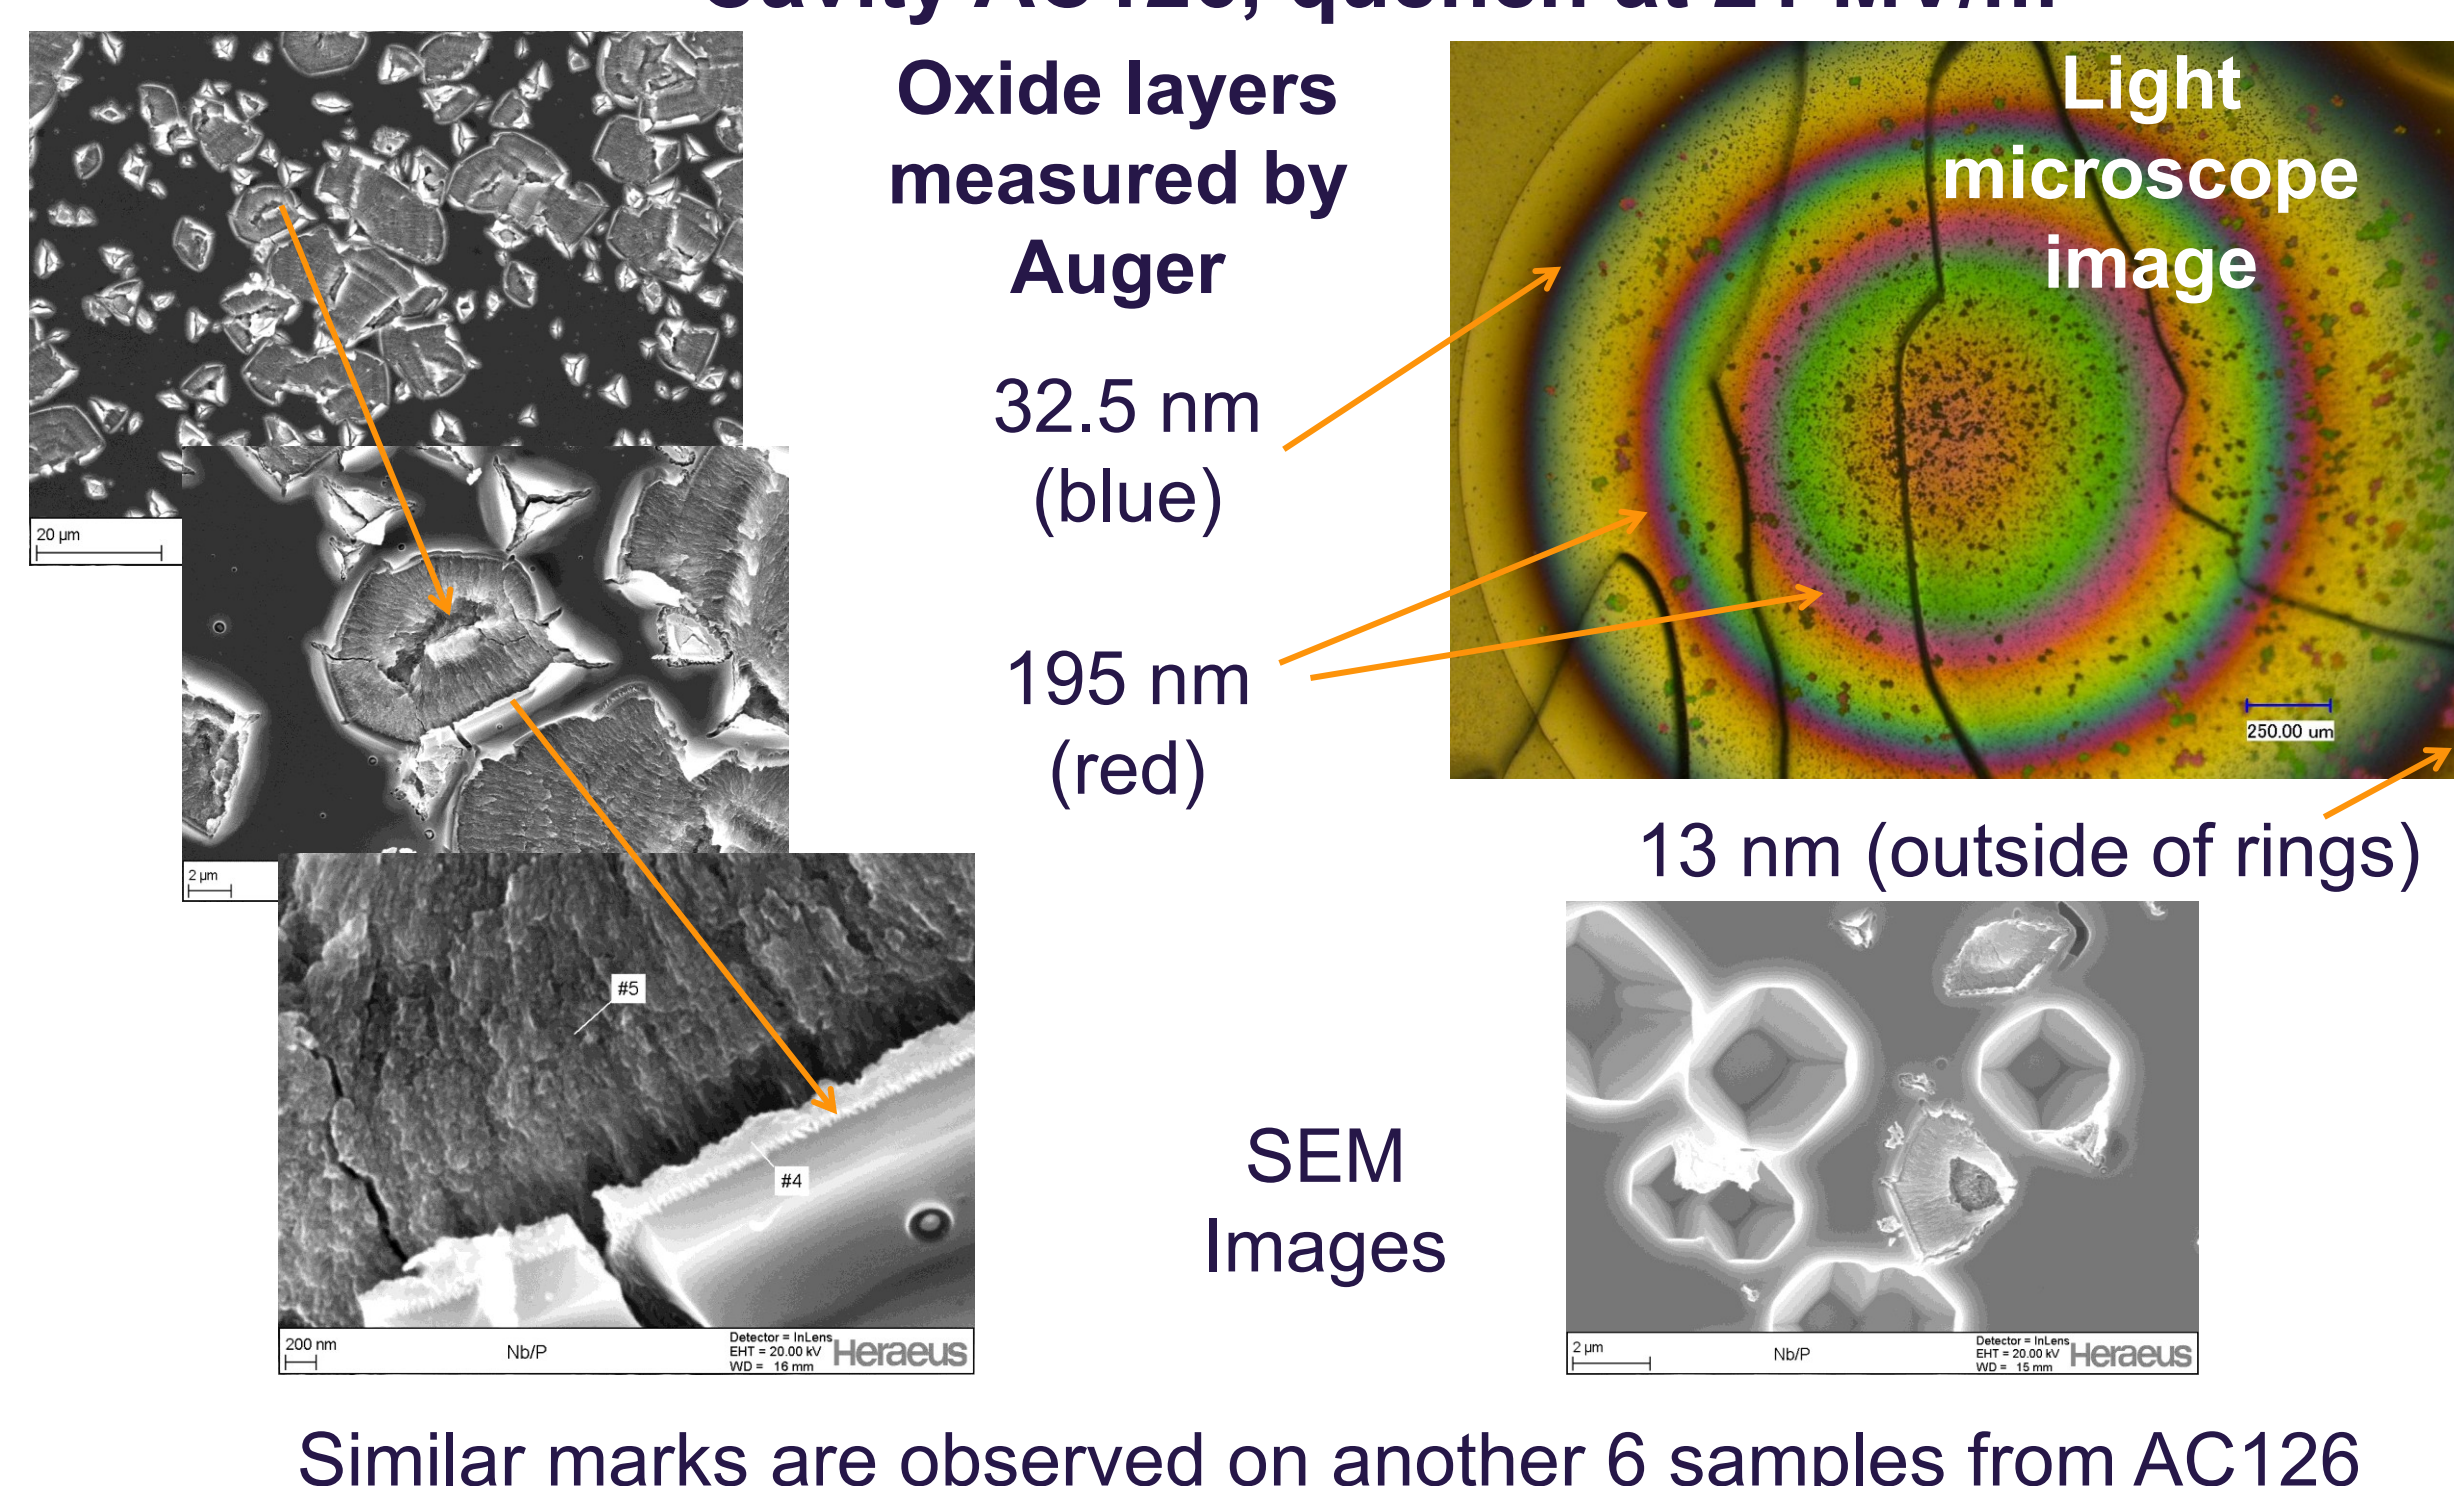
## Damaged surface (high pressure water rinsing mark). Cavity AC126, quench at 21 MV/m

- A high pressure water rinsing mark was detected in the cavity AC126. This defect caused quench at Eacc of 21 MV/m.
