# CHARACTERIZATION OF SURFACE DEFECTS ON EXFEL SERIES AND ILC-HIGRADE CAVITIES\*

A. Navitski<sup>#</sup>, E. Elsen, V. Myronenko, J. Schaffran, and O. Turkot DESY, Hamburg, Germany  
Y. Tamashevich, University of Hamburg, Hamburg, Germany

A detailed analysis of surface quality of around 100 EXFEL series and ILC-HiGrade SRF cavities has been performed applying high-resolution optical system OBACHT and replica. Typical surface features and defects as well as their influence on the cavity performance and possible repair methods are presented and discussed.

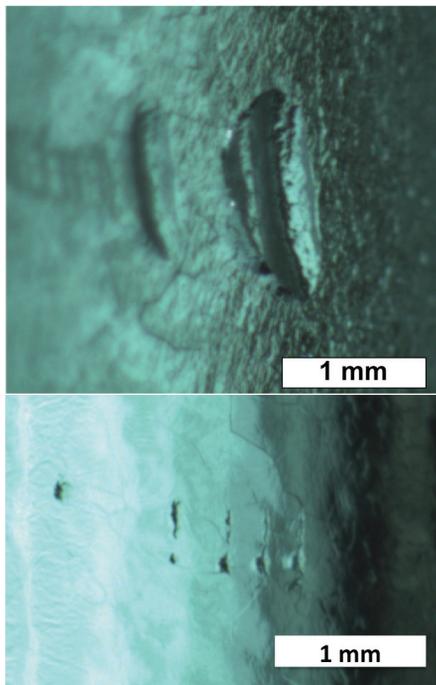
The scratches (Fig. 1) are usually localized in the iris region of the cavities and are indications of some mishandling or errors during the production steps leading to contacts or collisions between production tools and cavities thus resulting in mechanical damages of the niobium surface. The main impact of such defects on the cavity performance is an excessive x-ray radiation in the

Figure 1: Typical OBACHT images of scratches found on irises of EXFEL series and ILC-HiGrade cavities.

operational range of  $E_{acc}$  of the cavities due to the electron field emission, enhanced on sharp edges and spikes in the scratched regions. The high-pressure ultra-pure water rinsing (HPR) and in some cases even a light buffered chemical polishing (BCP) of around  $10\ \mu\text{m}$  (maximum possible due to constrains of the helium tank) followed by the high-pressure ultra-pure water rinsing (HPR) could not cure the field emission load of the cavities with such defects. Local grinding and more heavy etching were

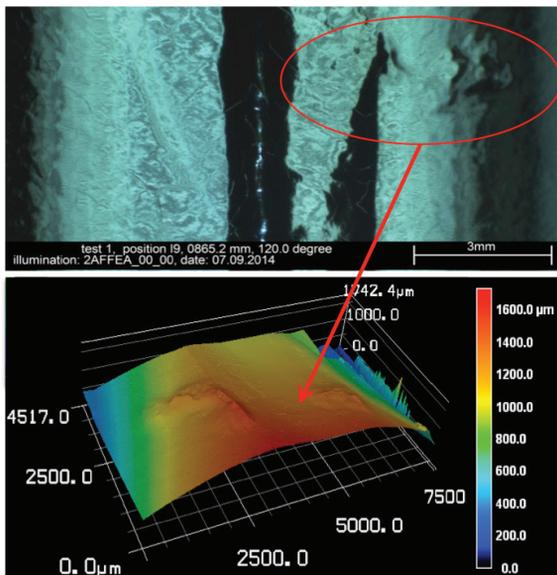
Figure 2: OBACHT (top) and laser microscope on replica-sample (bottom) images of scratches on a cavity limited at 23 MV/m by quench with strong radiation, usable gradient 16 MV/m.

In one case, however, almost **10** cavities were affected by the same error before it was localized. Such an example is presented in Fig. 2. Here the irises 2 to 8 of the cavity were scratched at almost the same angle. During the cryogenic cold RF test the cavity reached 23 MV/m of maximum gradient, limited by thermal breakdown (quench) with strong radiation. The usable gradient of the cavity was just 16 MV/m. Additional HPR and  $10\ \mu\text{m}$  BCP polishing could not cure the cavity. Additional local grinding will be applied for this cavity to remove the defect as qualified and already applied for several other cavities [4].

needed. This requires, however, additionally a complete tank removal, retuning of the cavities, and a second whole surface preparation pass. This operation upsets the mass production flow. Few reasons for the scratches have been identified in the EXFEL production flow and were mostly some occasional accidents.

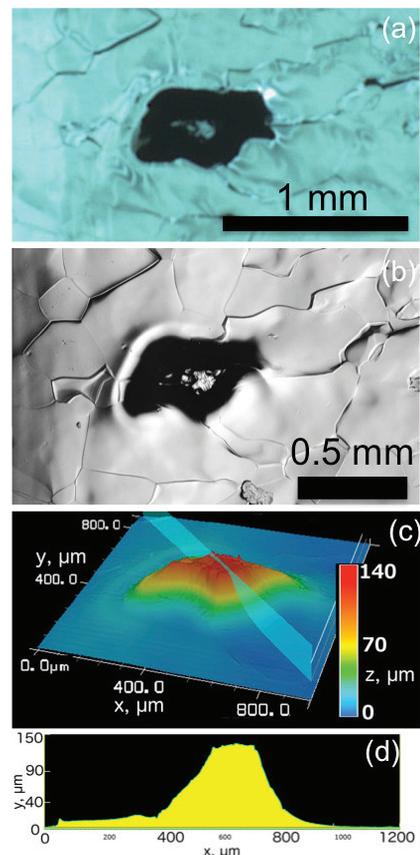
Figure 3: Foreign inclusion observed by OBACHT (a) and visualized by laser scanning microscopy on replica sample (c-e). The height of the protrusion is about 130  $\mu\text{m}$ .

usually limited by thermal breakdown at fields well below 20 MV/m. Figure 3 represents a defect found on the inner surface of a cavity limited by thermal breakdown at 16 MV/m. Replica studies helps to better visualize the defect-areas and analyse its microstructure without cavity-destruction. The defects look very similar to the inclusions observed on niobium sheets and extracted samples. Such defects illustrate clearly pronounced protrusion of 120 to 140  $\mu\text{m}$  and are usually not affected by the main EP treatment as revealed by laser scanning microscopy on replica samples. Similar etching behaviour has been observed e.g. in the past by presence of aluminium flakes on the surface [5]. This indicates different chemical properties of the defects than of the niobium. Additionally, the surface microstructure of the inclusions is completely different from the niobium surface. These facts are considered as strong hints for foreign material inclusions. A similar morphology difference has been observed on foreign inclusions confirmed by SEM and EDX material analysis. Such analysis in the cavities is unfortunately not yet possible without cavity destruction.

It can be surmised that the inclusions were embedded during one of the production steps like deep drawing, clamping for machining, or assembly for EBW. Such big defects of more than 500  $\mu\text{m}$  size would be definitely

The defects have to be locally grinded away and followed by the second full surface preparation step.

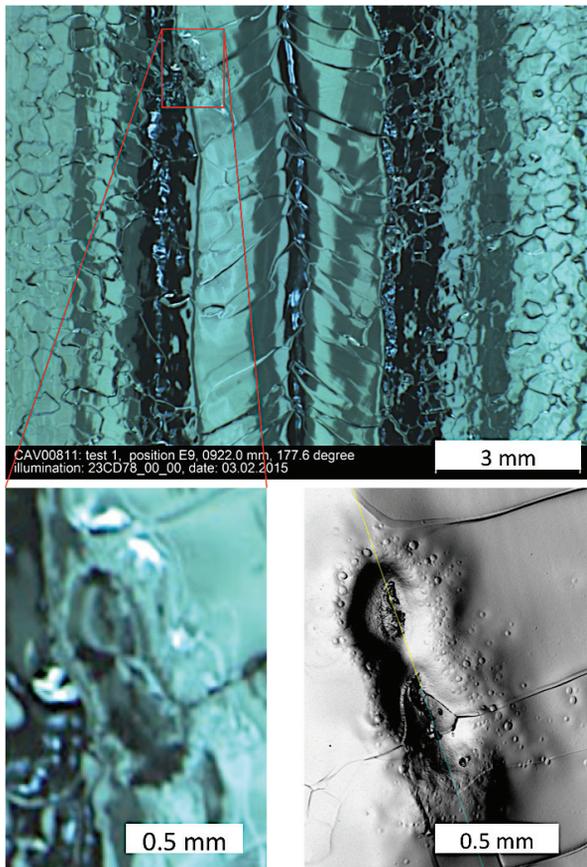
Figure 4: Surface erosion with a foreign inclusion (marked by red square on top and magnified on lower left image) observed by OBACHT and additionally visualized by laser microscopy on surface-replica (lower right).

Another kind of defects associated with foreign material inclusions is shown in Fig. 4. The local surface erosions have been observed on the equator-welding seams of several cavities. In the presented case, the cavity reached only 16 MV/m limited by thermal breakdown without any radiation. X-ray fluorescence spectroscopy confirmed the presence of iron as a foreign inclusion in the defect area [6].

The repair of such cavities is not really feasible since the pollution seems to go deep into the material and remain after almost 150  $\mu\text{m}$  material removal.

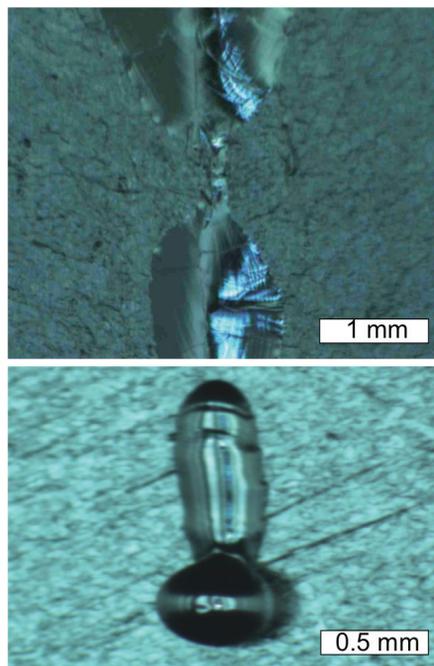
An incomplete penetration of the welding seams (Fig. 5, top), strong variation of the seam-width, and rough welding are some difficulties that occurred during the ramp-up phase of the EXFEL cavity production. Optical inspections with conventional endoscopes at companies gave some indications of the problem. Detailed analysis of the defects was done using OBACHT system. Meanwhile, settling the welding parameters solved the problem with the incomplete welding and only some variation of the seam-width could be observed. The cavities with the incomplete welding have never been cold RF tested since problems with low field quenches and leak tightness were expected.

Figure 5: Incomplete welding seam (top) and welding spatter on the inner cavity surface.

The ~mm-sized “spatters” (Fig. 5, bottom) are occasionally occurring on the surface during the electron beam welding as observed during the endoscope and OBACHT inspections. This might happen due to sparks in the high voltage circuit of the welding machine or due to the presence of some dust in the contact of two Nb half-cells. Dust flakes have often been observed around the “spatters” area, those supporting the second idea. The reason for this is as yet unclear and is the subject of further investigation as well. As a consequence, additional local repair of the cavities is required to remove these defects, which are essentially unaffected by

A complicated repair of such cavities is required, which was usually done by the immediate second pass welding if discovered during the welding. Re-welding after some surface processing steps is accomplished with some pollution of the welding joint. Some problems with

the standard EP/BCP polishing procedure. The local grinding of such defects has been successfully applied on several cavities as reported elsewhere [4].

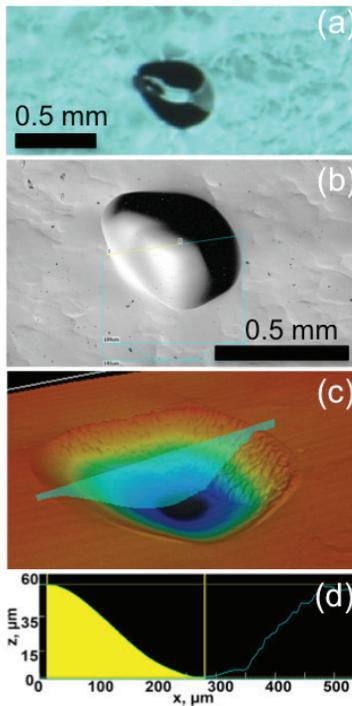
Figure 6: OBACHT and replica investigation of a “cat eye” on the surface of cavity: (a) OBACHT image and (b) 3D view, (c) topography view, and (d) a profile of the “cat eye” as measured by means of a 3D laser scanning microscope on a replica sample.

The defects called “cat eyes” are probably the most often appearing defects on the surface. The reason for this is as yet not fully clear and is the subject of further investigations. Replica studies indicate that these are rounded etching holes as shown in Fig. 6. The “cat eyes” and etching pits (Fig. 7) both are etching artefacts. The nature of these artefacts seems to be different because of their different geometry and optical appearance. Whereas the etching pits are most probably created due to a sticking of hydrogen bubbles on the surface during the etching process, the “cat eyes” are most probably originating from local material properties such as defects or even inclusions. The “etching pits” and “cat eyes” seem to be harmless in terms of SRF properties since several cavities showed excellent results exceeding even ILC specifications despite of the observation of many such defects on the surface.

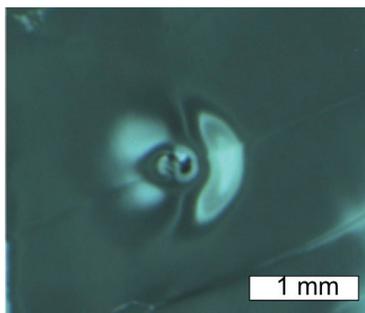
Figure 7: Typical OBACHT image of etching pit on the cavity surface.

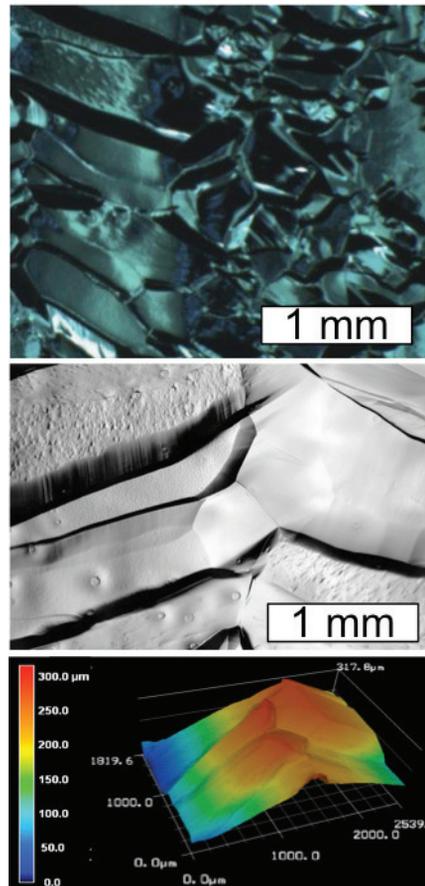
Rough surface is a polishing artefact appearing mostly due to a switch of the EP polishing process from the

Figure 8: Typical OBACHT image of etching pit on the cavity surface.

polishing to etching regime. It happens when improper polishing parameters like acid temperature, current density etc. have been applied. Only very few cavities were affected by this. In the polishing regime sharp edges and burrs are smoothed out and a very glossy surface is obtained, whereas the etching regime leads to different polishing rate at grains of different orientation and grain boundaries and leads to sharp edges and steps between the grains. An example of a very rough surface is presented in Fig. 8. Here some tests have been performed with the EP system leading to the very rough surface. The cavities with such defects show usually a very low quality factor  $Q_0$  and achievable accelerating gradient  $E_{acc}$ . The cavity in the presented case reached only 16 MV/m maximum  $E_{acc}$  and had a strong  $Q_0$  slope at  $E_{acc}$  above 10 MV/m.

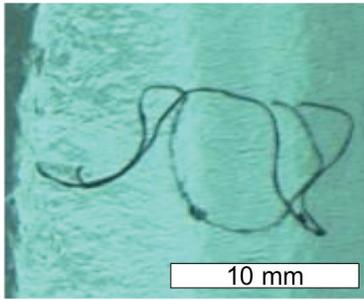
Figure 9: Typical OBACHT image of dust (fibre) contamination on the cavity surface.

Dust is probably the second most frequently observed defect on the surface (Fig. 9). Contamination of the cavity surface with dust particles leads to an enhanced x-ray radiation due to field emission from irises, i.e. high electric field regions. Low  $Q_0$  or early quenches are possible if some dust is located on the equators, i.e. in the high magnetic field regions.

The main reason for such contamination is cleanliness of the assembly process as well as the reliability of the cleaning procedure. It must be pointed out, however, that it is difficult to use OBACHT results to judge about the cleanliness since OBACHT tests are performed not in a cleanroom environment. Some pollution may happen during or before the OBACHT tests.

The cavities polluted with dust particles require usually only one additional HPR cycle to recover their performance. Second assembly and cryogenic RF test is still required to confirm the success of cleaning.

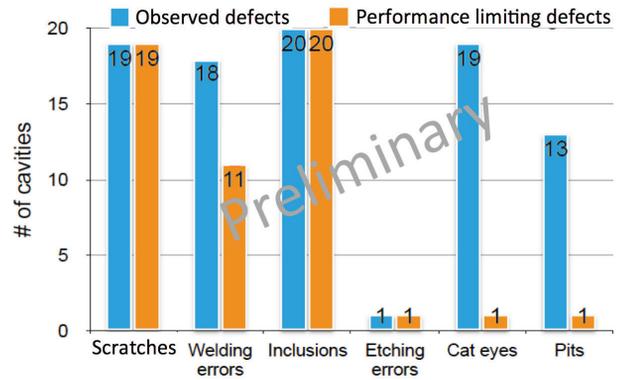
The distribution of detected surface defects over almost 100 inspected EXFEL series and ILC-HiGrade cavities is presented in Fig. 10. These are preliminary results because of the still running cavity production. One can see, that scratches, welding errors, and foreign inclusions are the most critical surface defects. The scratches and welding spatters can be successfully removed by local grinding technique, whereas the incomplete weld penetration and contaminations by foreign material, especially of the welding seam, is still to be understood and repair procedure to be defined or even not possible.

Figure 10: Distribution of defects observed during optical inspections of about 100 EXFEL and ILC-HiGrade cavities.
