# INSPECTION AND REPAIR TECHNIQUES FOR THE EXFEL SUPERCONDUCTING 1.3 GHz CAVITIES AT ETTORE ZANON S.P.A: METHODS AND RESULTS

G. Massaro<sup>#</sup>, N. Maragno, G. Corniani, Ettore Zanon S.p.A, Schio, Italy  
 C A. Matheisen, A. Navitski, DESY, Hamburg, Germany  
 P. Michelato, L. Monaco, INFN Milano-LASA, Segrate, Italy

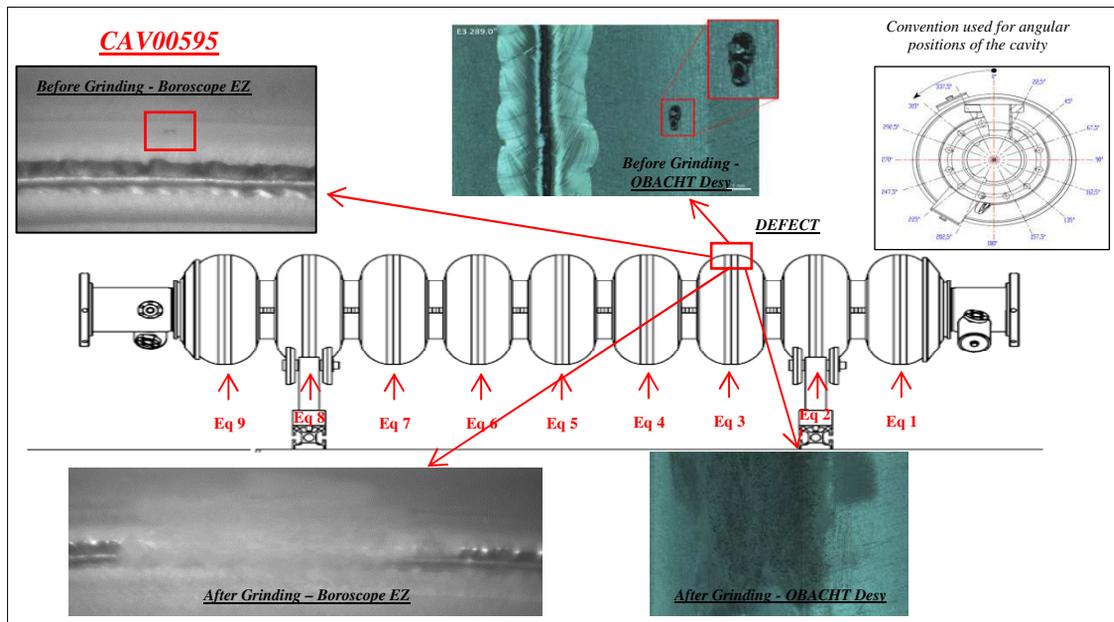
Figure 4: Defect found after the EBW final welding on the equator 3 of CAV00595: OBACHT and boroscope images before and after the grinding procedure used for qualification of the repair techniques.

The optical inspection on the cavity CAV00595, performed regularly in the production cycle after the EBW final welding, discovered a spatter weld close to the weld bead of the equator No3 at the angular position of 289°. This defect was also analyzed with the OBACHT system, in collaboration with DESY (see Fig. 4).

After the complete removal of the defects, as confirmed by the optical inspections both at EZ and DESY (see Fig. 4), the cavity has followed the production cycle according to the scheme shown in Fig. 3.

At the vertical cold RF test at DESY the cavity has reached finally maximum accelerating gradient  $E_{max}$  of 35 MV/m and usable gradient  $E_{usable}$  [7] of 30MV/m, limited by some field emission.

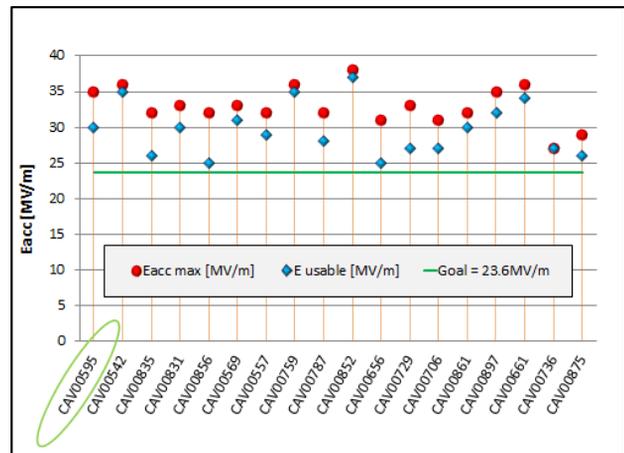
Figure 5: Results of the cold RF test of the cavities grinded after the EBW and before the main EP.

With this result the repair procedure has been successfully qualified and finally applied on 18 cavities. The results of vertical cold RF tests of these cavities are shown in Fig. 5. All the cavities perform well above the XFEL performance goal.

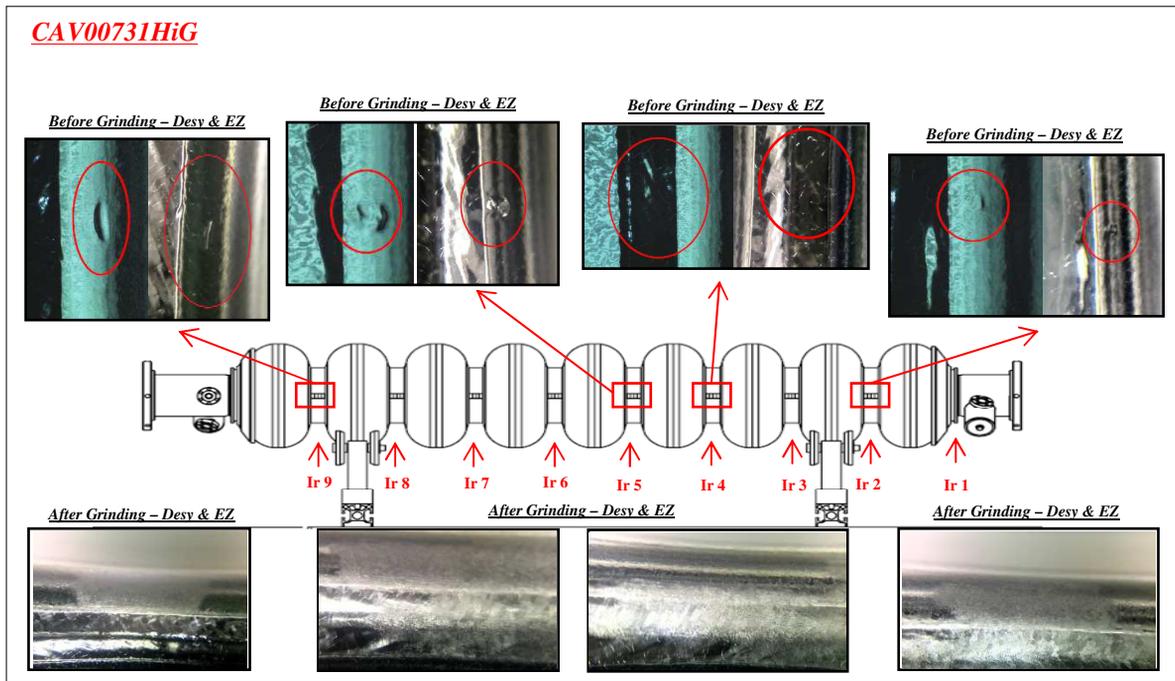
Figure 6: Defects found on the irises of CAV00731 after an unsuccessful cold RF test: OBACHT and boroscope images before and after grinding procedure used for qualification of the repair techniques.

At the 1<sup>st</sup> vertical test at DESY, the cavity has reached  $E_{max}$  of 32 MV/m and  $E_{usable}$  of 23 MV/m, limited by quench and strong field emission.

Even after HPR reprocessing at DESY, this result didn't improve. Two optical inspections has been performed.

By the camera at EZ and OBACHT system at DESY, the following defects have been discovered:

- Scratch on iris 2, 4 and 5 at angular position of 120°.
- Incision on iris 9 at angular position of 6°.

The defects have been successfully removed with the grinding techniques, as shown in Fig. 6 and the cavity has followed the production cycle according to the scheme shown in Fig. 3 for the cavities that received already once the main EP treatment.

During the 2<sup>nd</sup> vertical test at DESY the cavity has reached  $E_{max}$  of 39 MV/m and  $E_{usable}$  of 38 MV/m, limited by low field emission. With these results the procedure of the removal of such defects has been successfully qualified as well (see Fig. 7).

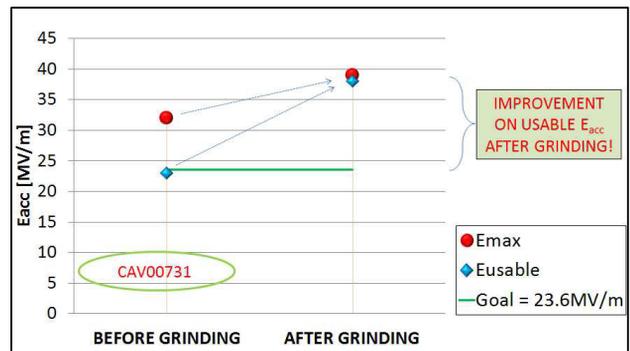
Figure 7: Comparison of the results of cold RF test of CAV00731 before and after the grinding.
