# EXPERIENCE WITH LONG TERM OPERATION WITH DEMINERALIZED WATER SYSTEMS AT DAANE

L. Pellegrino, LNF – INFN, Frascati (Roma) - Italia

During eight years operation of the DAANE water cooling system some critical situations have been successfully managed by upgrading the demineralized water system. The collected data and the experience gained in the field of copper corrosion and related water treatment are critically revised.

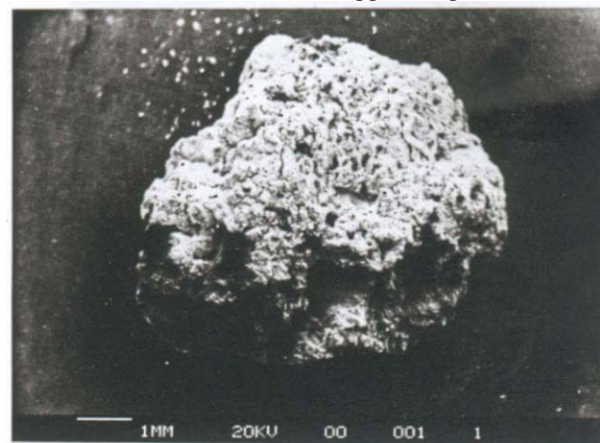
The rubber hose between the manifold spigot and the coil end forms a flow section enlargement, with internal diameter going from 4 to 6 and again to 4 mm, as a little "chamber". Solid pebbles (D>5 mm) formed in some of these "chambers" inside the hoses and, there, moved back and forth, obstructing sometime the flow in one or more coils. Therefore the coils, no more cooled, heated until safety thermal device switched down the whole chain of four wiggler magnets.

Figure 3: copper oxide pebbles.

The material of obstruction was analysed by the CSM of Pomezia, Italy, (SEM microscopy with EDS spectrometer), showing copper and copper oxides as

the only component, as well as the water at inlet and outlet of the polishing system, as in table 2. In figure 3 is the micrographic picture of a pebble.

The conclusion was that the relatively high conductivity, the relevant dissolved oxygen contents of cooling water and the high electric potential of some coils with respect to the grounded piping yield the production of copper oxides and their migration according to the potential difference. Probably, sulphide-reducing bacteria catalysed the agglomeration process of the oxide, starting on the lips of the inlet copper spigots, in a slower flow region.

The deposits grew until detached and continued growing, probably without leaving the "chamber".

We modified the polishing circuit and its location in the plant, to assure a continuous treatment of the whole water mass with the proper flow in the mixed bed bottles, and added new instruments and a data logger; the N<sub>2</sub> cushion system was reviewed and frequently checked; the whole plant pressurization scheme was reviewed, to ensure a positive pressure everywhere, avoiding unwanted air intakes.

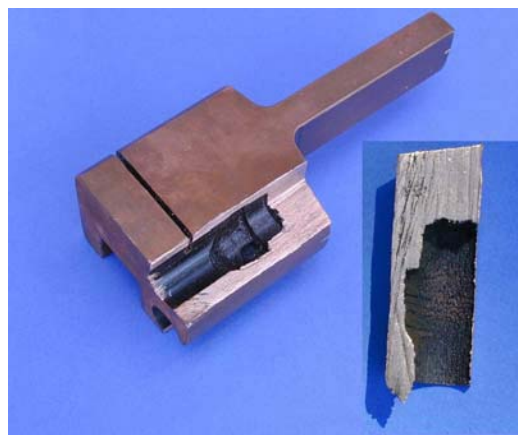
Nevertheless, after some year of operation, a tiny crack opened a way to the water. The alarm was early on, so the damage was limited, but the probability of other occurrences of a similar failure was high, due to the large number of absorbers installed.

A visual endoscopic inspection revealed a pitted area downstream of the hole between the inlet and the outlet channels (figure 4). Moreover, the water flow was measured as more than twice the design one.

Because of the local narrowing of the water passage, a very high velocity was reached in the water flow, leading to cavitation that damaged the internal surface of the outlet channel. This phenomenon was surely enhanced by corrosion, until the opening of the crack. Some similar cases are reported in literature.

Figure 4: the tip of an absorber and a section showing the internal of the crack area.

Following this analysis, a proper flow velocity was restored, with no further consequences.
