SNS INJECTION FOIL EXPERIENCE

M.A. Plum, S.M. Cousineau, J. Galambos, S.-H. Kim, P. Ladd, C.F. Luck, C.C. Peters, Y. Polsky,
R.W. Shaw, Oak Ridge National Laboratory*, Oak Ridge, TN, USA
R.J. Macek, Los Alamos National Laboratory, Los Alamos, NM, USA
D. Raparia, Brookhaven National Laboratory, Upton, NY, USA

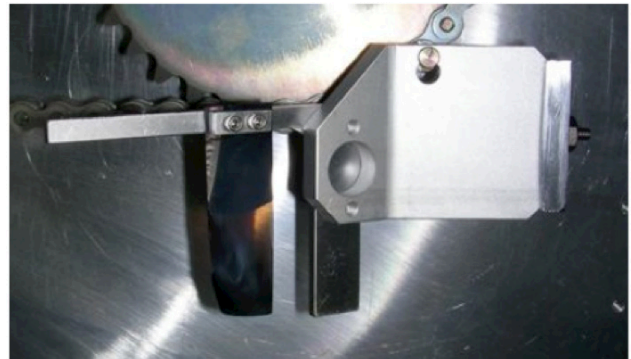
The nominally 17 mm x 45 mm x 0.30 mg/cm² stripper foils have three free edges and are mounted on L-shaped brackets that hang from pins on the foil changing mechanism. A photo of a first generation foil and bracket is shown in Fig. 1. The long arm and leg of this bracket style were designed to accommodate stripper foils that require support from thin carbon fibers that can be stretched across the arm and the leg. The diamond foils do not require fiber support.

Figure 1: A first generation foil bracket mounted on the foil-changer mechanism. The long arm and leg of the L-shaped bracket were designed to stretch carbon fibers across the span to support foils if needed (not used in this case). (Figure reproduced from Ref. 3.)

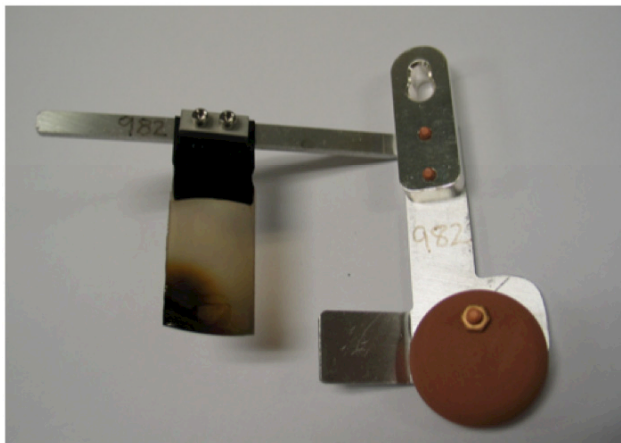
Figure 2: A used second-generation foil bracket. The beam power in this case was only 400 kW, so this foil and bracket show very little damage. (Figure reproduced from Ref. 3.)

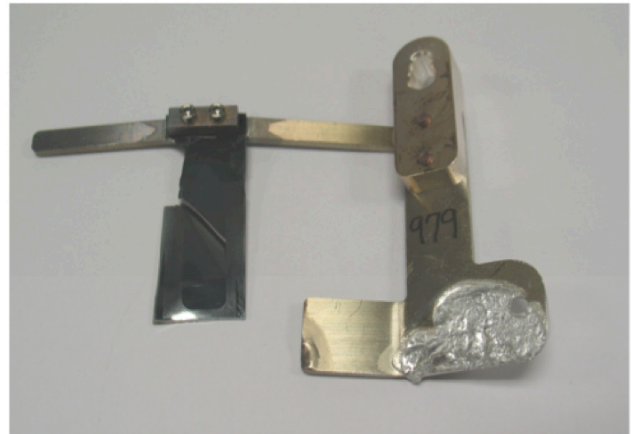
The first failure mechanism is simple – the lower portion of the L-shaped bracket was too close to the foil, so the convoy electrons struck the bracket on their first revolution around the magnetic field lines. It should be stressed that this failure mechanism is actually a bracket failure, not a foil failure. A photograph of a second generation bracket (the type in use at the time of the first set of failures) is shown in Fig. 2. An example of a failed bracket is shown in Fig. 3. The bottom-left corner of the bracket shows the melting that occurred from the convoy electrons striking the bracket. The large melted area on the lower right shows where a circular counterweight was attached before the material around the mounting hole melted, causing the counterweight to fall off.

Figure 3: A failed second-generation foil and bracket. This foil lasted for a few hours at ~ 840 kW beam power. (Figure reproduced from Ref. 3.)

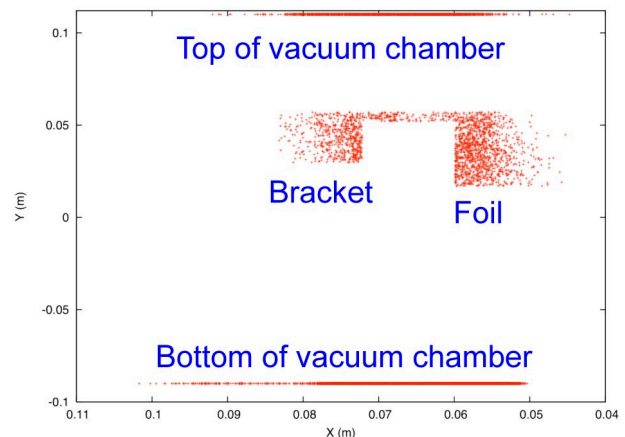
The trajectories of the reflected convoy electrons were simulated [6] using a particle tracking code and magnetic fields from a detailed 3-D model of the magnet [7]. An example result is shown in Fig. 4, where it can be seen that the reflected electrons will strike both the stripper foil and the bracket.

Figure 4: The results of a particle tracking simulation showing the locations where the reflected convoy electrons strike the stripper foil, the bracket, and the top of the vacuum chamber.

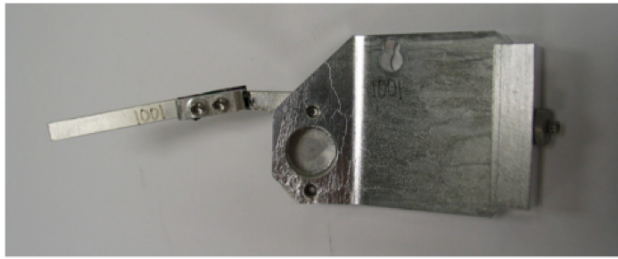
Figure 5 shows a used third-generation foil and bracket. The lower leg on this bracket was removed so that the convoy electrons would not hit it as they travel down to the electron catcher, yet it still shows melting damage on the lower left corner, and the arm of the bracket has also softened enough to allow the arm to droop down. This damage is consistent with the tracking results in Fig. 4.

However, these simulations do not explain all the damage to this bracket. There is also a vertical hole created in the bracket along the inner edge of the foil substrate (see next section).

Figure 5: A used third-generation foil bracket. (Figure reproduced from ref. 3.)

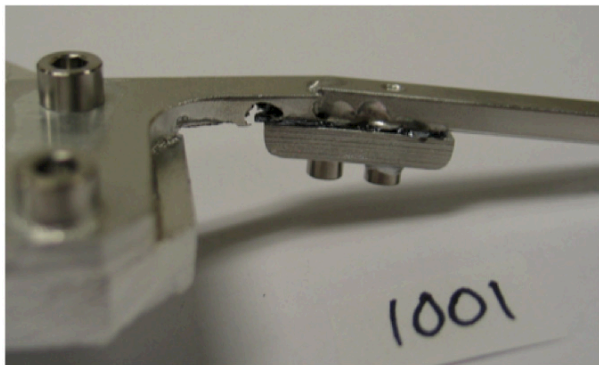
The third failure mechanism is cathode-spot in-vacuum breakdown. This is a form of electrical breakdown that can take place in a perfect vacuum. To initiate the breakdown, the anode (foil) first develops a positive electrical charge due to secondary electron emission. If the foil is hot enough, thermionic electron emission can further charge the foil. The next step is evaporation of sharp points on the cathode (bracket) that become hot from field emission due to the strong electric field that has been created between the bracket and the foil. The evaporated cathode material then provides the gaseous environment needed to sustain the breakdown. Each breakdown event creates a small crater in the bracket, and over time large holes can develop. Figure 6 shows a close up photo of the same bracket as in Fig. 5. Several holes can be seen where the silicon foil substrate was clamped to the bracket. One hole passes completely through the bracket arm. The top of the bracket also shows similar material erosion at locations where the foil substrate had sharp edges that helped initiate the vacuum breakdown events.

Figure 6: A close-up view of the foil clamp for the bracket shown in Fig. 5. (Figure reproduced from ref. 3.)

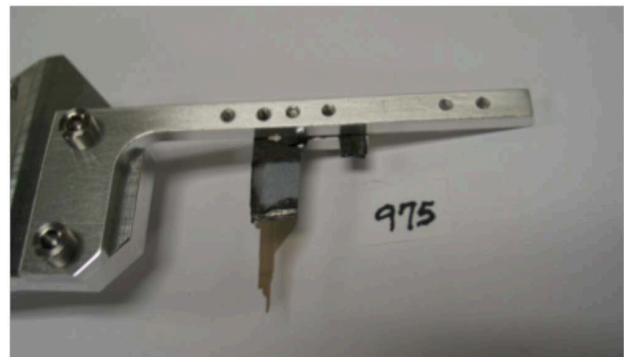
generations 1 through 3 foil brackets were made of aluminium due to its ease of machining, good conductivity, light weight, and low radioactivation. However, aluminium also has a low melting point and a high coefficient of thermal expansion (CTE) which is approximately 8 times higher than that of the Silicon foil substrate. Titanium screws were used at one point creating an additional CTE mismatch between the fastening components. As the temperature increases in this arrangement, it pinches the stripper foil between the clamp and the bracket arm because the aluminum between the screw head and nut expands more than the titanium. The clamping of the foil to the holder in combination with the expansion of the holder induces significant tensile stresses in the silicon substrate. This can cause the silicon to fracture, which can then lead to rips and tears in the free-standing portion of the foil, and also create sharp edges that contribute to the vacuum breakdown. Some of the failed foils exhibited this symptom, such as the one shown in Fig. 7, where most of the right half of the silicon substrate is missing.

Figure 7: An example of a fractured foil substrate on a third-generation foil bracket.

During the summer of 2009 several modifications were made to the foil and the bracket. The bracket material was changed from aluminium to titanium, since the thermal expansion coefficient of titanium is much better matched to that of silicon. Also titanium has a relatively high melting point, good electrical conductivity, and it is lightweight. However, the radioactivation properties are not as good as aluminium due to its high atomic number. The bracket and clamp were machined flat, and before clamping the foil to the bracket, both the bracket arm and the clamp were carefully polished to remove any sharp points that could contribute to cathode-spot in-vacuum breakdown. Some of the foils we installed in September 2009 were also sandwiched between layers of gold foil ~0.025 mm thick to help improve the large-area electrical contact between the foil and the bracket.

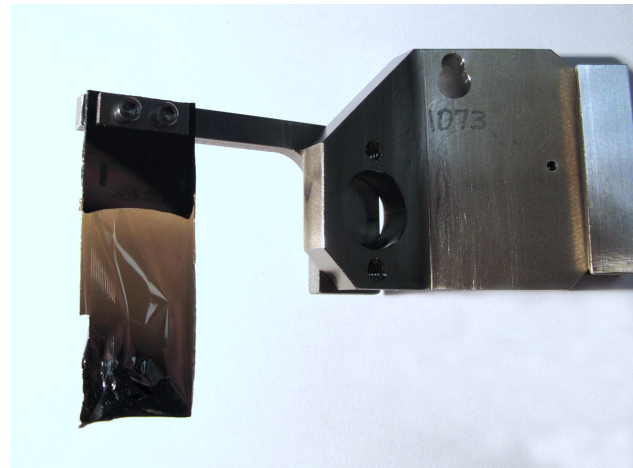
A new set of foils, half with the gold foil mounting and half without, were installed for the September to December 2009 run cycle. The first foil selected was one with the gold foil mounting method, and it lasted the entire run cycle, even after increasing the beam power to 1 MW. The total charge delivered to the target using this foil was 4820 C, to be compared to the previous high-power record of 978 C. The used bracket shows no signs of damage, although there is an unknown coating on the upstream side of the bracket and foil substrate that is not understood at this time. The foil itself is blackened, twisted, and wrinkled, but it was still performing well at the end of the run cycle. A photograph of this foil, taken after it was removed in February 2010, is shown in Fig. 8.

Figure 8: Photo of the foil and bracket that lasted the entire Sept. – Dec. 2009 run cycle at high beam power. (Figure reproduced from ref. 3.)
