SNS Injection Foil Experience

HB2010

By Mike Plum, Ring Area Manager

Brief history of SNS stripper foils

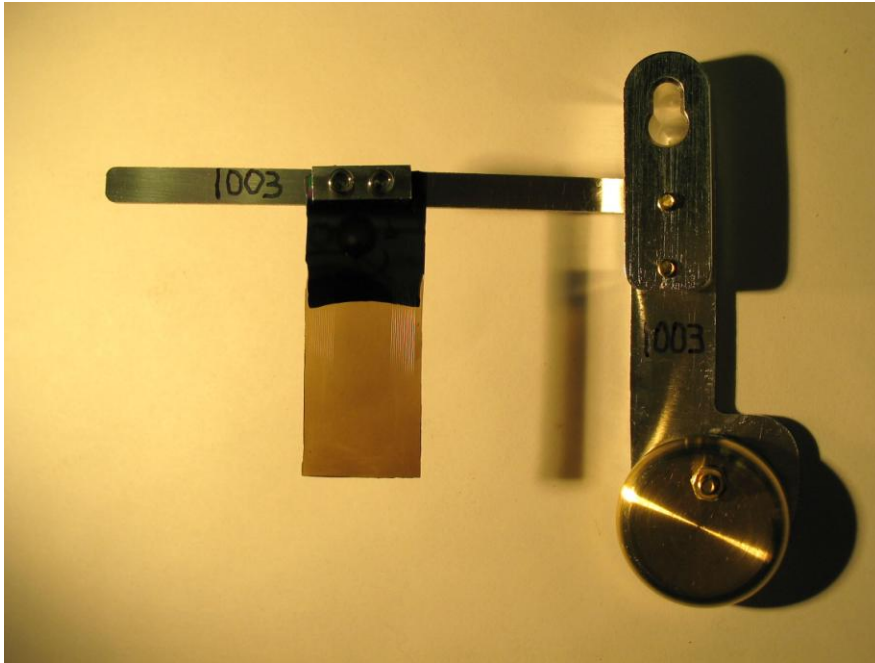
Typical foil damage, prior to 3/May/09

Typical foil damage before May 3, 2009

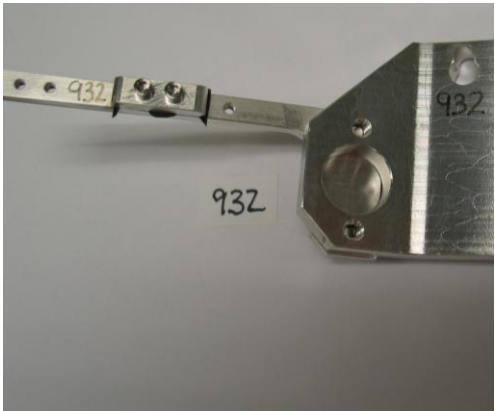
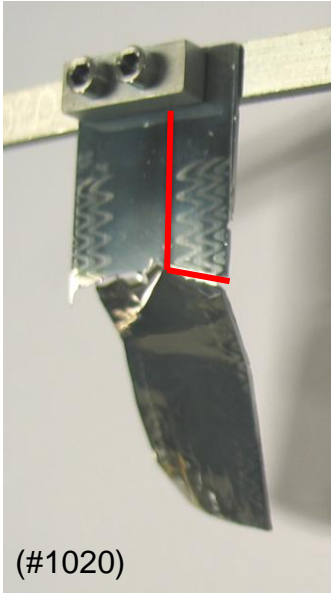
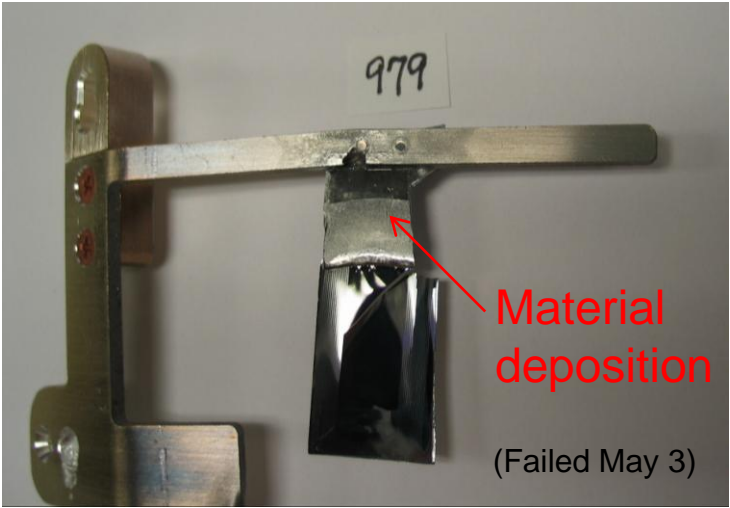
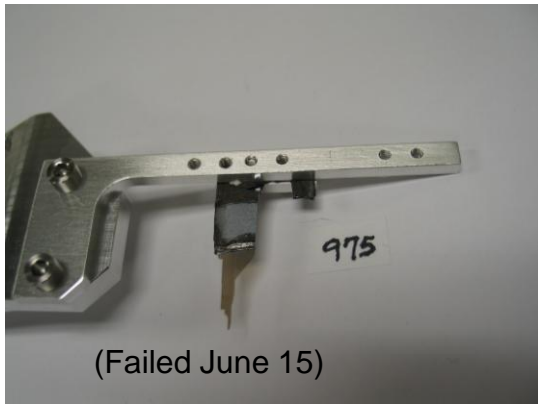
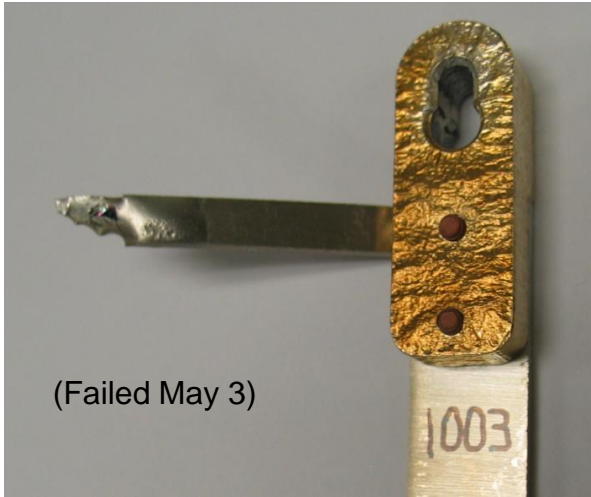
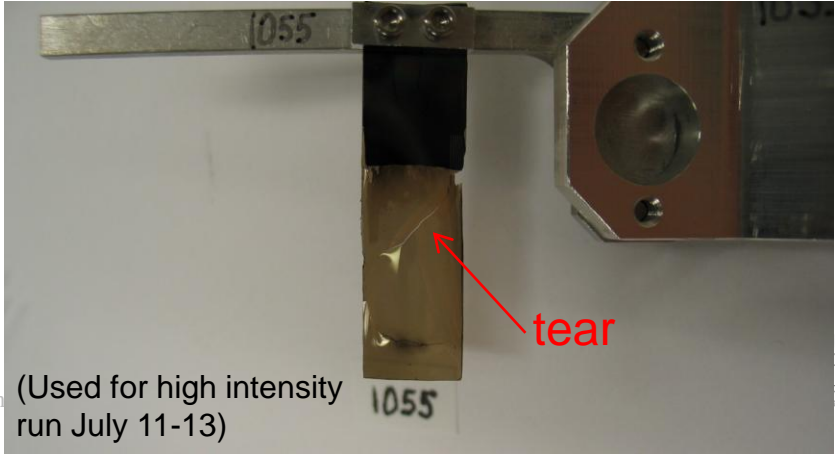
Foil failures

- A primary cause is believed to be **vacuum breakdown** (arcing) caused by charge build up on the stripper foils, due to secondary electron emission (SEM) and maybe also thermionic electron emission
- Another primary cause is **reflected convoy electrons** striking the foil and bracket
- Some of our foil failures also involved **convoy electrons** hitting the foil bracket as they travel downward to the electron catcher
- Other contributing factors may be:
 - Aluminum coating (from previous foil bracket melting) on vacuum chamber which may increase the trailing edge multipacting electrons
 - Trailing edge multipacting
 - Beam halo hitting Si substrate and/or bracket
 - Sudden beam excursions (e.g. RF station 2.1 failures), causing beam to hit Si substrate and/or bracket
 - Eddy current heating
 - Electron collector in wrong position
 - Normal operation – foil just gets too hot

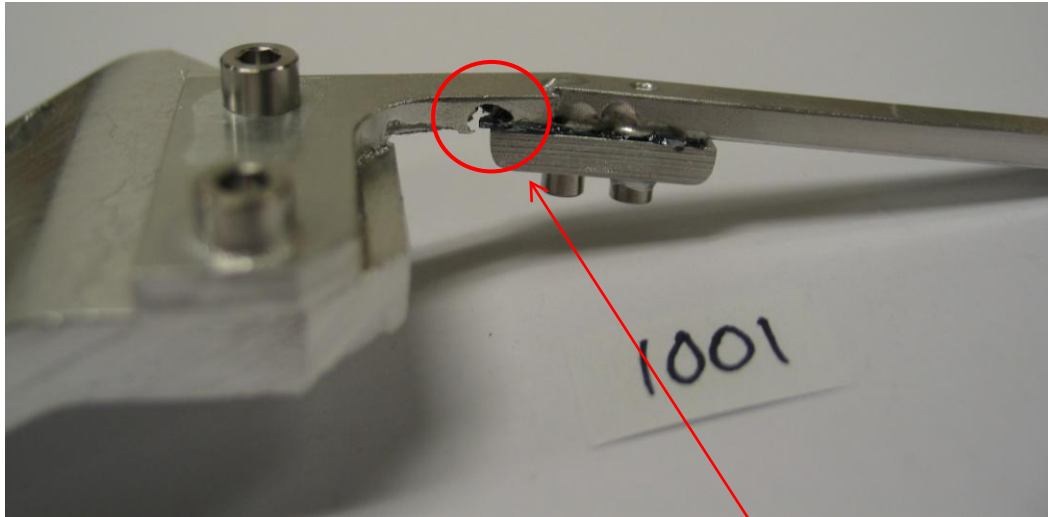
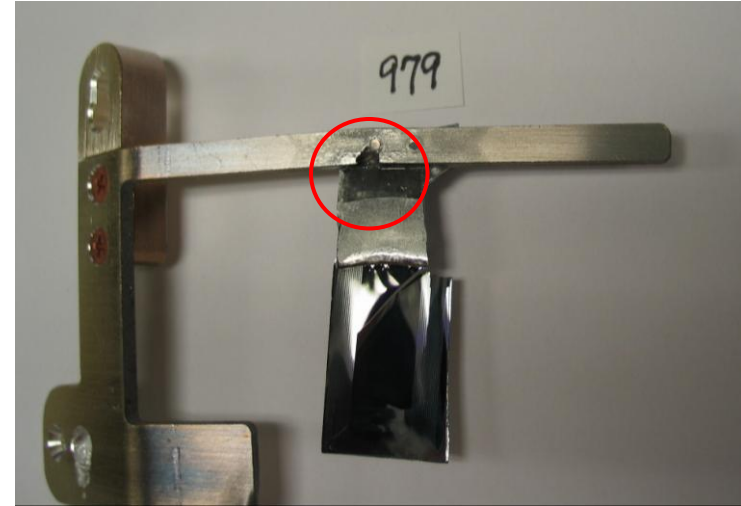
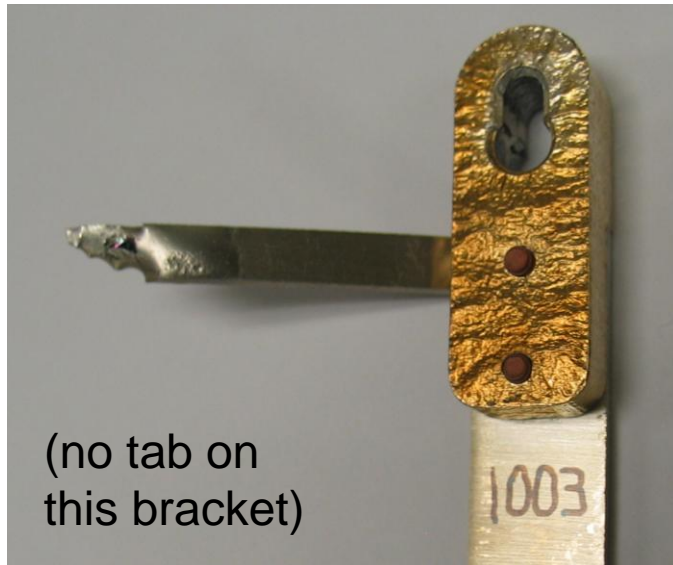
Arcs and sparks (vacuum breakdown)

Clearest evidence to date of vacuum breakdown

(no tab on this bracket)

Estimate of voltage on an isolated foil in the SNS Ring:

$$V = Q/C = (1e14 \text{ ppp}) (10 \text{ hits/prot}) (0.02 \text{ SEM}) \\ \times (1.6e-19 \text{ Coul/prot}) / (10 \text{ pF})$$

$$= 320,000 \text{ V per pulse !!!}$$

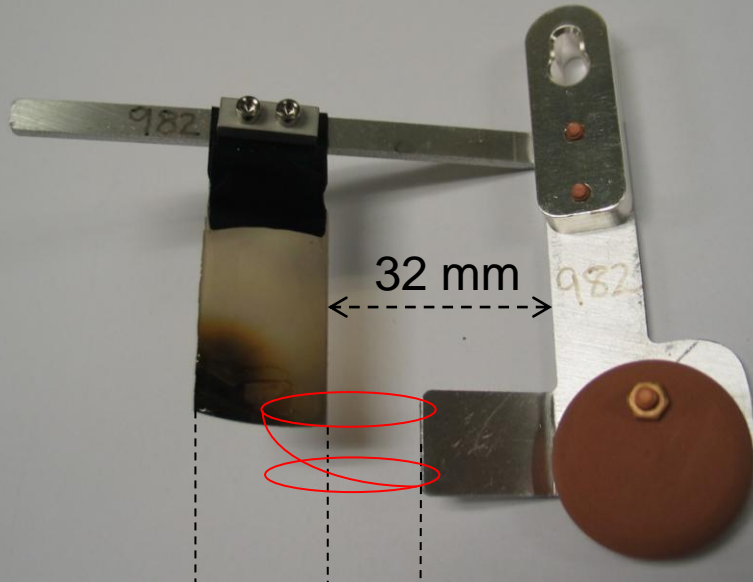
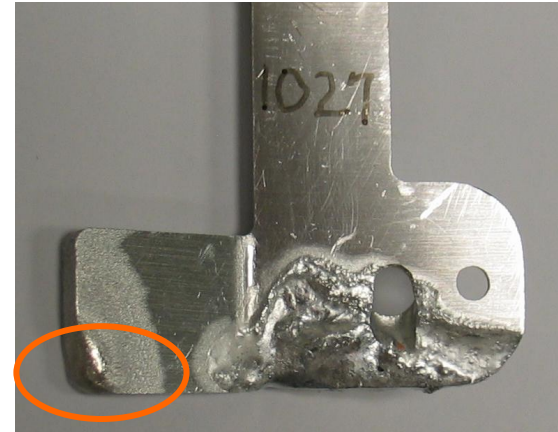
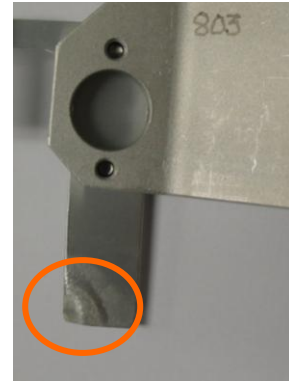
Bracket failures and convoy electrons

All this melted aluminum evaporated and was deposited on the vacuum chamber walls, other foil brackets, and everything else in sight

Foils should be mounted >24 mm horizontally from the bracket. All new foils will be mounted at the “+1 cm” position. Also helps to use high temperature material for brackets.

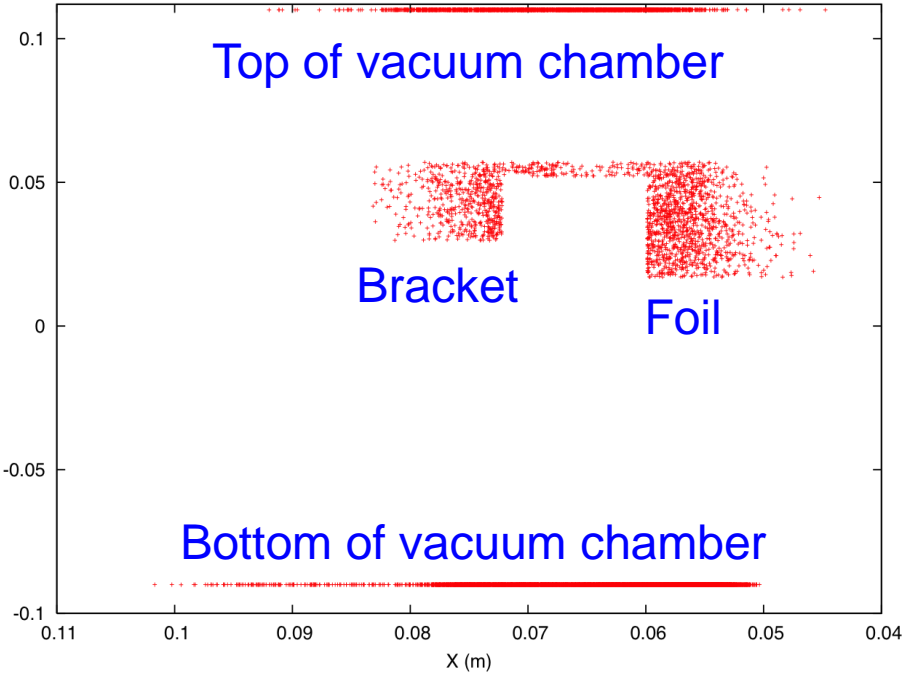
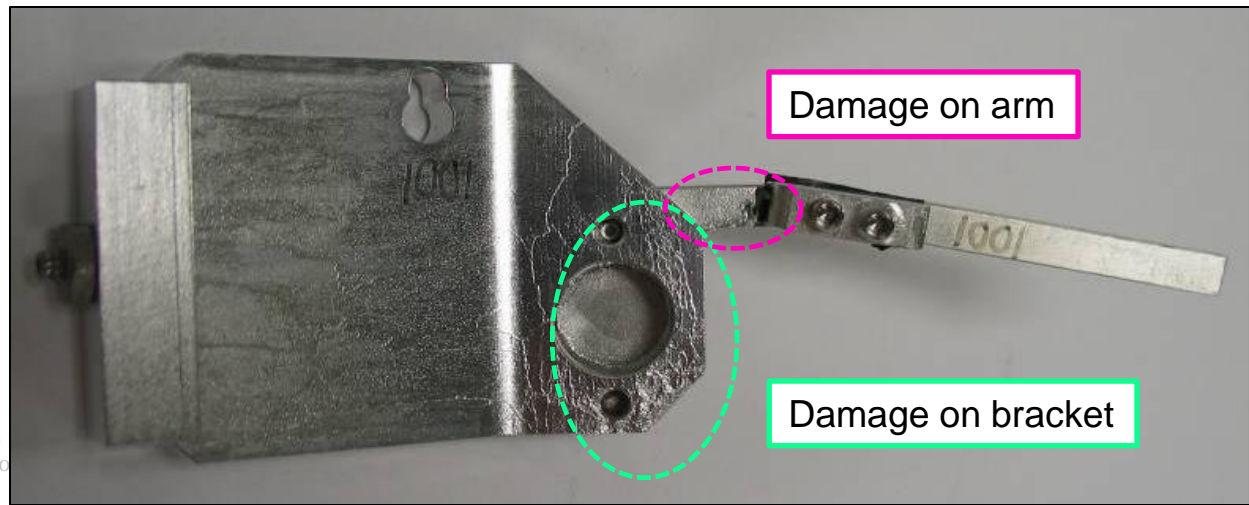
Impact locations

Reflected convoy electrons (S. Cousineau)

- High-temperature material with low coeff. of thermal expansion (Ti)
- Bracket material removed from path of convoy electrons (both arm and leg cut off)
- All foils mounted at the “+1 cm” position
- Bracket arm and clamp are machined flat and then polished for good electrical contact

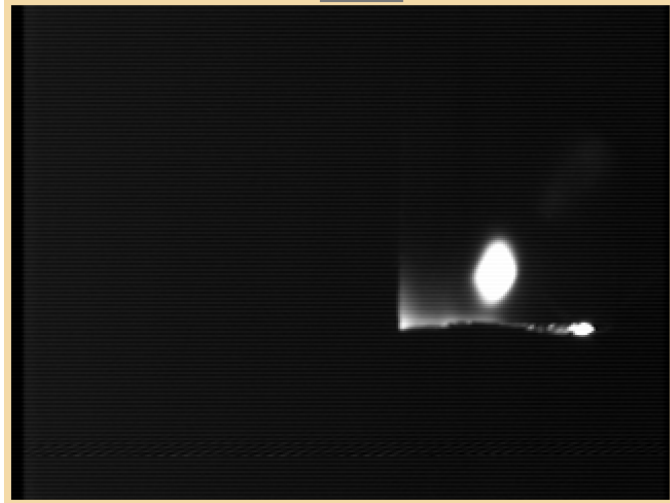
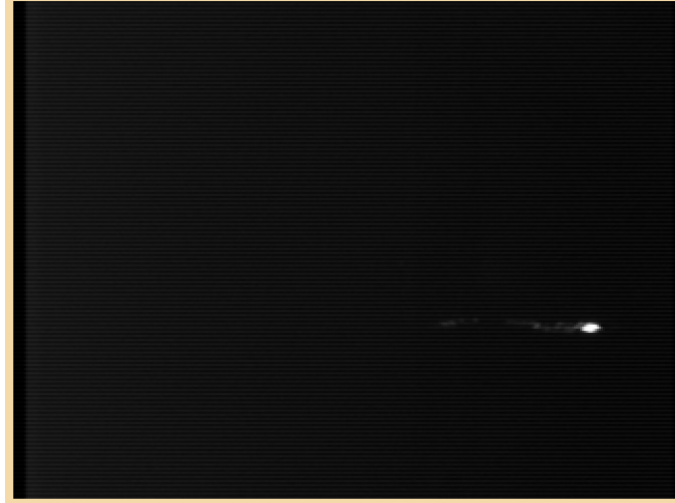
Beam on (1.02 MW, 18/Sep/09)

A remaining puzzle: Anode spot in-vacuum breakdown?

1 – 2 sec after beam shuts off

- “Hot spots” on the bottom edge of the foil were observed for the first time in September 2009. They are visible at 600 kW, maybe less... Not always just on the bottom edge.
- Most likely explanation is anode-spot in-vacuum breakdown. If so, this could actually be helping us.

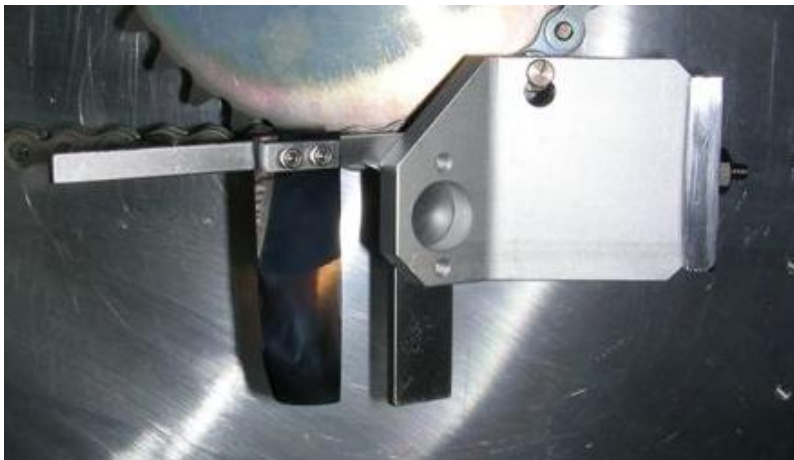
1st gen., used thru Jan/09
Al bracket 0.25 in, Al snap ring washer 0.090 in

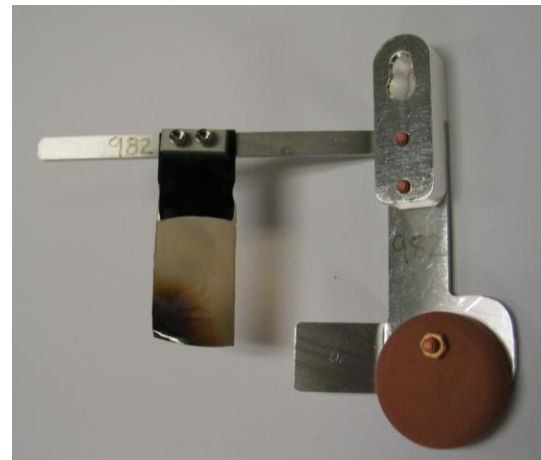
2nd gen., used Mar/09 – 17/May/09
Silver plated Al "tombstone" hanger, 0.340 inch thick

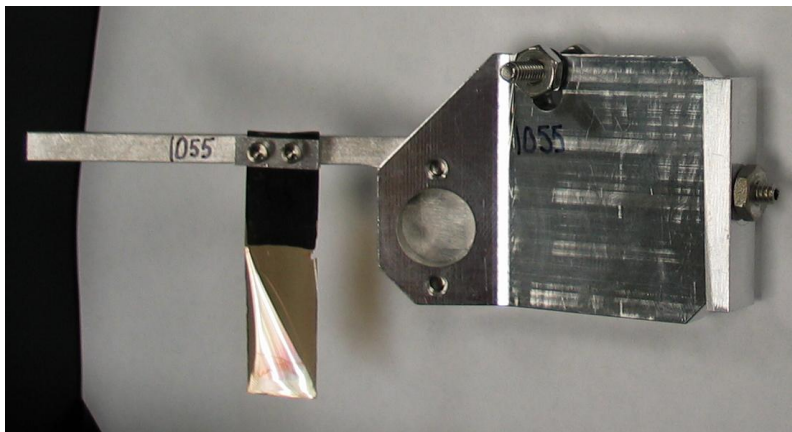
3rd gen., used 19/May/09 – 13/Jul/09
Same original but has bottom cut off.
Silver-plated aluminum washers, 0.085 inch thick

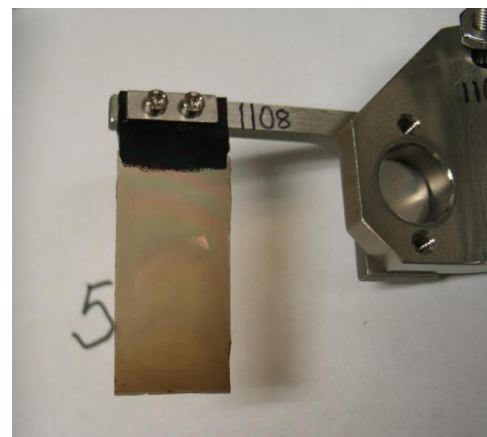
4th gen., used Sep/09 to present
Ti bracket, SS washer 0.093 inch, +1 cm position

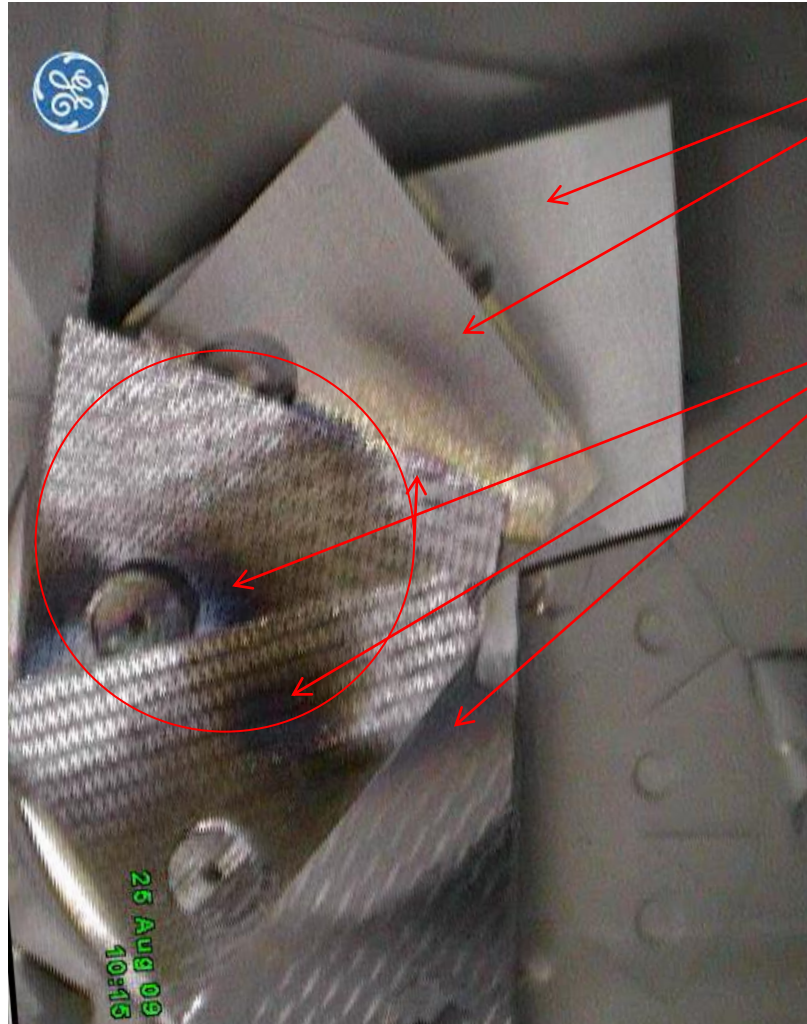
Electrons that hit the top of the catcher can be easily reflected back up into the vacuum chamber

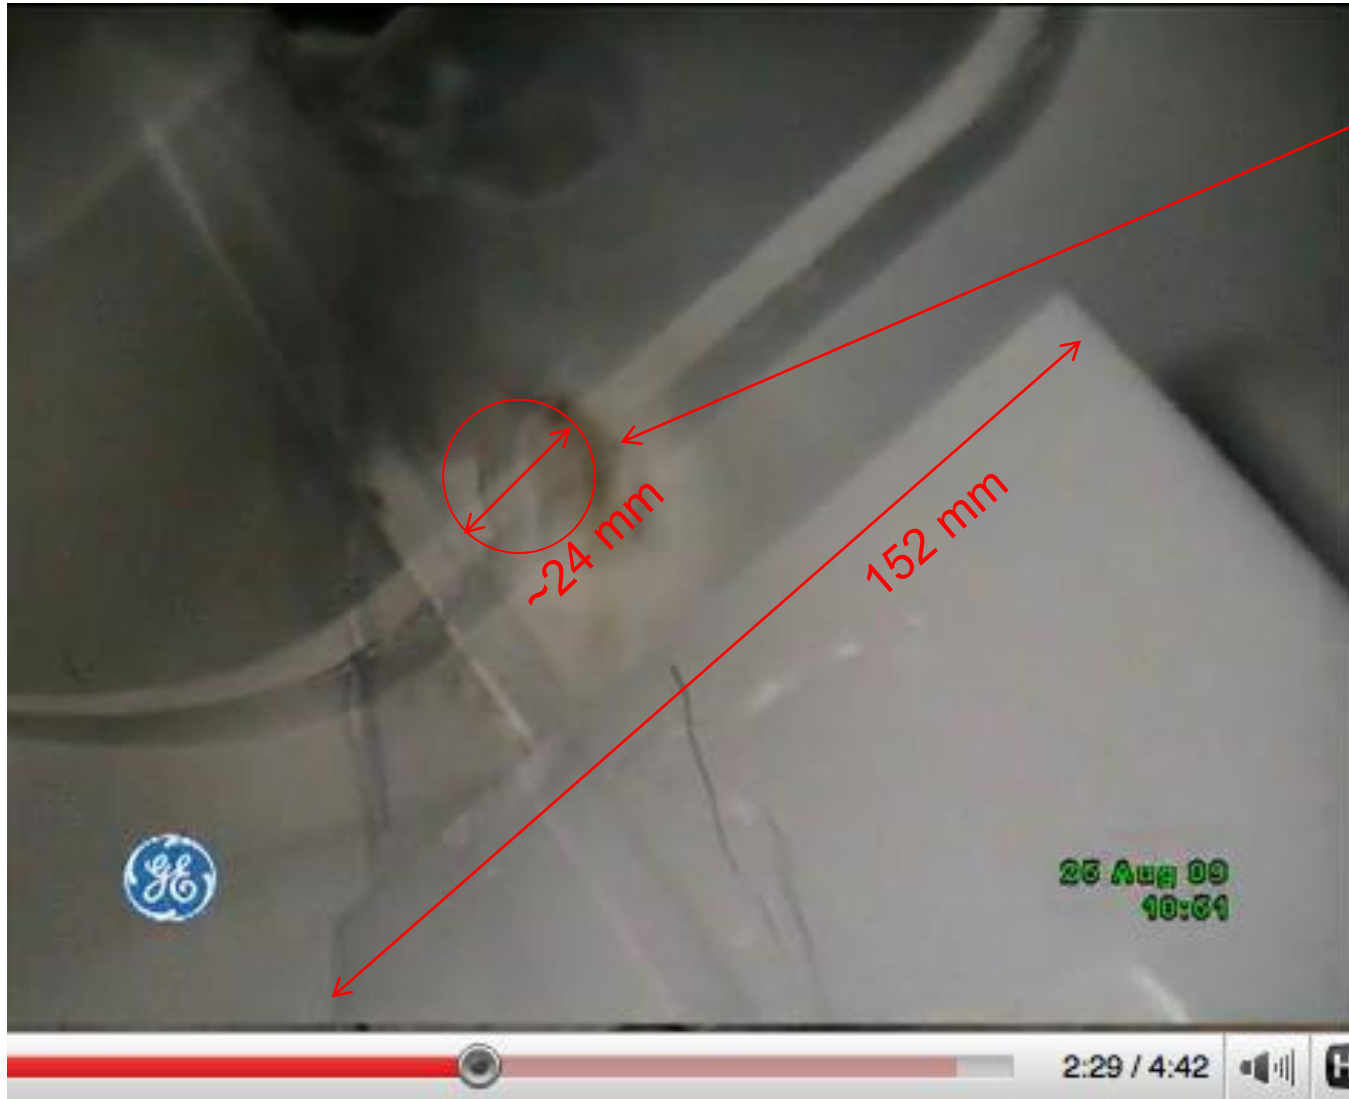
Graphitization at top of vacuum chamber

Could be reflected
convoy electrons
or trailing-edge
multipactoring

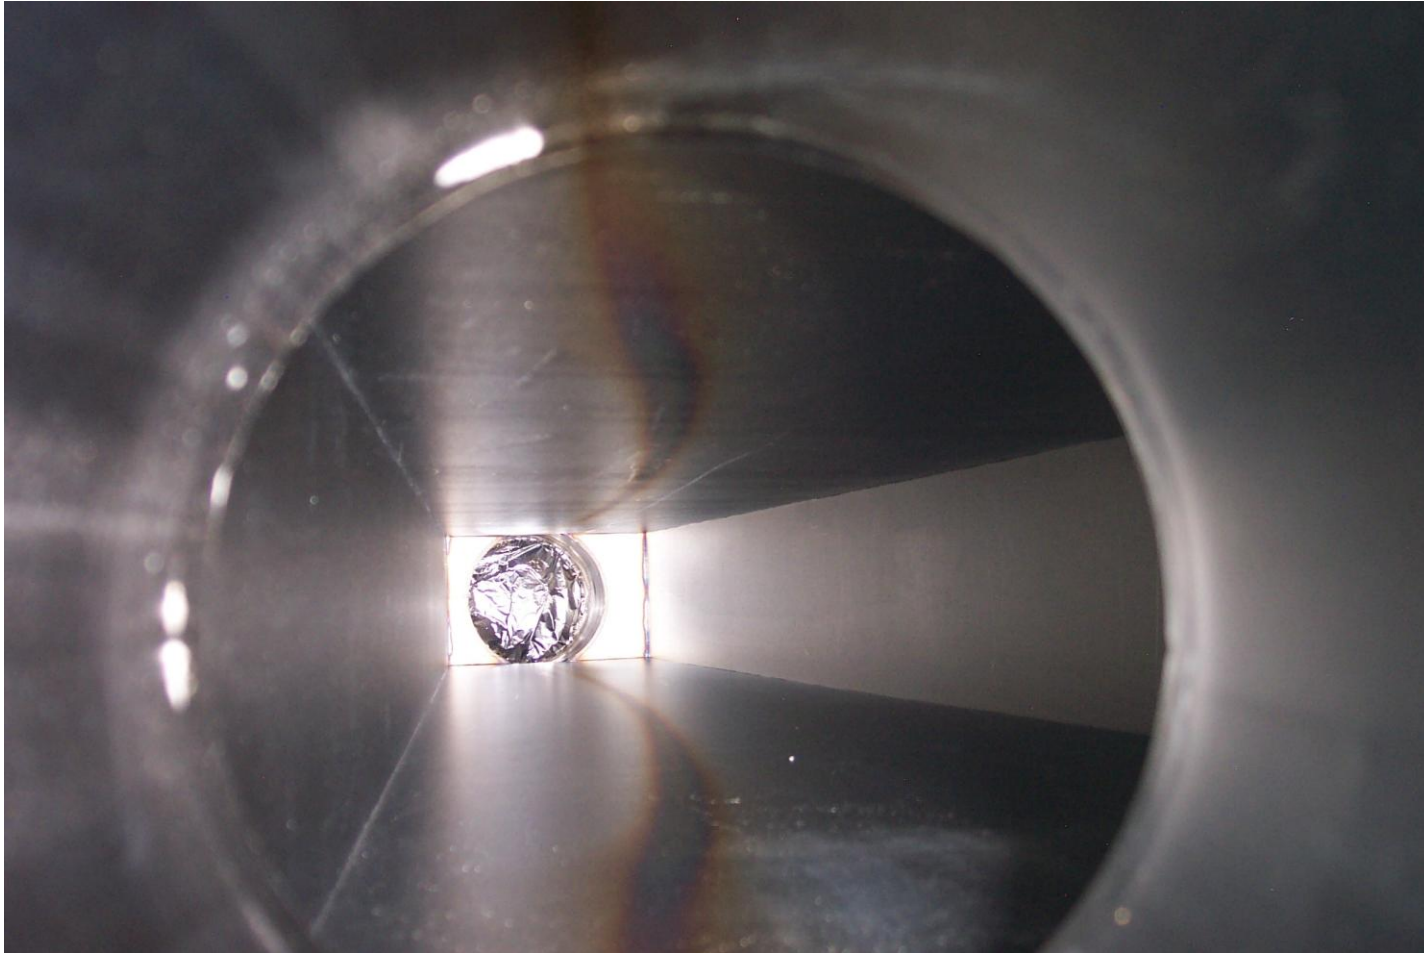
Graphitization

Example of graphitization by multipacting electrons in SRBM11 at PSR. This is not a thermal effect!
