# HIGH VOLTAGE PERFORMANCE DEGRADATION OF THE 14UD TANDEM ACCELERATOR\*

P. Linardakis<sup>†</sup>, N. R. Lobanov, T. B. Tunningley, D. Tsifakis, S. T. Battisson, B. Graham,  
J. A. Bockwinkel, J. Heighway, Heavy Ion Accelerator Facility, Australian National University,  
Canberra, ACT, 2601, Australia

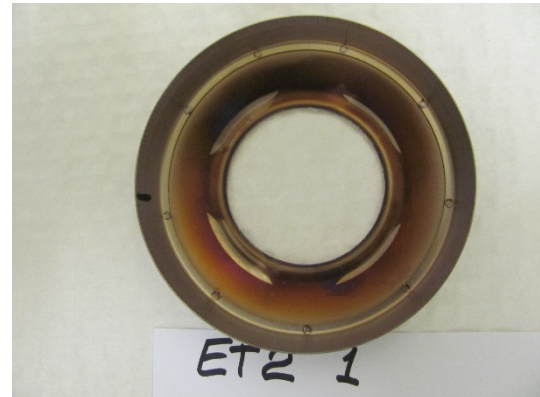
Figure 1 and Fig. 2 show the top of the first titanium electrode in unit 19, acceleration tube 2 (exposed to the ion beam) and the bottom of the last electrode in the same tube (chiefly exposed to electron flux). SEM images of the same electrodes are shown in Fig. 3 through Fig 6. These images

Figure 1: Top face of electrode 1 in unit 19, acceleration tube 2 after over 40 years of operation.

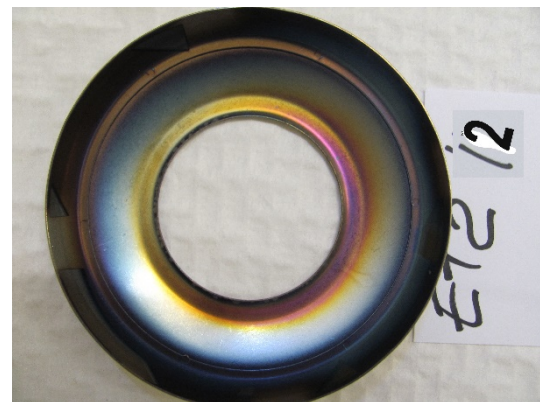
Figure 2: Bottom face of electrode 12 (last) in unit 19, acceleration tube 2 after over 40 years of operation.

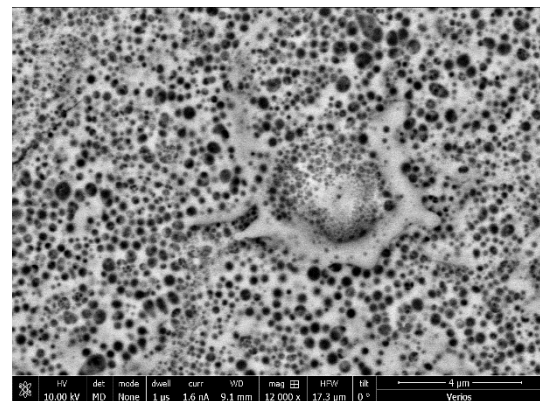
show varied but common features observed, such as porosity, metal vaporisation and material build up. Titanium sheet samples were also analysed as a comparison (Fig. 7) and the surface was shown to be relatively pure, with sparse embedded particles with a high oxygen and carbon content.

Figure 3: SEM image of the bottom of electrode 1 in unit 19, acceleration tube 2, showing metal vaporisation and surface porosity.

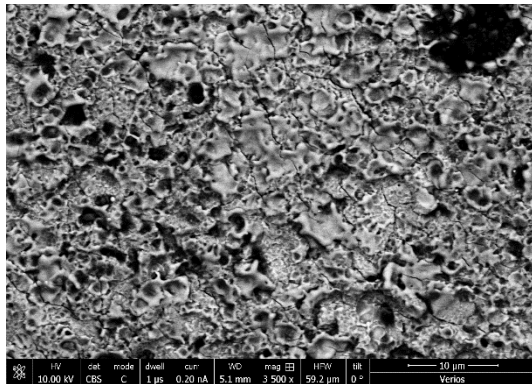
Figure 4: SEM image of the top of electrode 12 (last) in unit 19, acceleration tube 2 showing re-crystallisation of the surface layer of the Ti electrode.

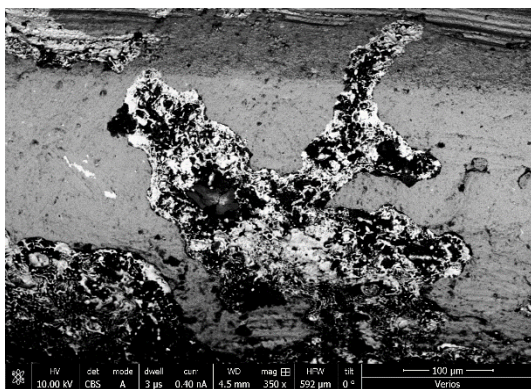
Figure 5: SEM image of the bottom of electrode 12 (last) in unit 19, acceleration tube 2, showing metal vaporisation.

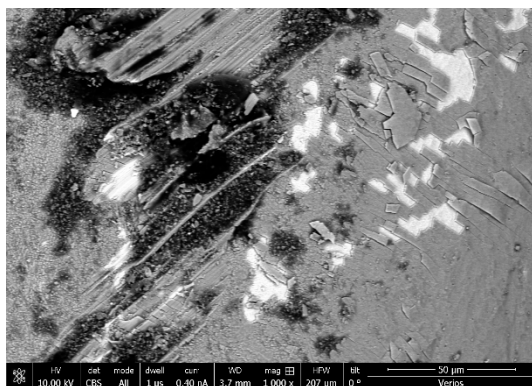
Figure 6: SEM image at the inner edge (toward the beam axis) of the bottom side of an acceleration tube electrode showing severe layer build up and subsequent possible flaking. The black regions are carbon rich layers and the white areas are pure Ti. The grey areas are loose films contaminated with O, F, S.

In combination with the SEM images, the oxygen and carbon content suggests a build-up of oxide and carbon layers, which aside from impacting the voltage gradient, would provide particulate material for increased initiation of vacuum breakdown. The supply of oxygen comes from residual gas in the acceleration tubes and oxygen gas that was historically used as a gas stripper medium. Most of the carbon contamination is likely to be from broken carbon stripper foils.

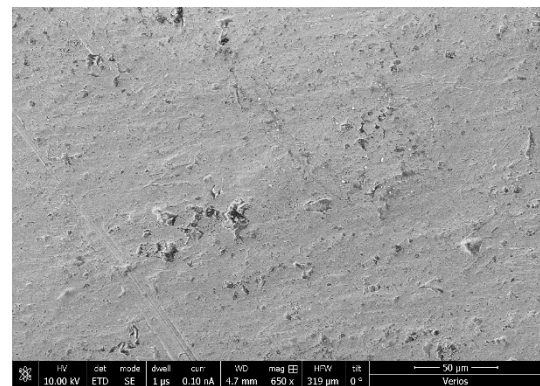
Figure 7: SEM image of titanium sheet as a comparison to used titanium electrodes in acceleration tubes.

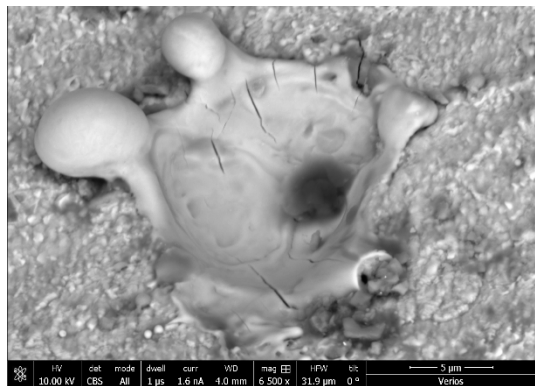
Other features were also observed upon disassembly of the acceleration tubes. Pure physical damage to electrodes was observed, with craters in electrode surfaces and sputtering of titanium. This then creates protrusions that then act as a trigger for the release of electrons. An example of cratering is shown in Fig. 8.

Figure 8: SEM image at the inner edge (toward the beam axis) of an acceleration tube electrode showing severe metal vaporisation.

From the observed conditions of the accelerator tube insert electrodes, their remediation through cleaning or replacement should be a priority. However, even new electrodes may need processing. New tubes and electrodes installed during the compressed geometry upgrade of the 14UD were processed via magnetron sputtering using argon, followed by baking in a vacuum oven at 600 °C [3, 5].
