## High Voltage Performance Degradation of the 14UD Tandem Accelerator

Linardakis P., Lobanov N., Tunningley T., Tsifakis T., Battisson S., Graham B., Bockwinkel J., Heighway J.  
HIAT 2018 – Lanzhou, China

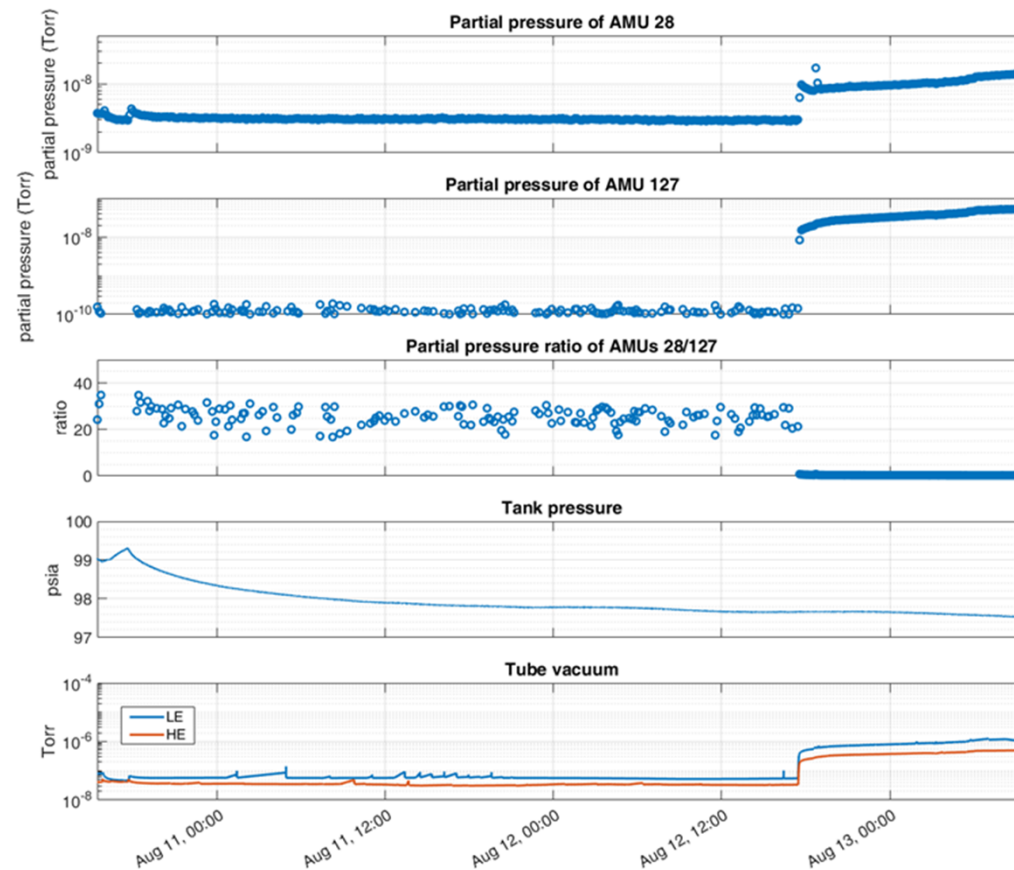
- RGA search for SF<sub>6</sub>
  - Sudden leak while idle

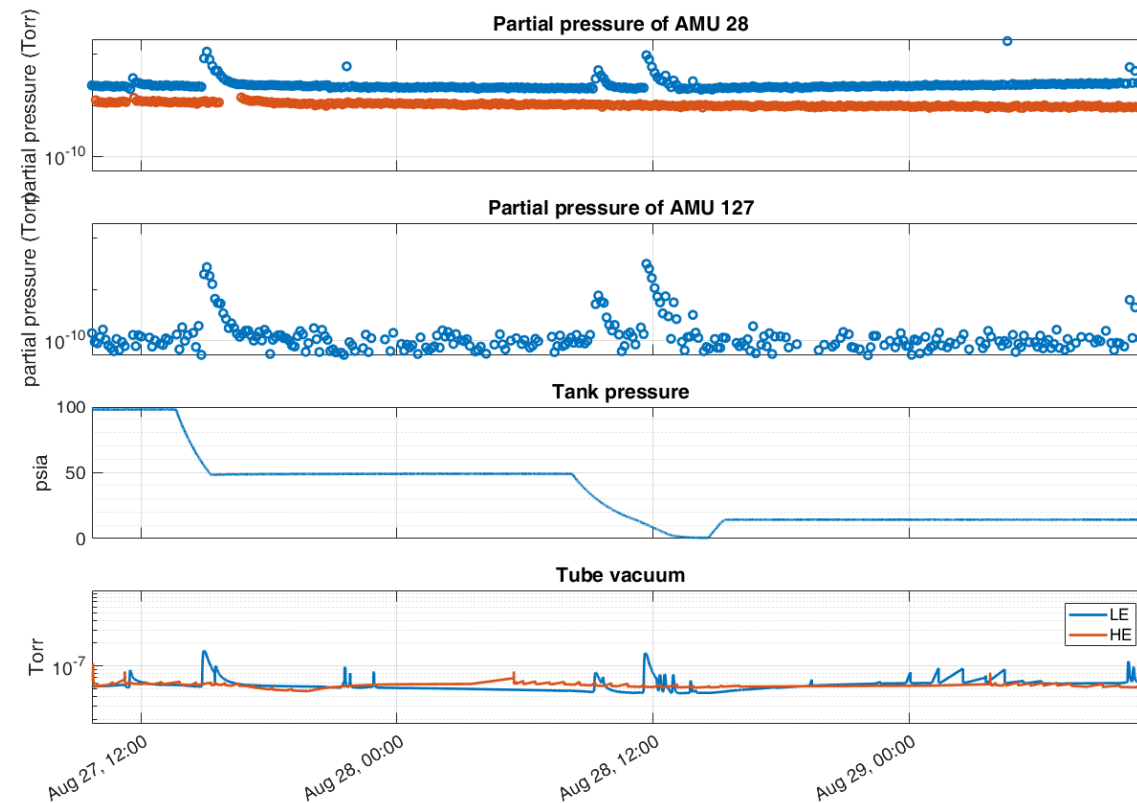
- RGA search for SF<sub>6</sub>
  - Small “burps” while pumping SF<sub>6</sub> from pressure vessel

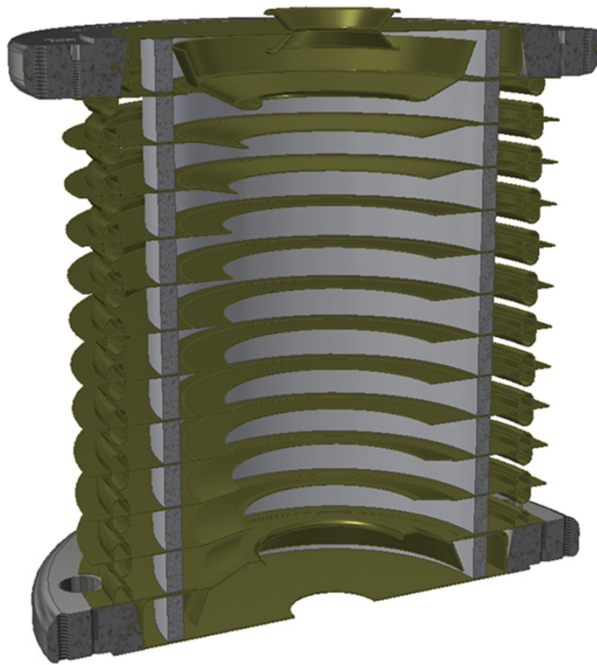
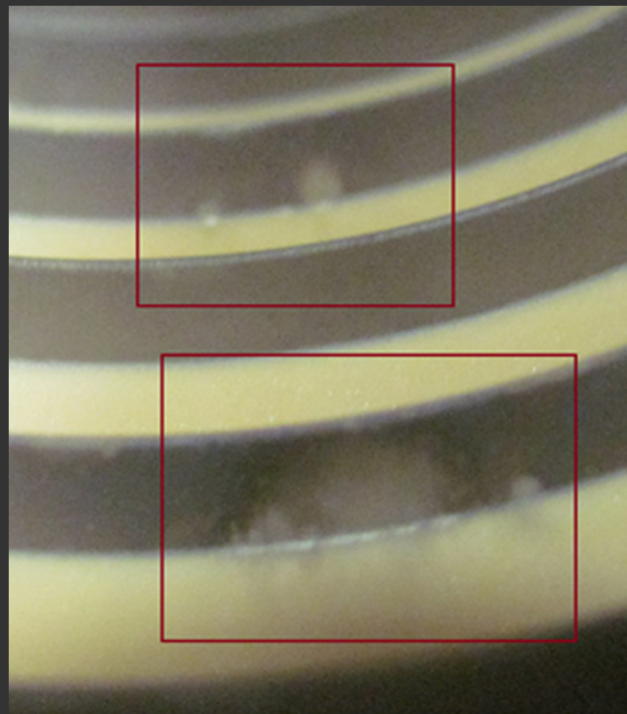
Damage arising from  
aluminum bonding  
layer between titanium  
and ceramic

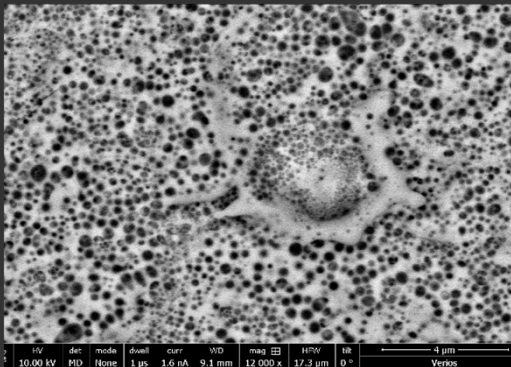
Porosity

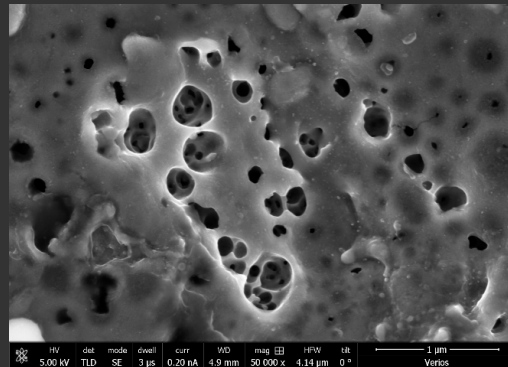
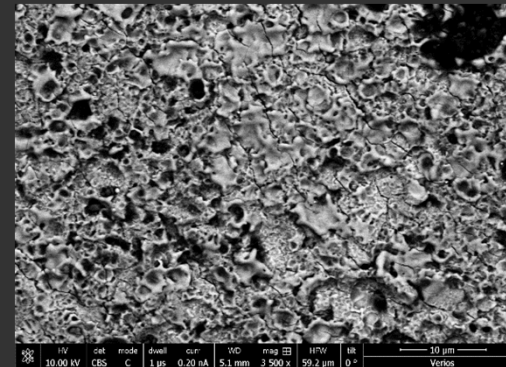
Recrystallization

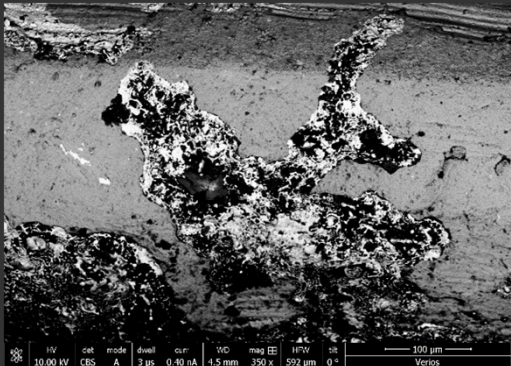
Metal vaporisation

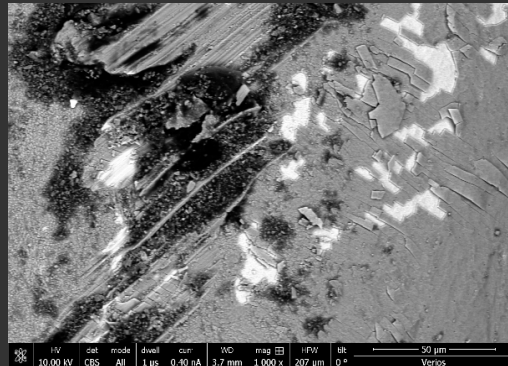
Layer build-up

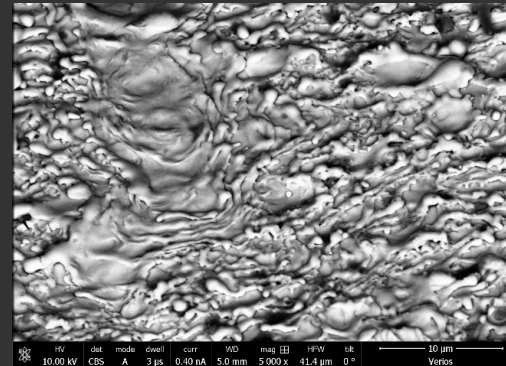
Melting

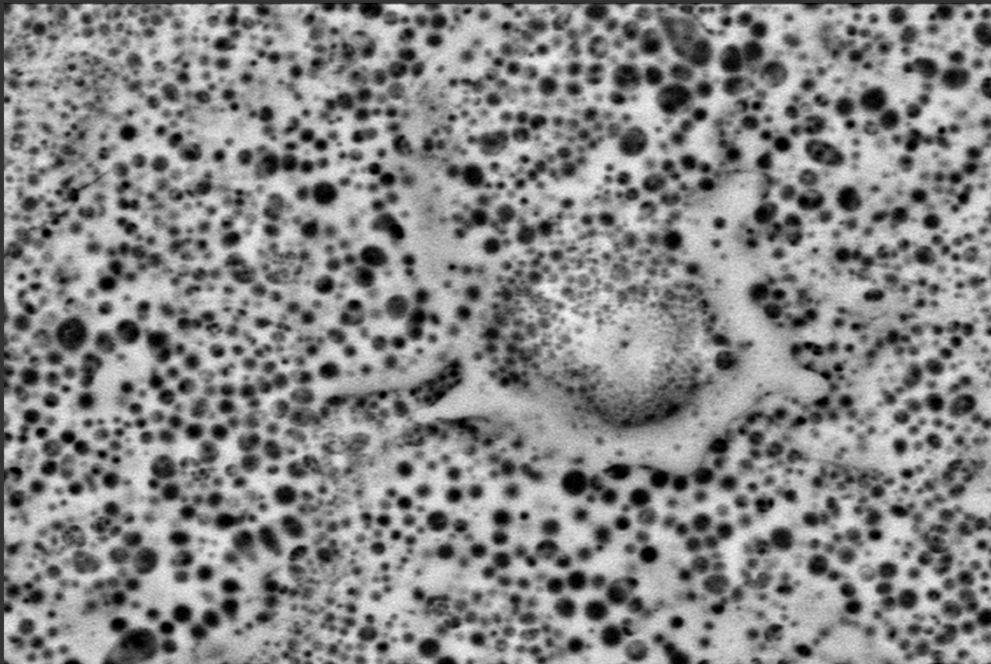
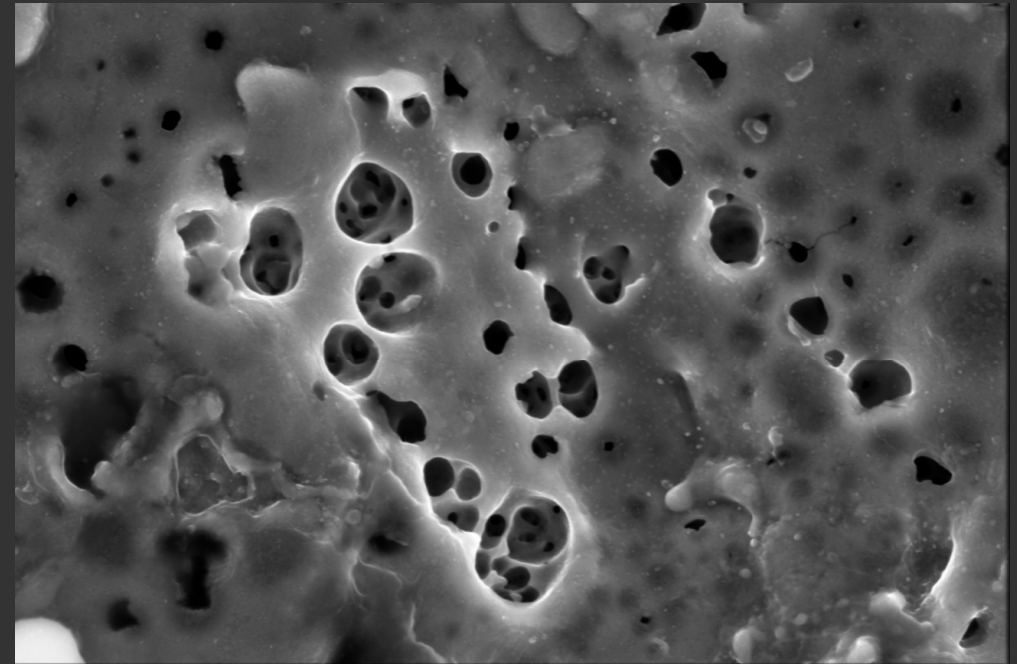
Porosity

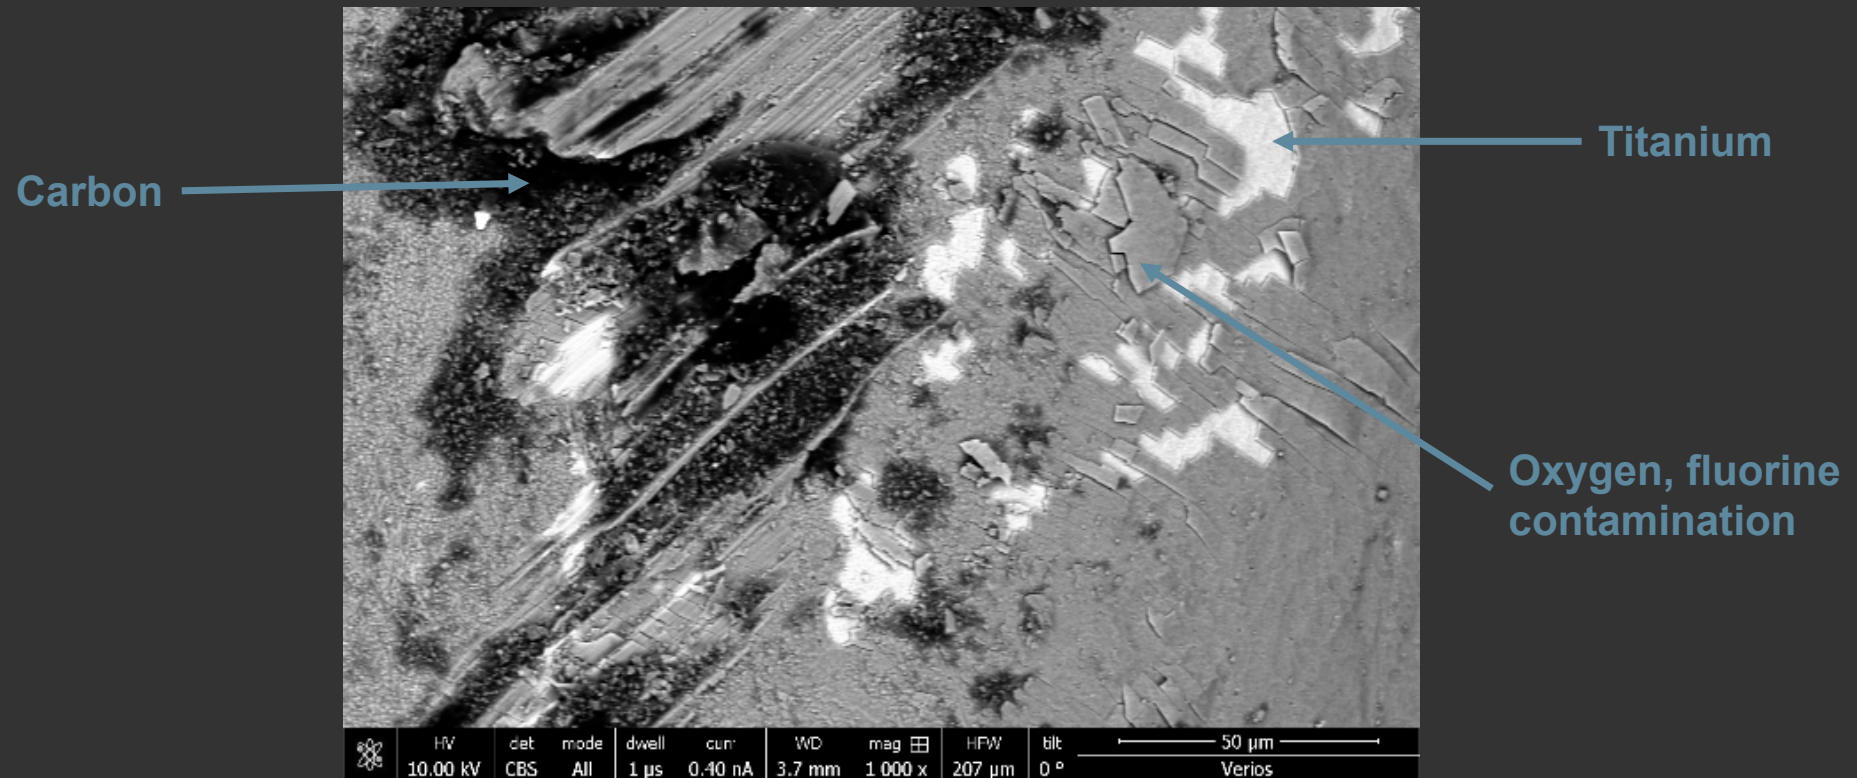
Layer build-up

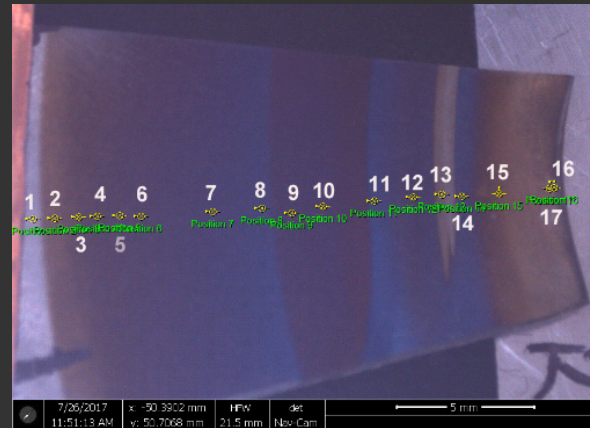
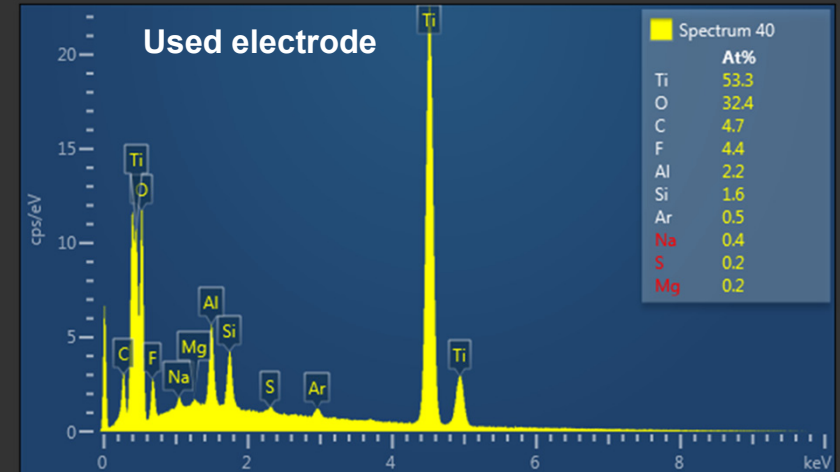
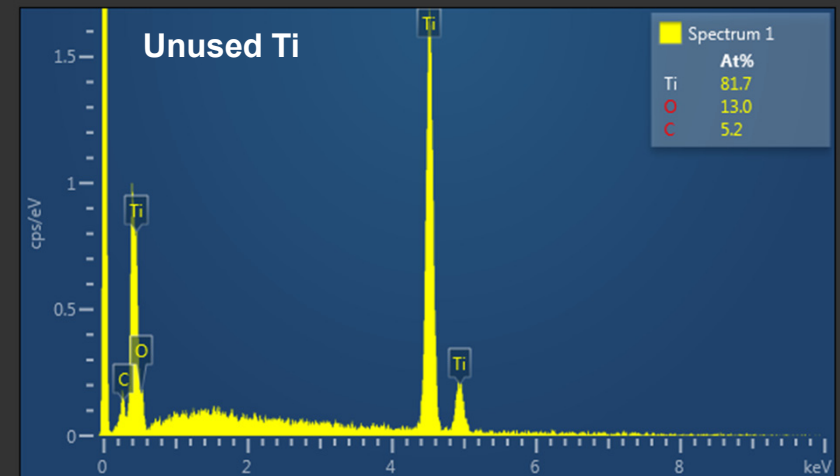
- SEM EDX on used electrodes
  - oxygen 20 – 40%
  - carbon 10 – 20%
  - **fluorine** 3 – 7%
  - aluminium 1 – 3%
- Unused Ti
  - oxygen 10 – 15%
  - carbon 3 – 6%

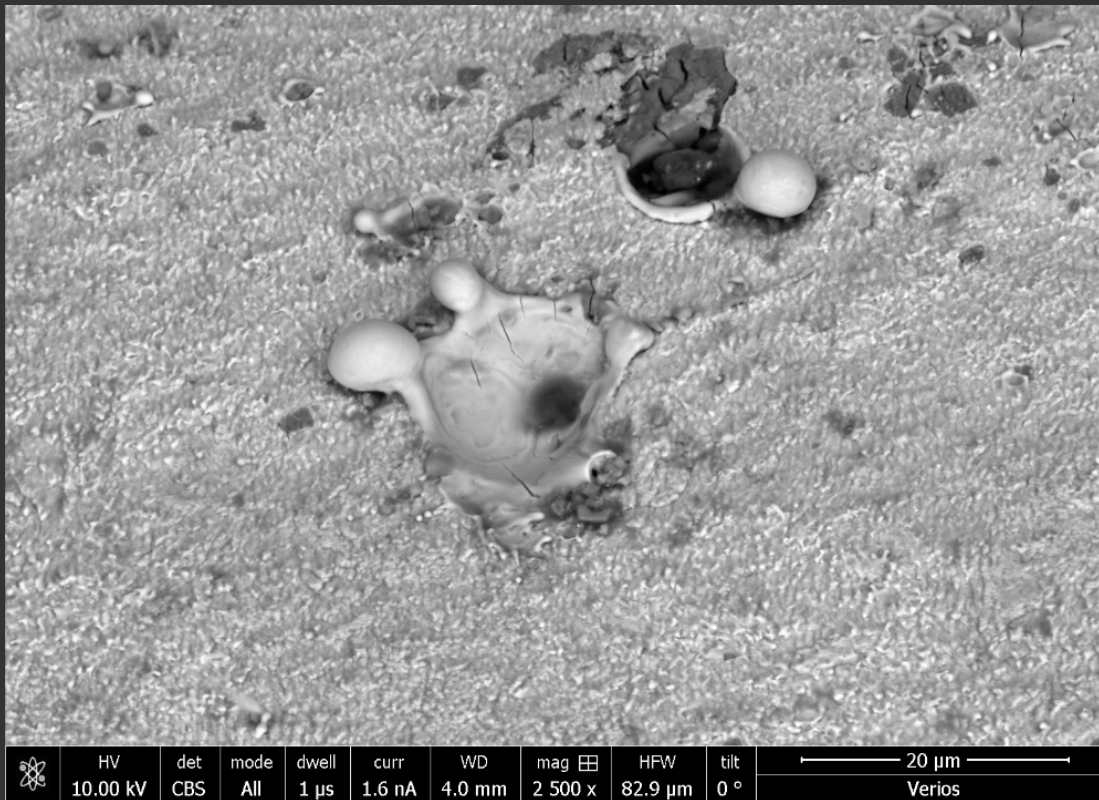
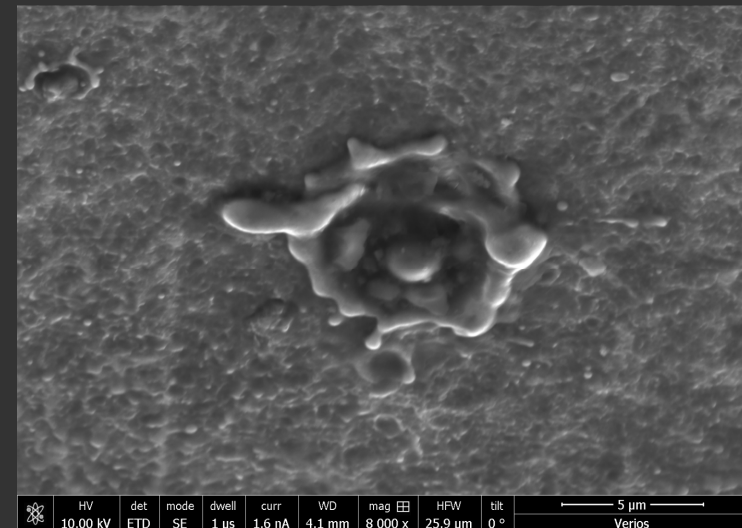
- Damaged electrodes exacerbate vacuum breakdown triggers
  - Field emission from protrusions
  - Ionisation of metal vapour

- New tubes
- Factory refurbishment (NEC)
- In-house refurbishment
  - High-pressure rinse
  - Electro-polishing
