During 5 years of operation in the 3 GeV storage ring of ALBA, the 124 BLMs have provided stable loss measurements around the machine, with around 10% breakdown of units. We have made an attempt to analyze these BLM failures and correlate them with integrated received doses and any special conditions of each BLM location which might have led to their breakdown.

ALBA storage ring operates 6 insertion devices to produce high-brilliance X-rays. Among them is the multipole wiggler (MPW). In this work we show studies of beam losses, possibly induced by the (suspected to be) misaligned 2m long vacuum chamber of MPW.

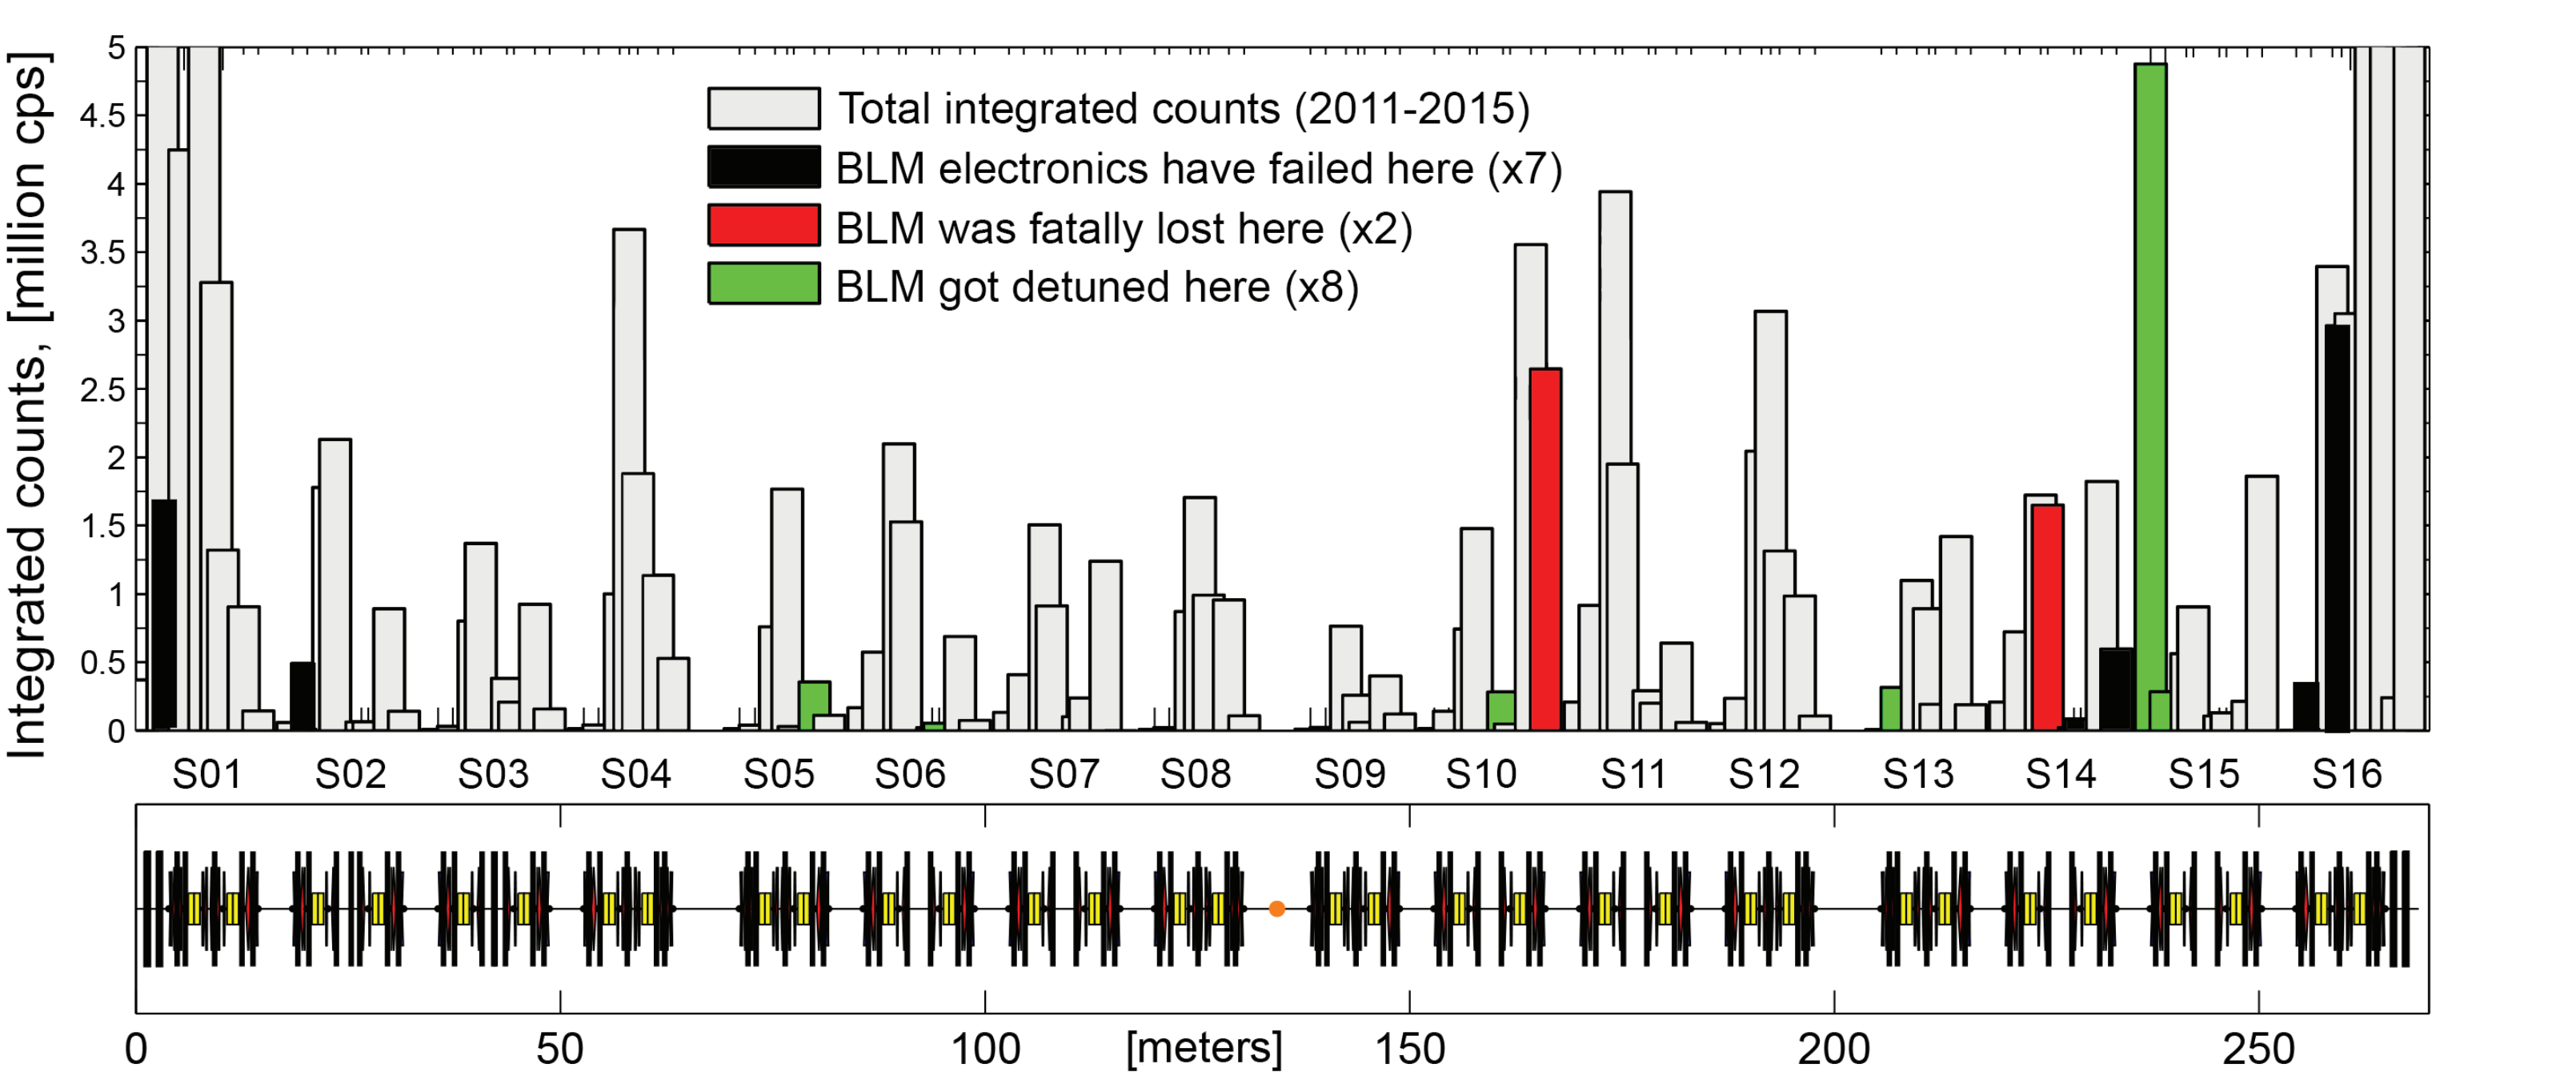
Overall integrated counts (2011-2015) for every storage ring BLM location vs. BLM failures.

Locations of 9 failed BLM units are highlighted:

2 fatal (red, non-repairable),  
7 with failed on-board electronics (black, repairable): 4 dead video amplifiers, 1 inductor, 1 transistor,  
+ 8 detuned units (green, repaired in-situ),  
+ 7 BSCs lost (1 fatally).

**No correlation** could be established: the high amount of received counts did not lead to a loss of BLM unit.

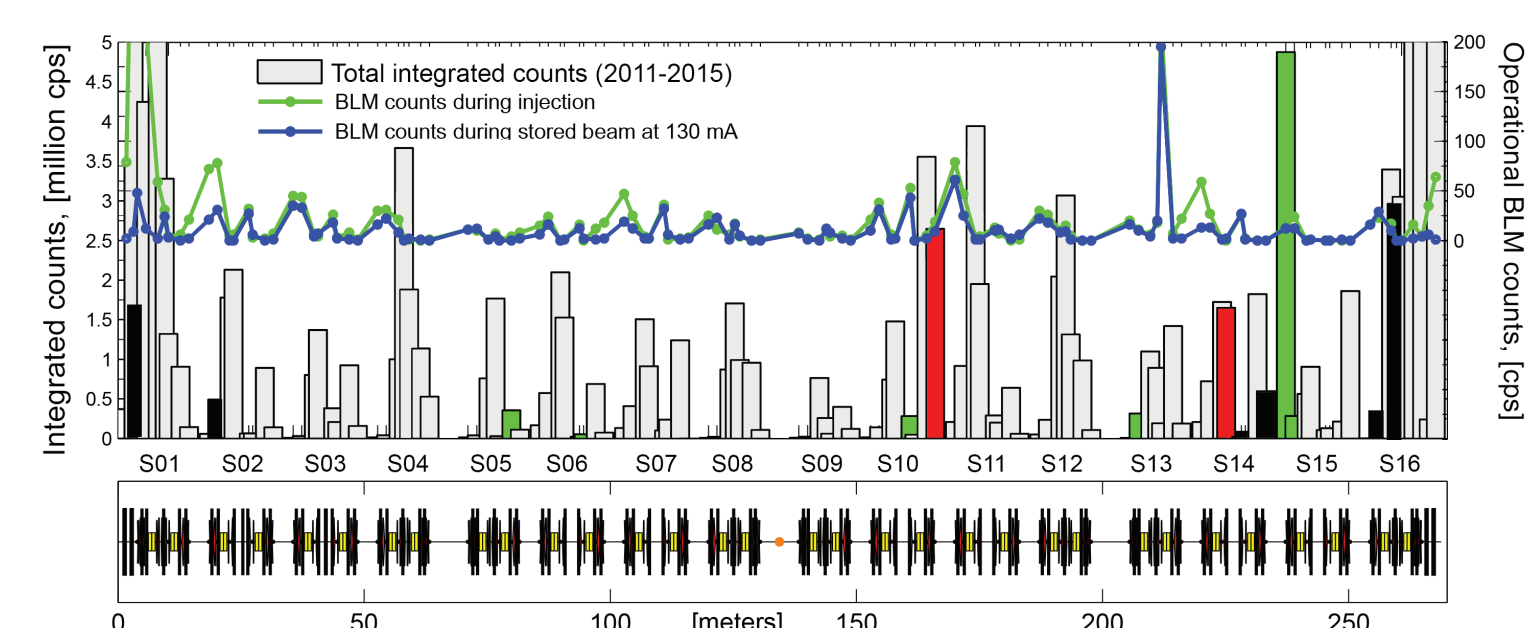
- with operational counts at 1 Hz during stored beam and a top-up injection: **no correlation**;

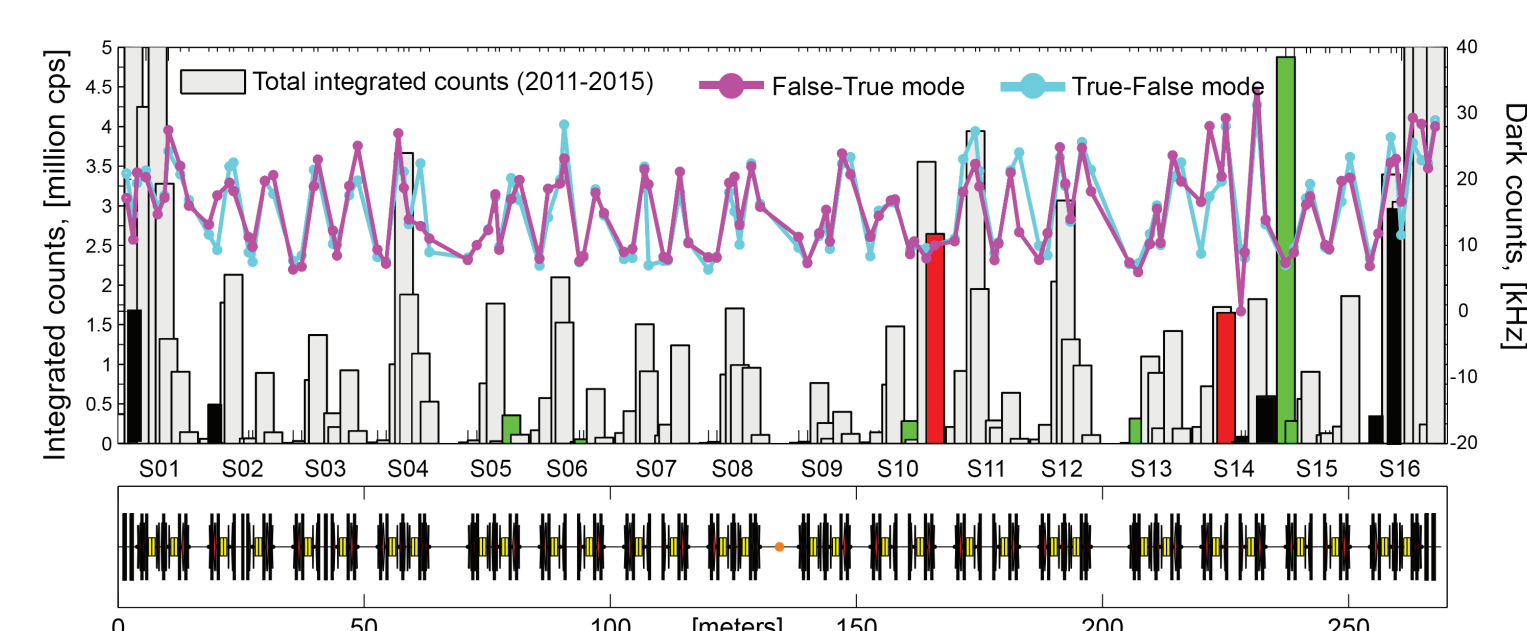
- with the dark (spurious) counts taken during beamtime: **no correlation**;

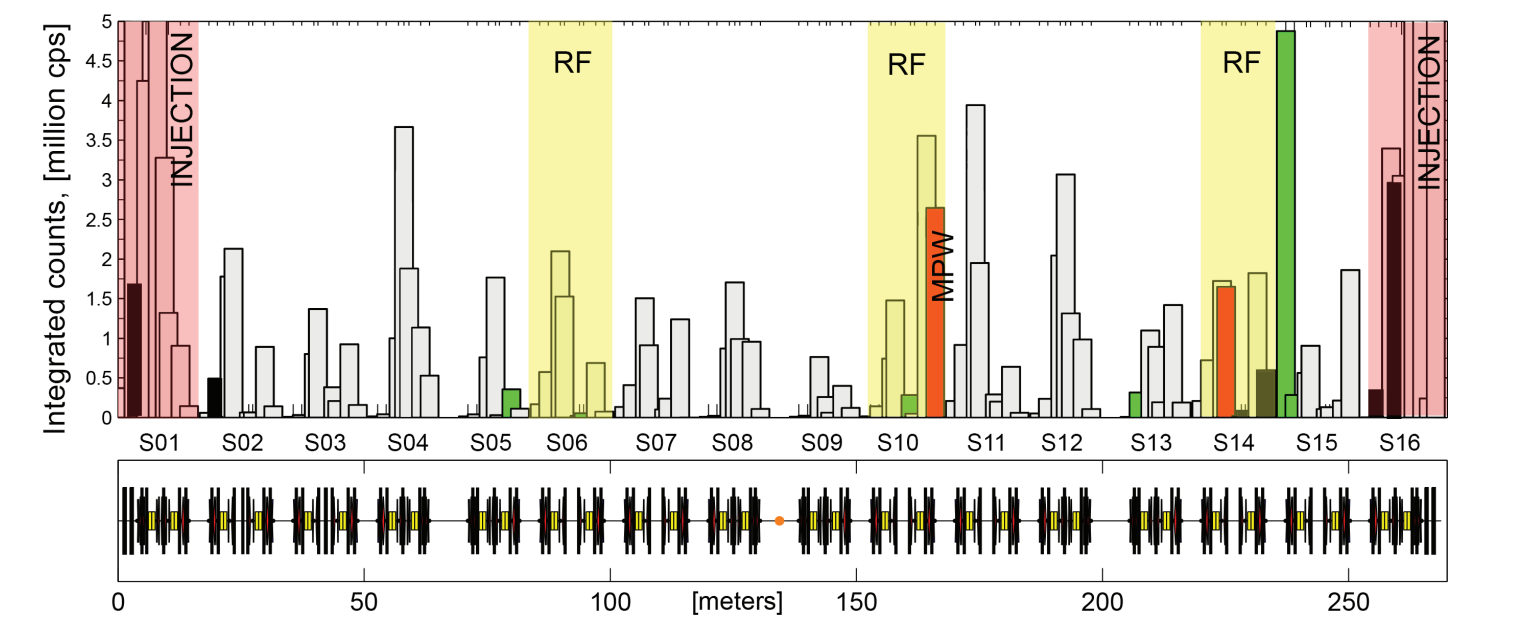
- with the high radiation environment around the ring: the RF plants and the injection sector. The majority of failed (7/9) and half of the detuned (4/8) BLMs units were located in these areas, which **can indicate their degradation**.

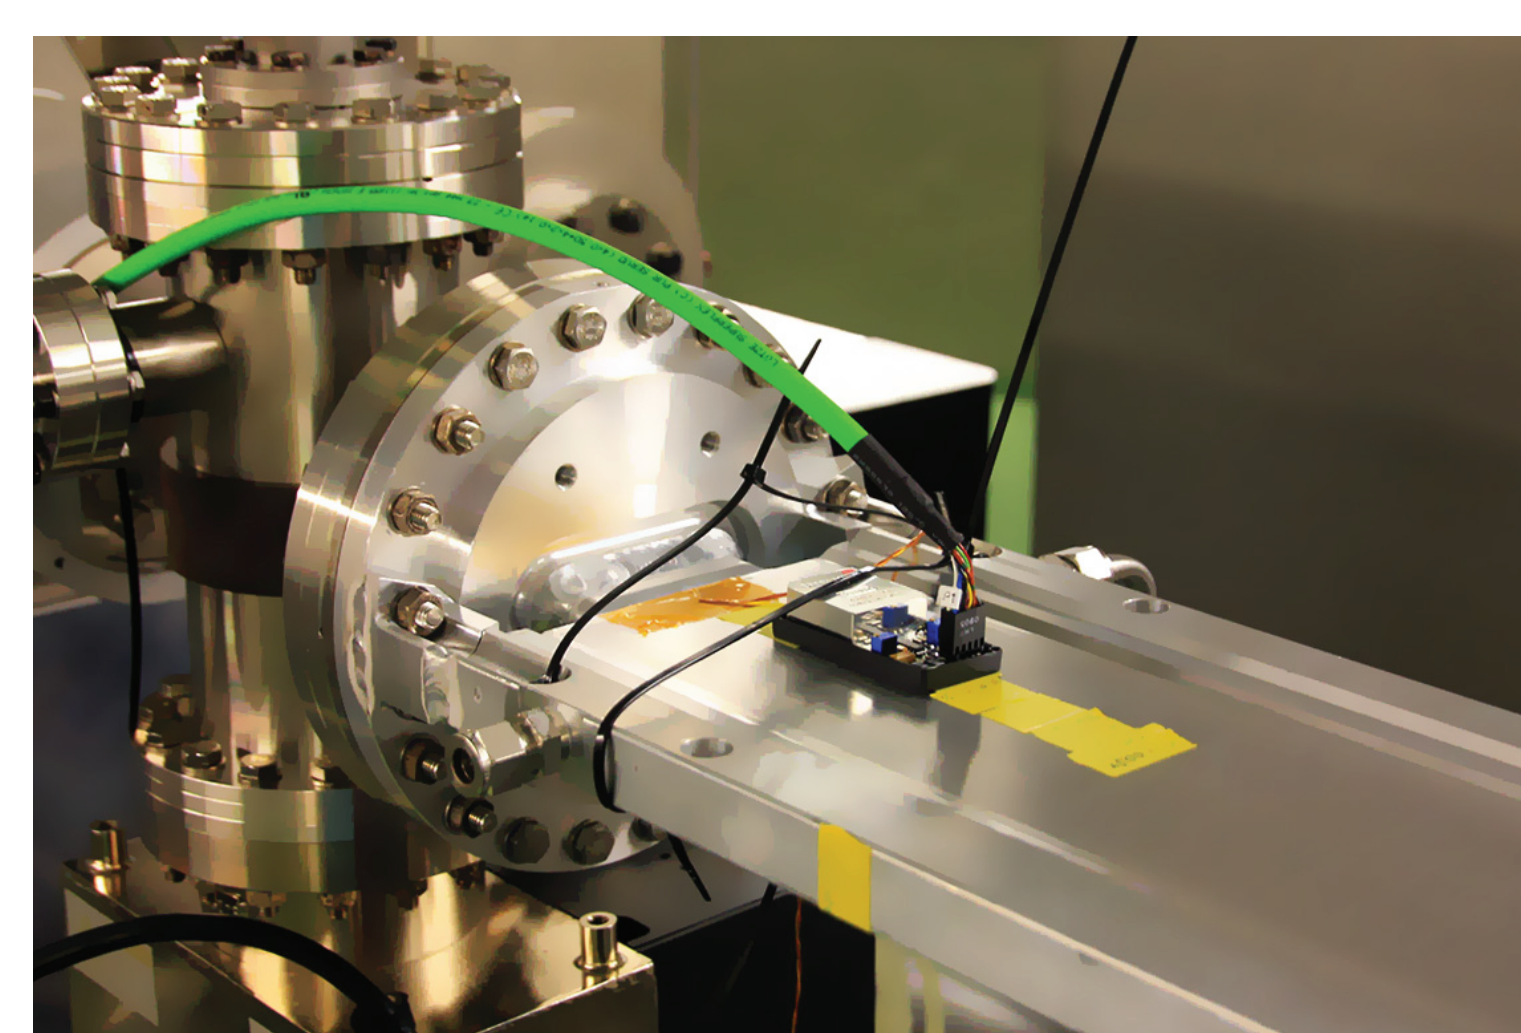
An alignment survey had indicated that the upstream girder is misaligned by 0.8mm downwards with respect to the downstream girder, thus tilting the MPW chamber. A pair of BLMs were placed on top and under the MPW chamber upstream to monitor possible beam losses. Very high, beam current-dependent losses were indeed detected, more on top of MPW than below.

Beam loss monitor placed on top of the MPW vacuum chamber to study losses induced by misaligned storage ring sections.

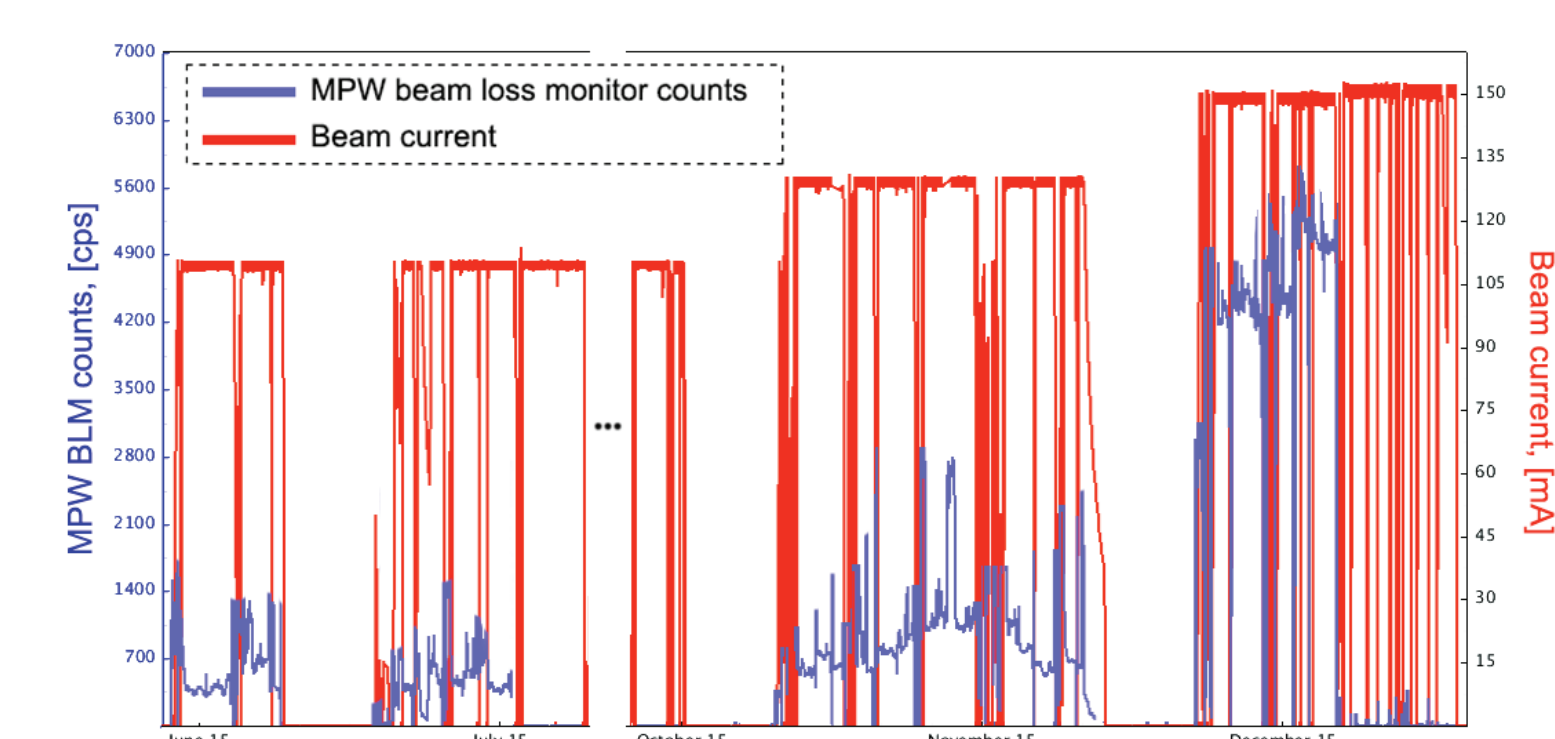
Beam losses measured on top of the MPW vacuum chamber in 2015, indicating a drastic dependence on beam current rising from 1000 cps at 120 mA to 6000 cps at 150 mA.

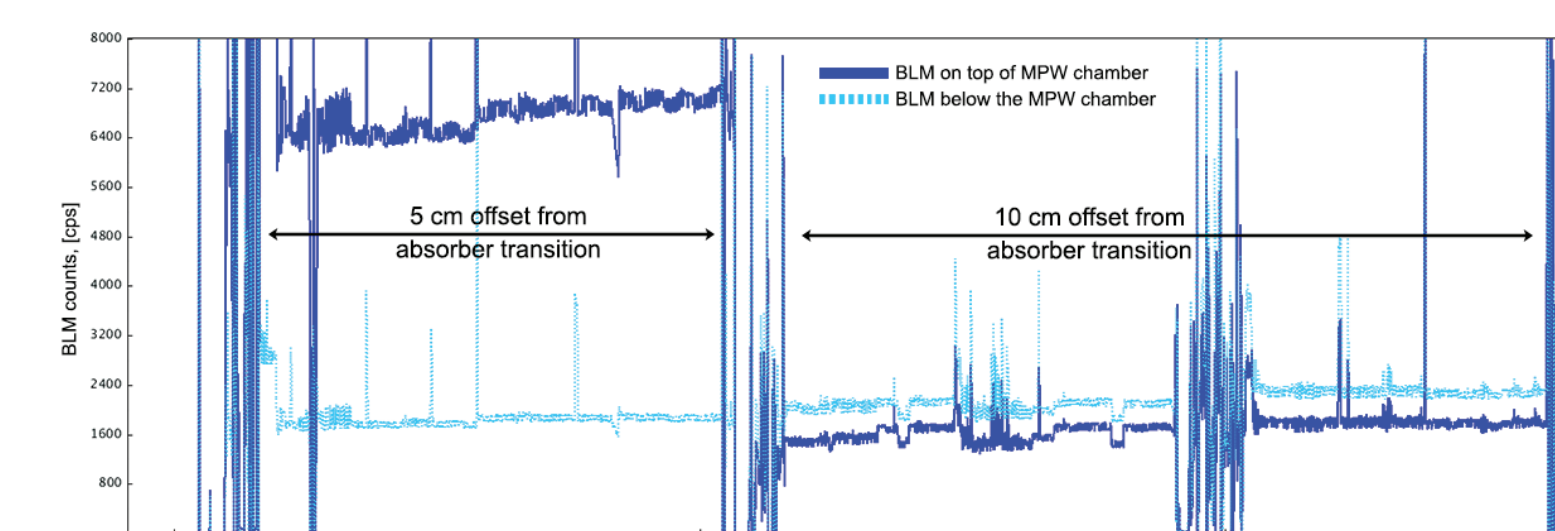
Longitudinal "scanning" of beam losses on top and bottom of the MPW vacuum chamber: the counts above decrease as the BLM gets farther from the misaligned region, while the counts below stay constant.
