FLOOR DEFORMATION OF J-PARC LINAC AFTER THE TOHOKU EARTHQUAKE IN JAPAN

T. Morishita[#], H. Asano, JAEA, Tokai, Ibaraki 319-1195, Japan
 M. Ikegami, KEK, Tsukuba, Ibaraki 305-0801, Japan

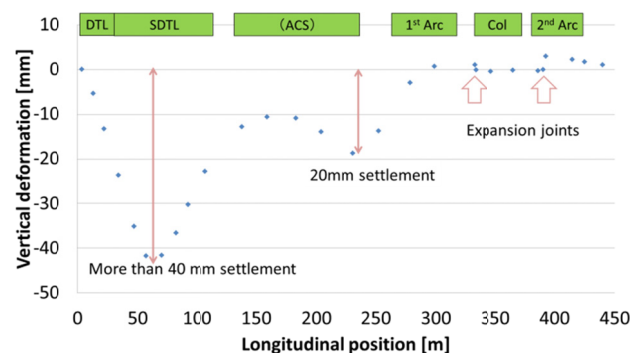
Figure 2: Relative level difference of the linac tunnel floor.

The level monuments are distributed on the tunnel floor. The heights of these monuments were measured using digital level (Leica DNA03 with bar-code staff). Figure 2 shows the relative level difference of these monuments with respect to the height measured at September 2010. The height difference for the uppermost monument is further subtracted to deduct the settlement of the whole linac tunnel. In the straight section, there are local settlements at the DTL/SDTL sections (more than 40 mm) and at the end of the ACS section (about 20 mm). From the first arc to the injection area to RCS, significant settlements did not occur. However, the step-like level difference occurred at the expansion joints.

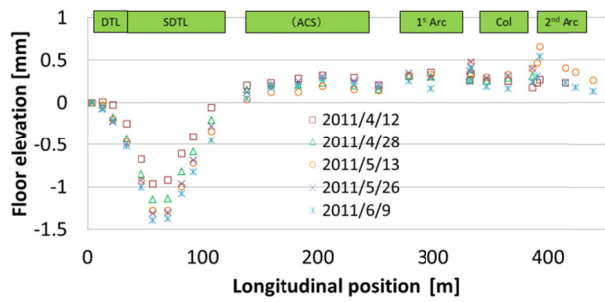
Figure 3: Floor elevation after the main quake.

weeks. Figure 3 shows the floor elevation change after March 31th. The local settlement continued at the upstream side of the straight section, this directional elevation change has mostly ceased two months later.

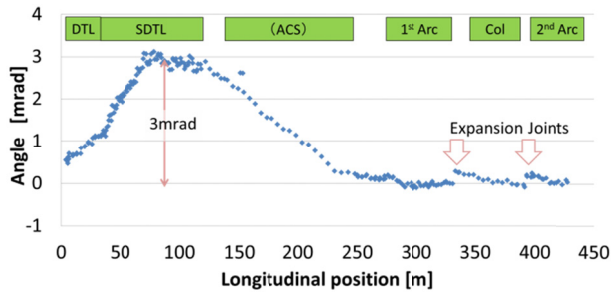
Figure 4: Inclination angles of the cavities and magnets.

The inclination angles of the cavities and magnets are shown in Fig. 4. The vertical axis is the rotating angle around the beam axis. In the straight section, more than 3 mrad tilt was observed toward westward direction. A small contortion occurred at the expansion joints.

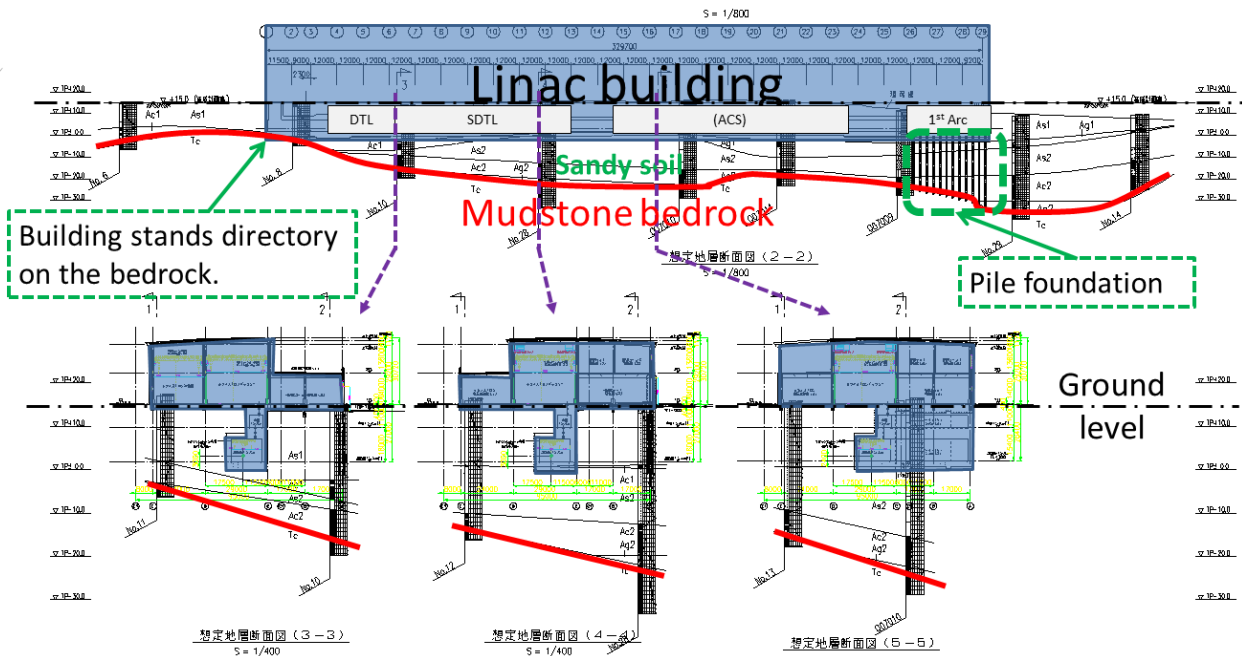
Figure 5: Foundation and soil distribution of the linac.

Figure 5 shows the soil distribution under the linac building. Upper figure is the cross-sectional drawing of the geological formation along the beam direction (north-to-south). Lower figures are those of perpendicular (west-to-east) direction. The upper end of the building directory stands on the mudstone bedrock, and the downstream end has pile foundation. However, at the middle of the straight section, the spread foundation stands on the sandy soil. The settlement noted above might be induced by this unequal foundation and the soil distribution. In the west-to-east direction, the direction of the inclination angle is the same as the soil distribution.

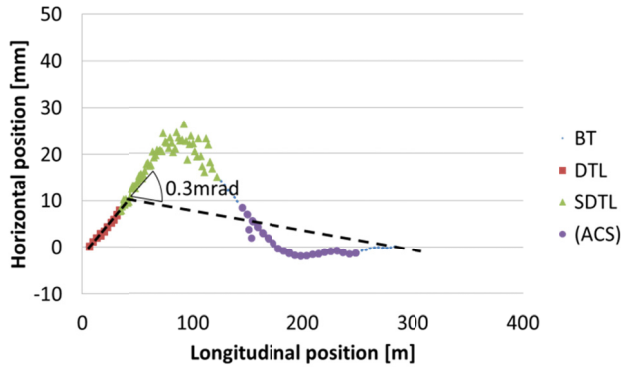
Figure 6a: Horizontal position of the accelerators in the straight section.

The reference base of the cavities and magnets were measured by using the laser tracker (Leica LT600). Horizontal and vertical displacements are shown in Figs. 6a and 6b respectively. The vertical displacement is consistent to the floor elevation as shown in Fig. 2. There is about 25 mm horizontal deformation at the straight section.

The influence of the DT misalignments on the beam might be a fatal problem especially on the DTL cavity. Then, the platform of the DTL/SDTL cavity has a vibration-damping structure to reduce relative misalignment of the drift tubes when the cavity receives a strong acceleration. With this structure, a cavity is fixed on a platform which can slide on a linear rail in the horizontal direction. The horizontal motion of the platform is restricted with a spring and a shock absorber. A random distribution of a few millimetres at the SDTL section in Fig. 6a is due to the slide on this rail.

The dotted line shows the target re-alignment line in the straight section. It is necessary to move the DTL cavity by 20mm or more to align on the ideal straight line in the whole area of the straight section toward the dump. However, the range of the DTL movement is a few millimetres without re-wiring for DTQs. Then, aiming at an early restart of the beam operation, we decided to steer the beam at the steering magnets downstream of the DTL section horizontally and vertically [2].

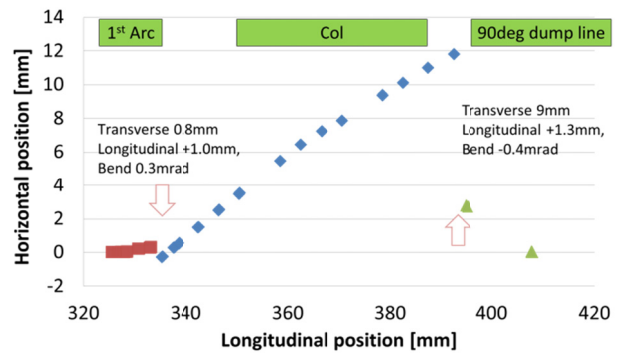
Figure 7: Relative position of the magnets after the first arc to the 90 degree dump.

Figure 7 shows the relative position of the magnets after the first arc to the 90 degree dump. Displacements at the expansion joints areas follows:

- 0.8 mm in transverse, 1.1 mm in vertical, + 1.0 mm in longitudinal, 0.3 mrad in bend at the exit of the first arc.
- 9 mm in transverse, 3 mm in vertical, + 1.3 mm in longitudinal, -0.4 mrad in bend at the exit of the collimator section.

The beam transport section (from the first arc to the injection line to RCS) will be adjusted to maintain the proper injection angle and position to RCS.
