Vacuum Issues with Argon Gas in the LANSCE Accelerator

LA-UR-21-24718

The LANSCE accelerator experienced down times due to trips of ion pumps starting in 2017. It turned out to be due to argon gas.

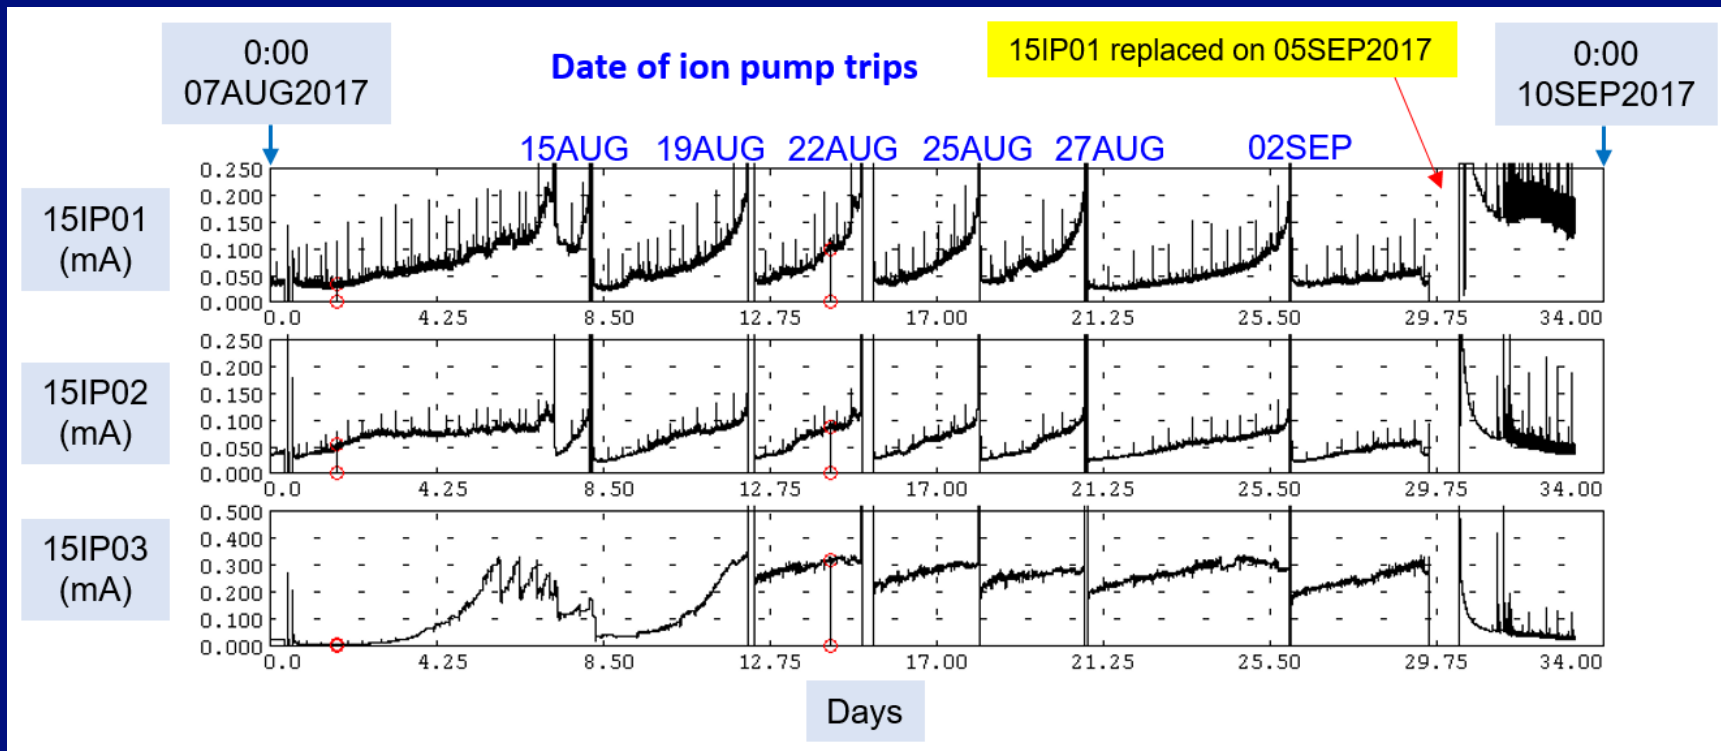
Figure: The currents of 3 ion pumps in module 15 from 07 August till the end of 09 September in 2017

1. It started in 2017. To the best of our knowledge, this did not occur before in the history of the accelerator that started its operation in early 1970s.
2. It stopped after an ion pump 15IP01 was replaced on 10 September 2017, but it occurred again in 2018 starting on 14 May 2018 and there were 7 trips until 27 July 2018.
3. In 2019, it occurred again starting on 19 September 2019 and there were a total of 4 trips until 01 December 2019.
4. In 2019, with a residual gas analyzer (RGA) we monitored the gas to find out which gas is causing these trips and we found it was argon gas as shown on the next slide.

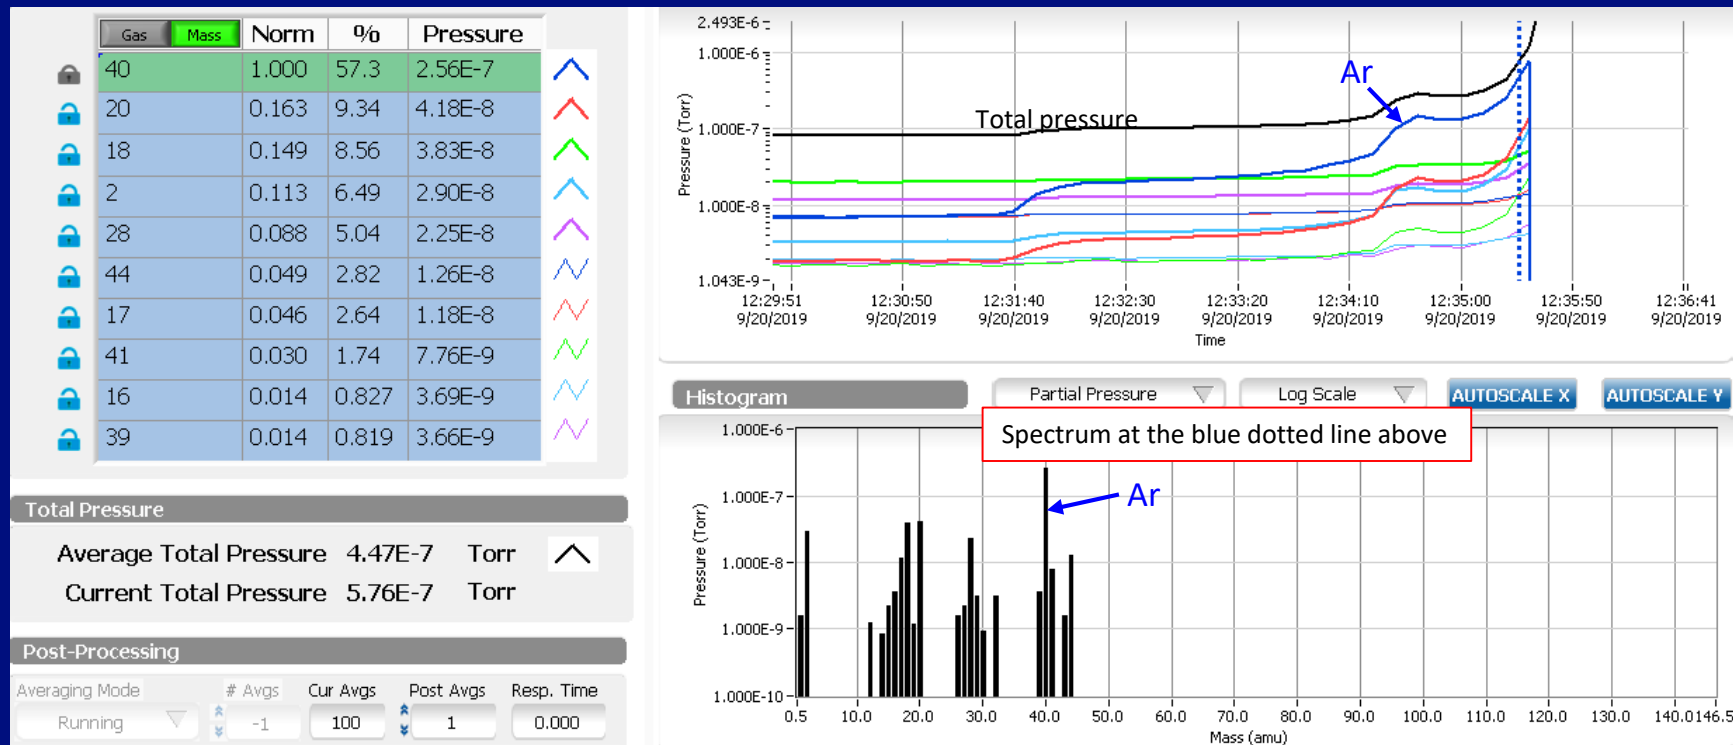
We found in 2019 that it was argon gas (mass 40 amu) that was causing the ion pump trips.

Figure: RGA data taken on module 15 on 20 September 2019.

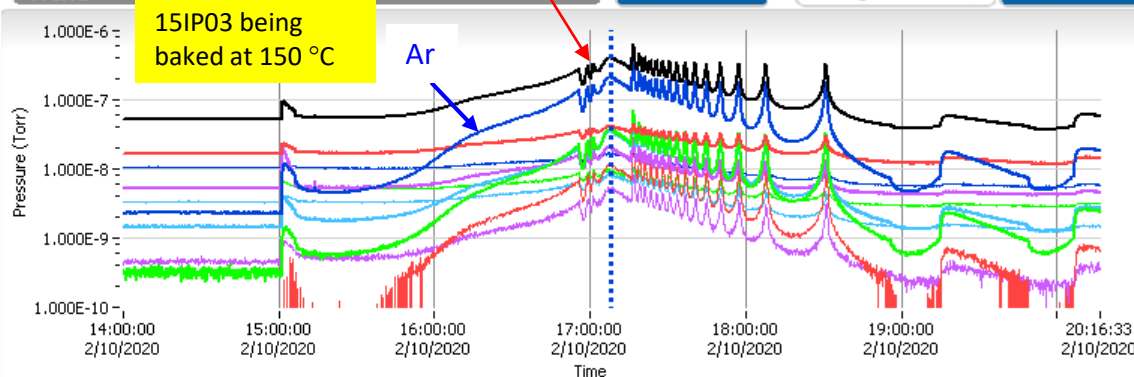
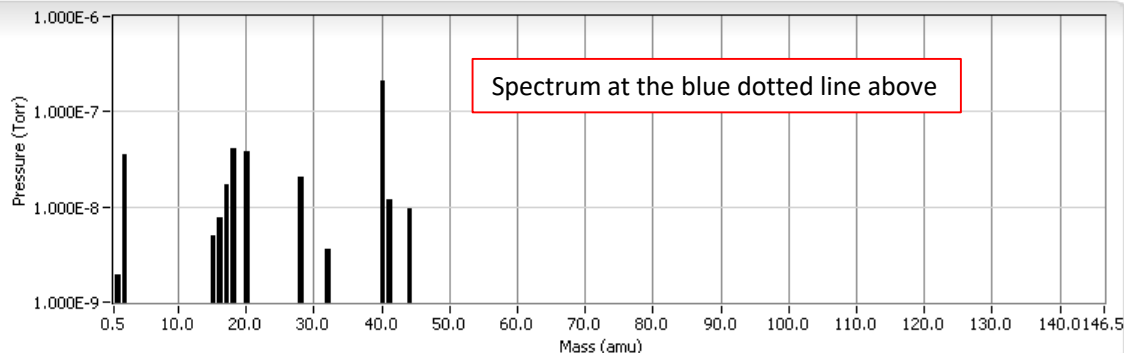
1. After we found that argon gas bursts were causing these trips definitively, we decided to bake out the oldest pump 15IP03 that was installed in March 1996. (FYI, 15IP02 was installed in August 2006.)
2. We baked the pump in February 2020.
3. When the temperature was raised from 135 °C to 150 °C, a large amount of argon gas was released from the pump as shown on the RGA data on the next slide.
4. We baked it at 150 °C for ~6 days while pumping the module with a turbo molecular pump.
5. We have not had any trips since 15IP03 was baked out in February 2020.
6. However, we are not 100 % sure if we have entirely eliminated the problem yet and we don't know why this particular module or section caused this problem.

Figure: RGA data that shows argon gas coming off from 15IP03 at 150 °C baking. The temperature was turned down to 100 °C to prevent RGA to trip.

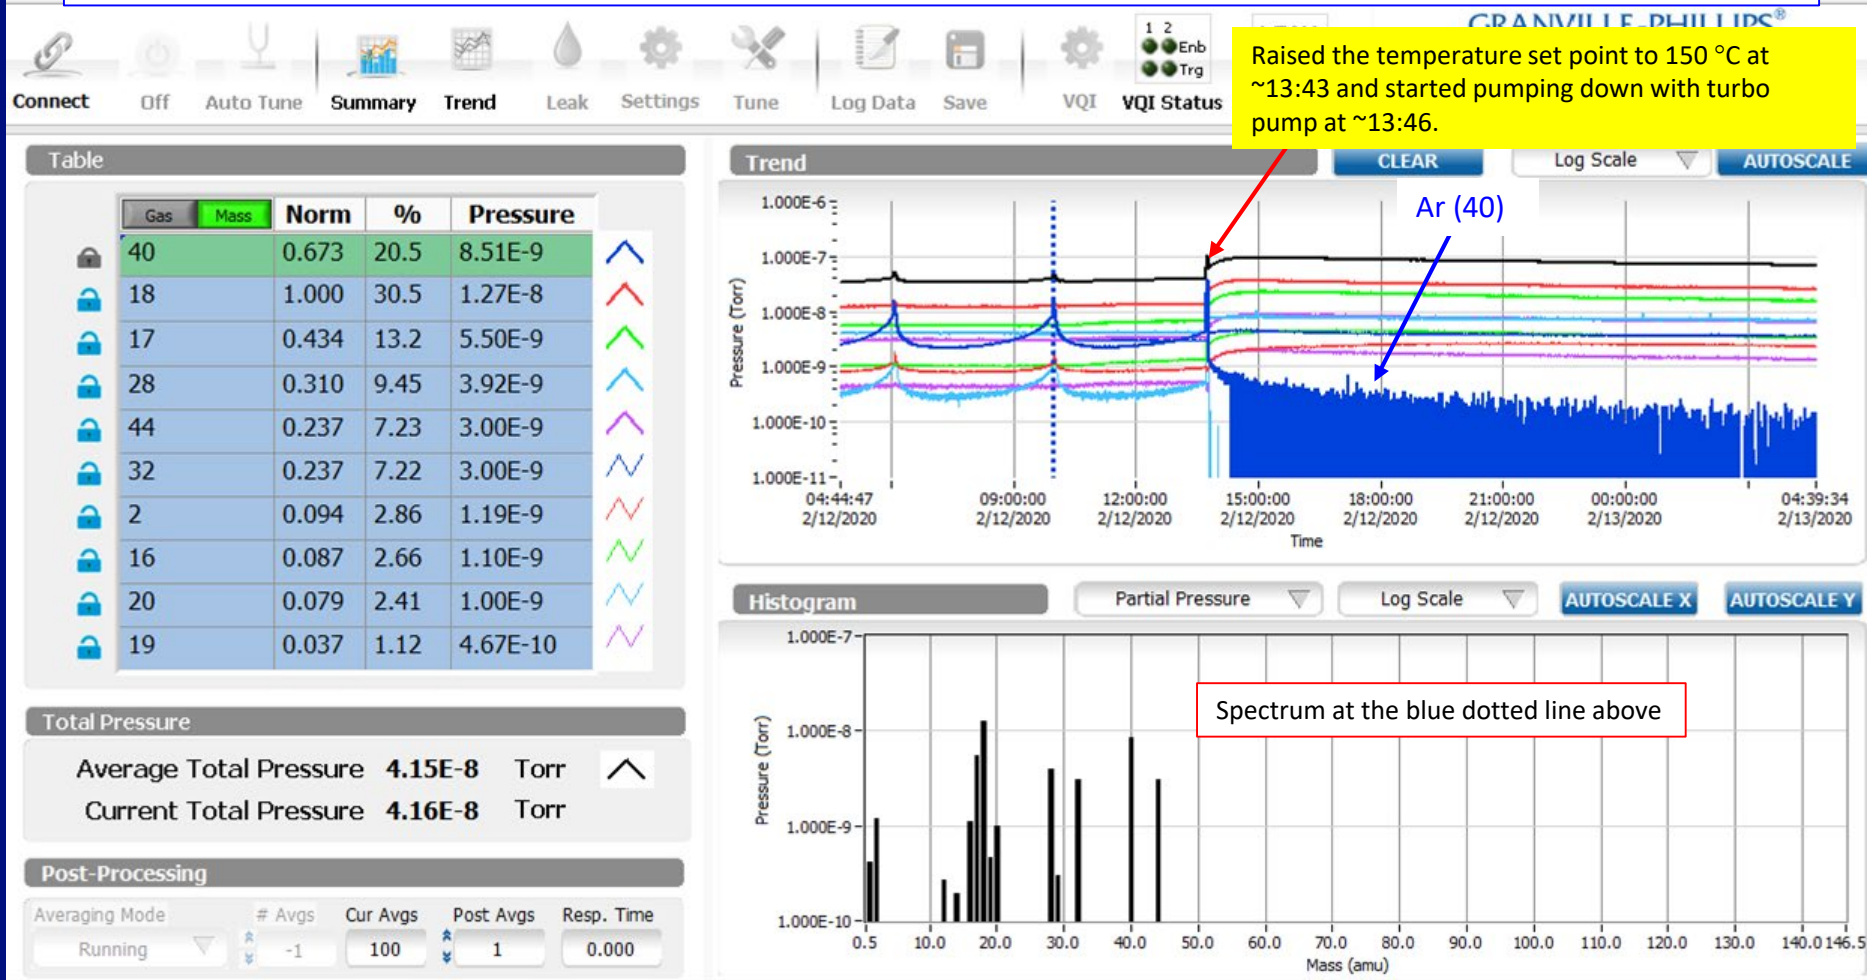
Figure: RGA data shows argon gas is being pumped down with a turbo pump effectively.

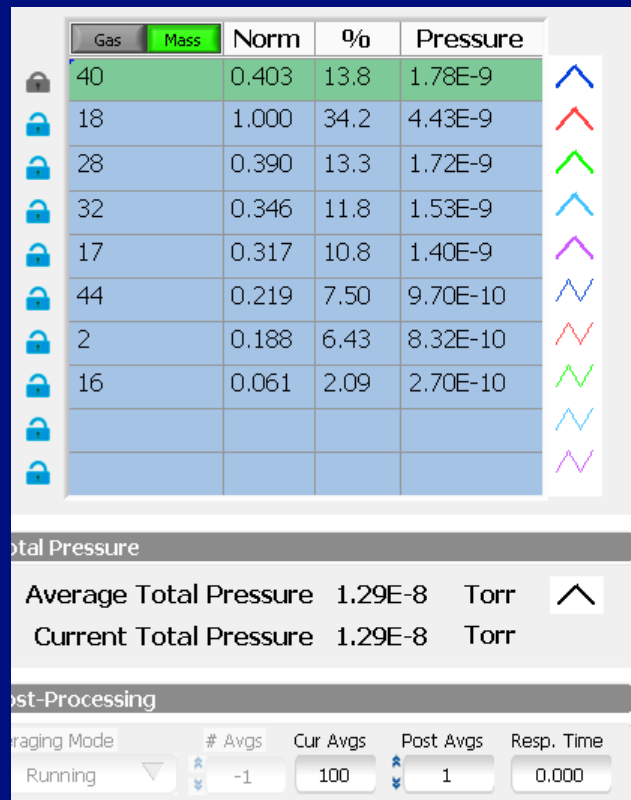
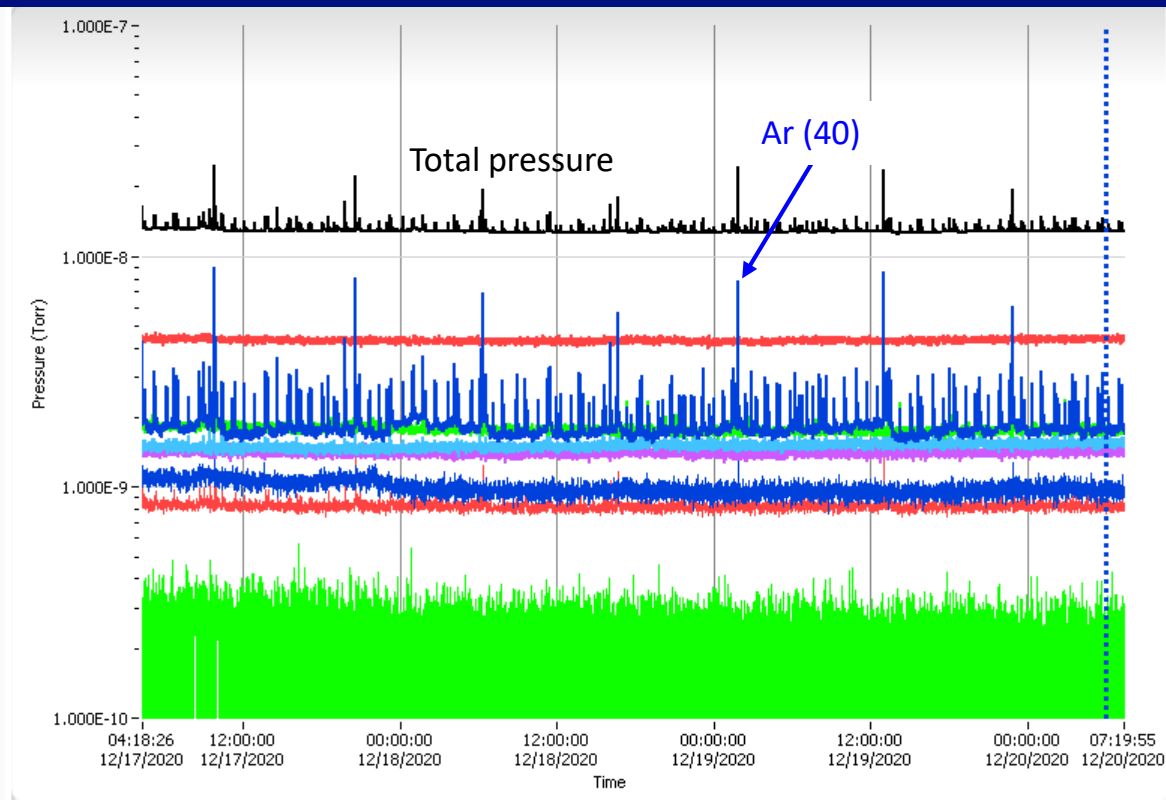
Figure: RGA data still shows small argon pulses in December 2020, but they have not led to a large burst of argon gas and resulting trips of ion pumps.

- The issue with argon gas bursts that caused accelerator down times due to trips of ion pumps in the LANSCE LINAC module 15 in 2017, 2018 and 2019 may have been solved by baking the oldest ion pump on this module since no ion pump trips have occurred since the baking in February 2020.
- We don't know if this problem could occur at other sections in the accelerator, but we plan to carefully monitor ion pumps currents and bake out the ion pumps that show spikes that might cause this problem in the future as a preventive maintenance.
