# REPORT ON COLLIMATOR DAMAGED EVENT IN SuperKEKB

High Energy Accelerator Research Organization (KEK), Tsukuba, Japan

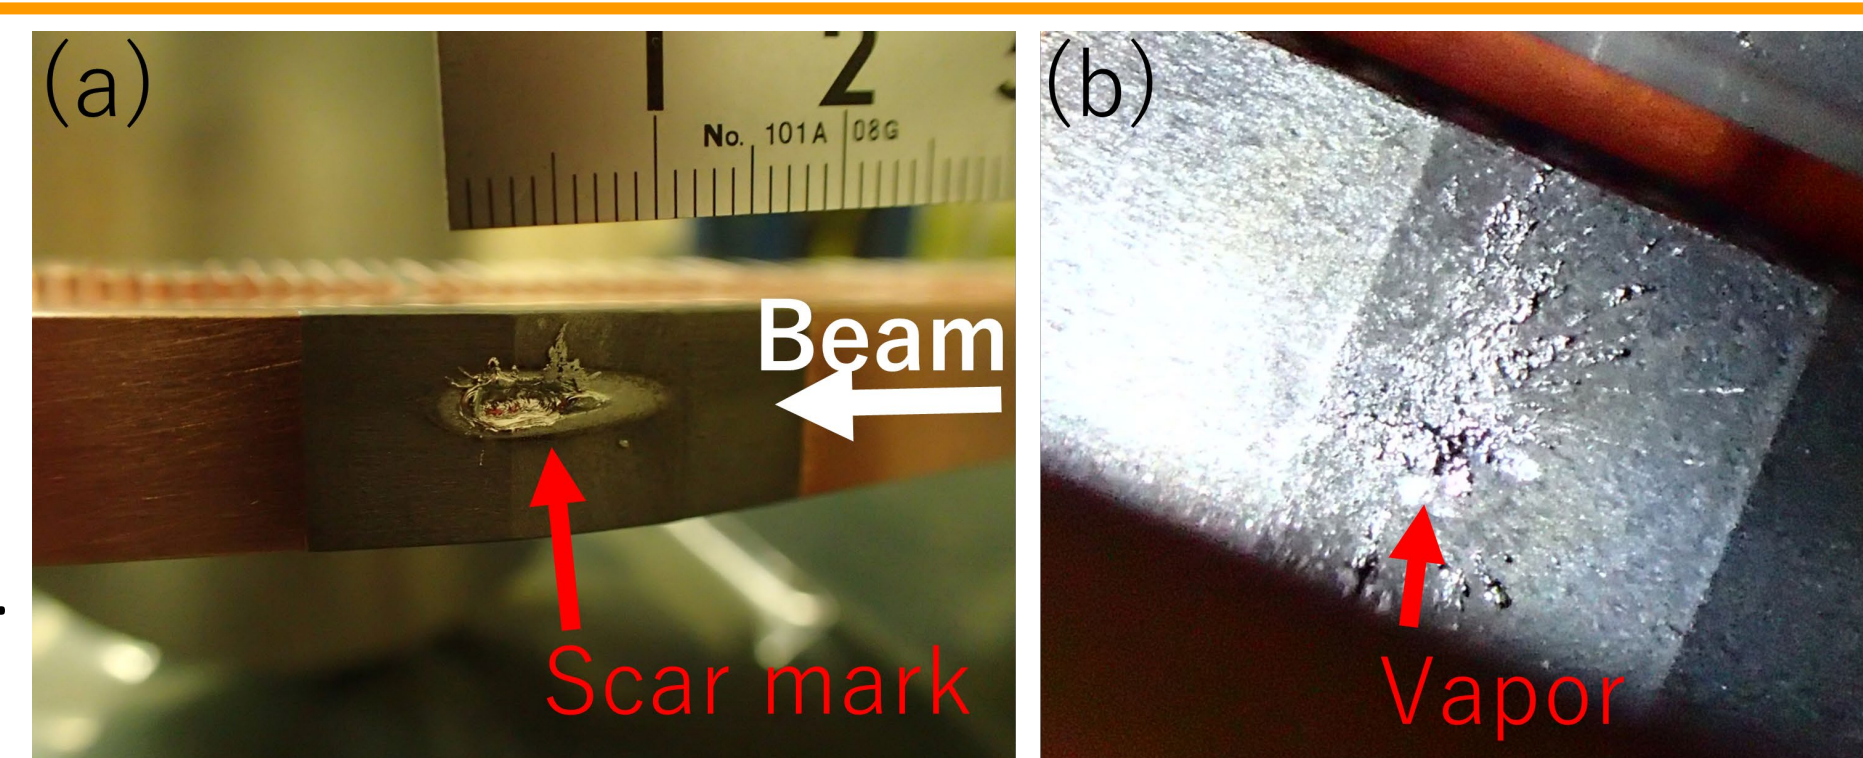
The vertical collimators are the point of the smallest aperture in the ring to prevent QCS quenching and depress BG. The jaw has a tungsten (or tantalum) block as the tip. The jaws damaged by the abnormal beam hitting are shown in Fig. 1.

Figure 1: (a) Damaged jaw, (b) protrusion by vapor deposition on the opposite side of the damaged jaw.

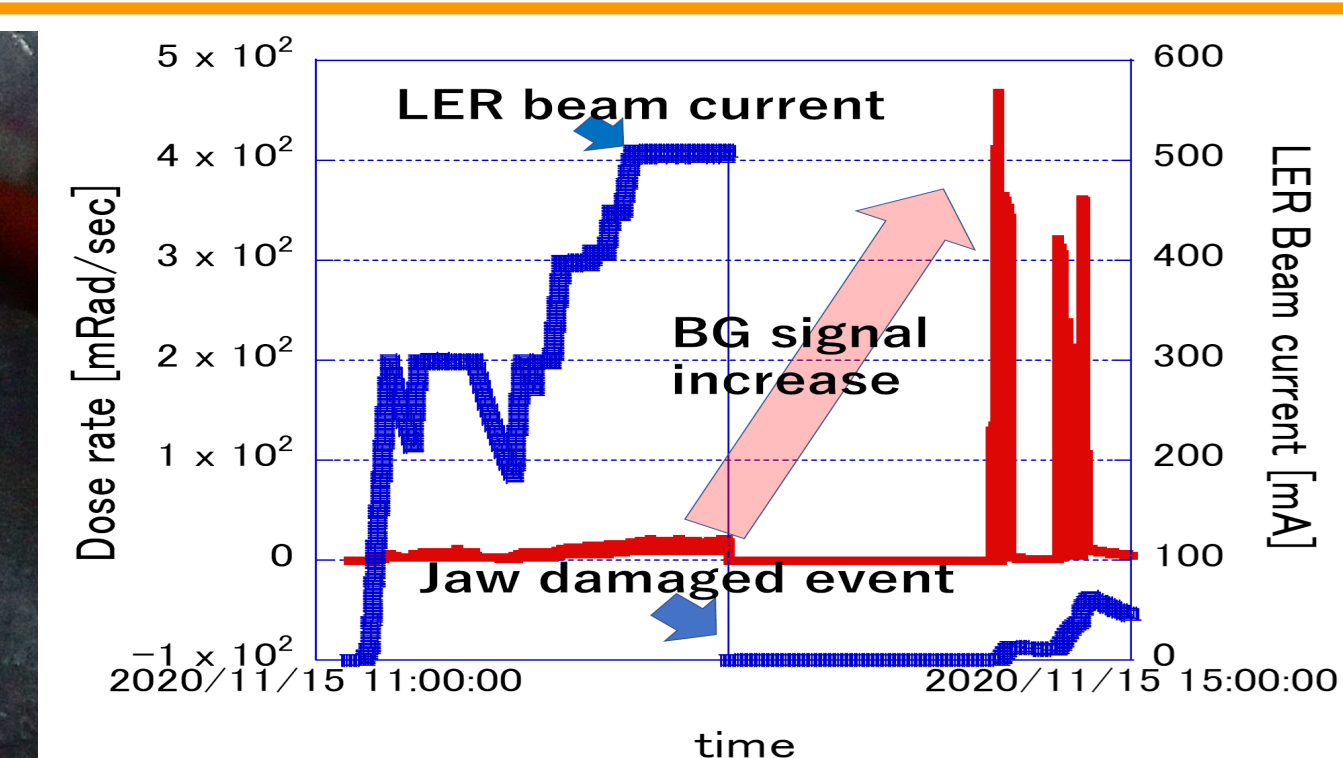
The peak value of the BG after this event was **200 times higher** than that before it (Fig. 2). When a jaw damage event occurred, a large beam loss was observed in Belle II. The soundness of the DEPFET pixel detector (PXD) in Belle II before and after the jaw was damaged is shown in Fig. 3.

Figure 2: BG signal before and after the event of the damaged jaw.

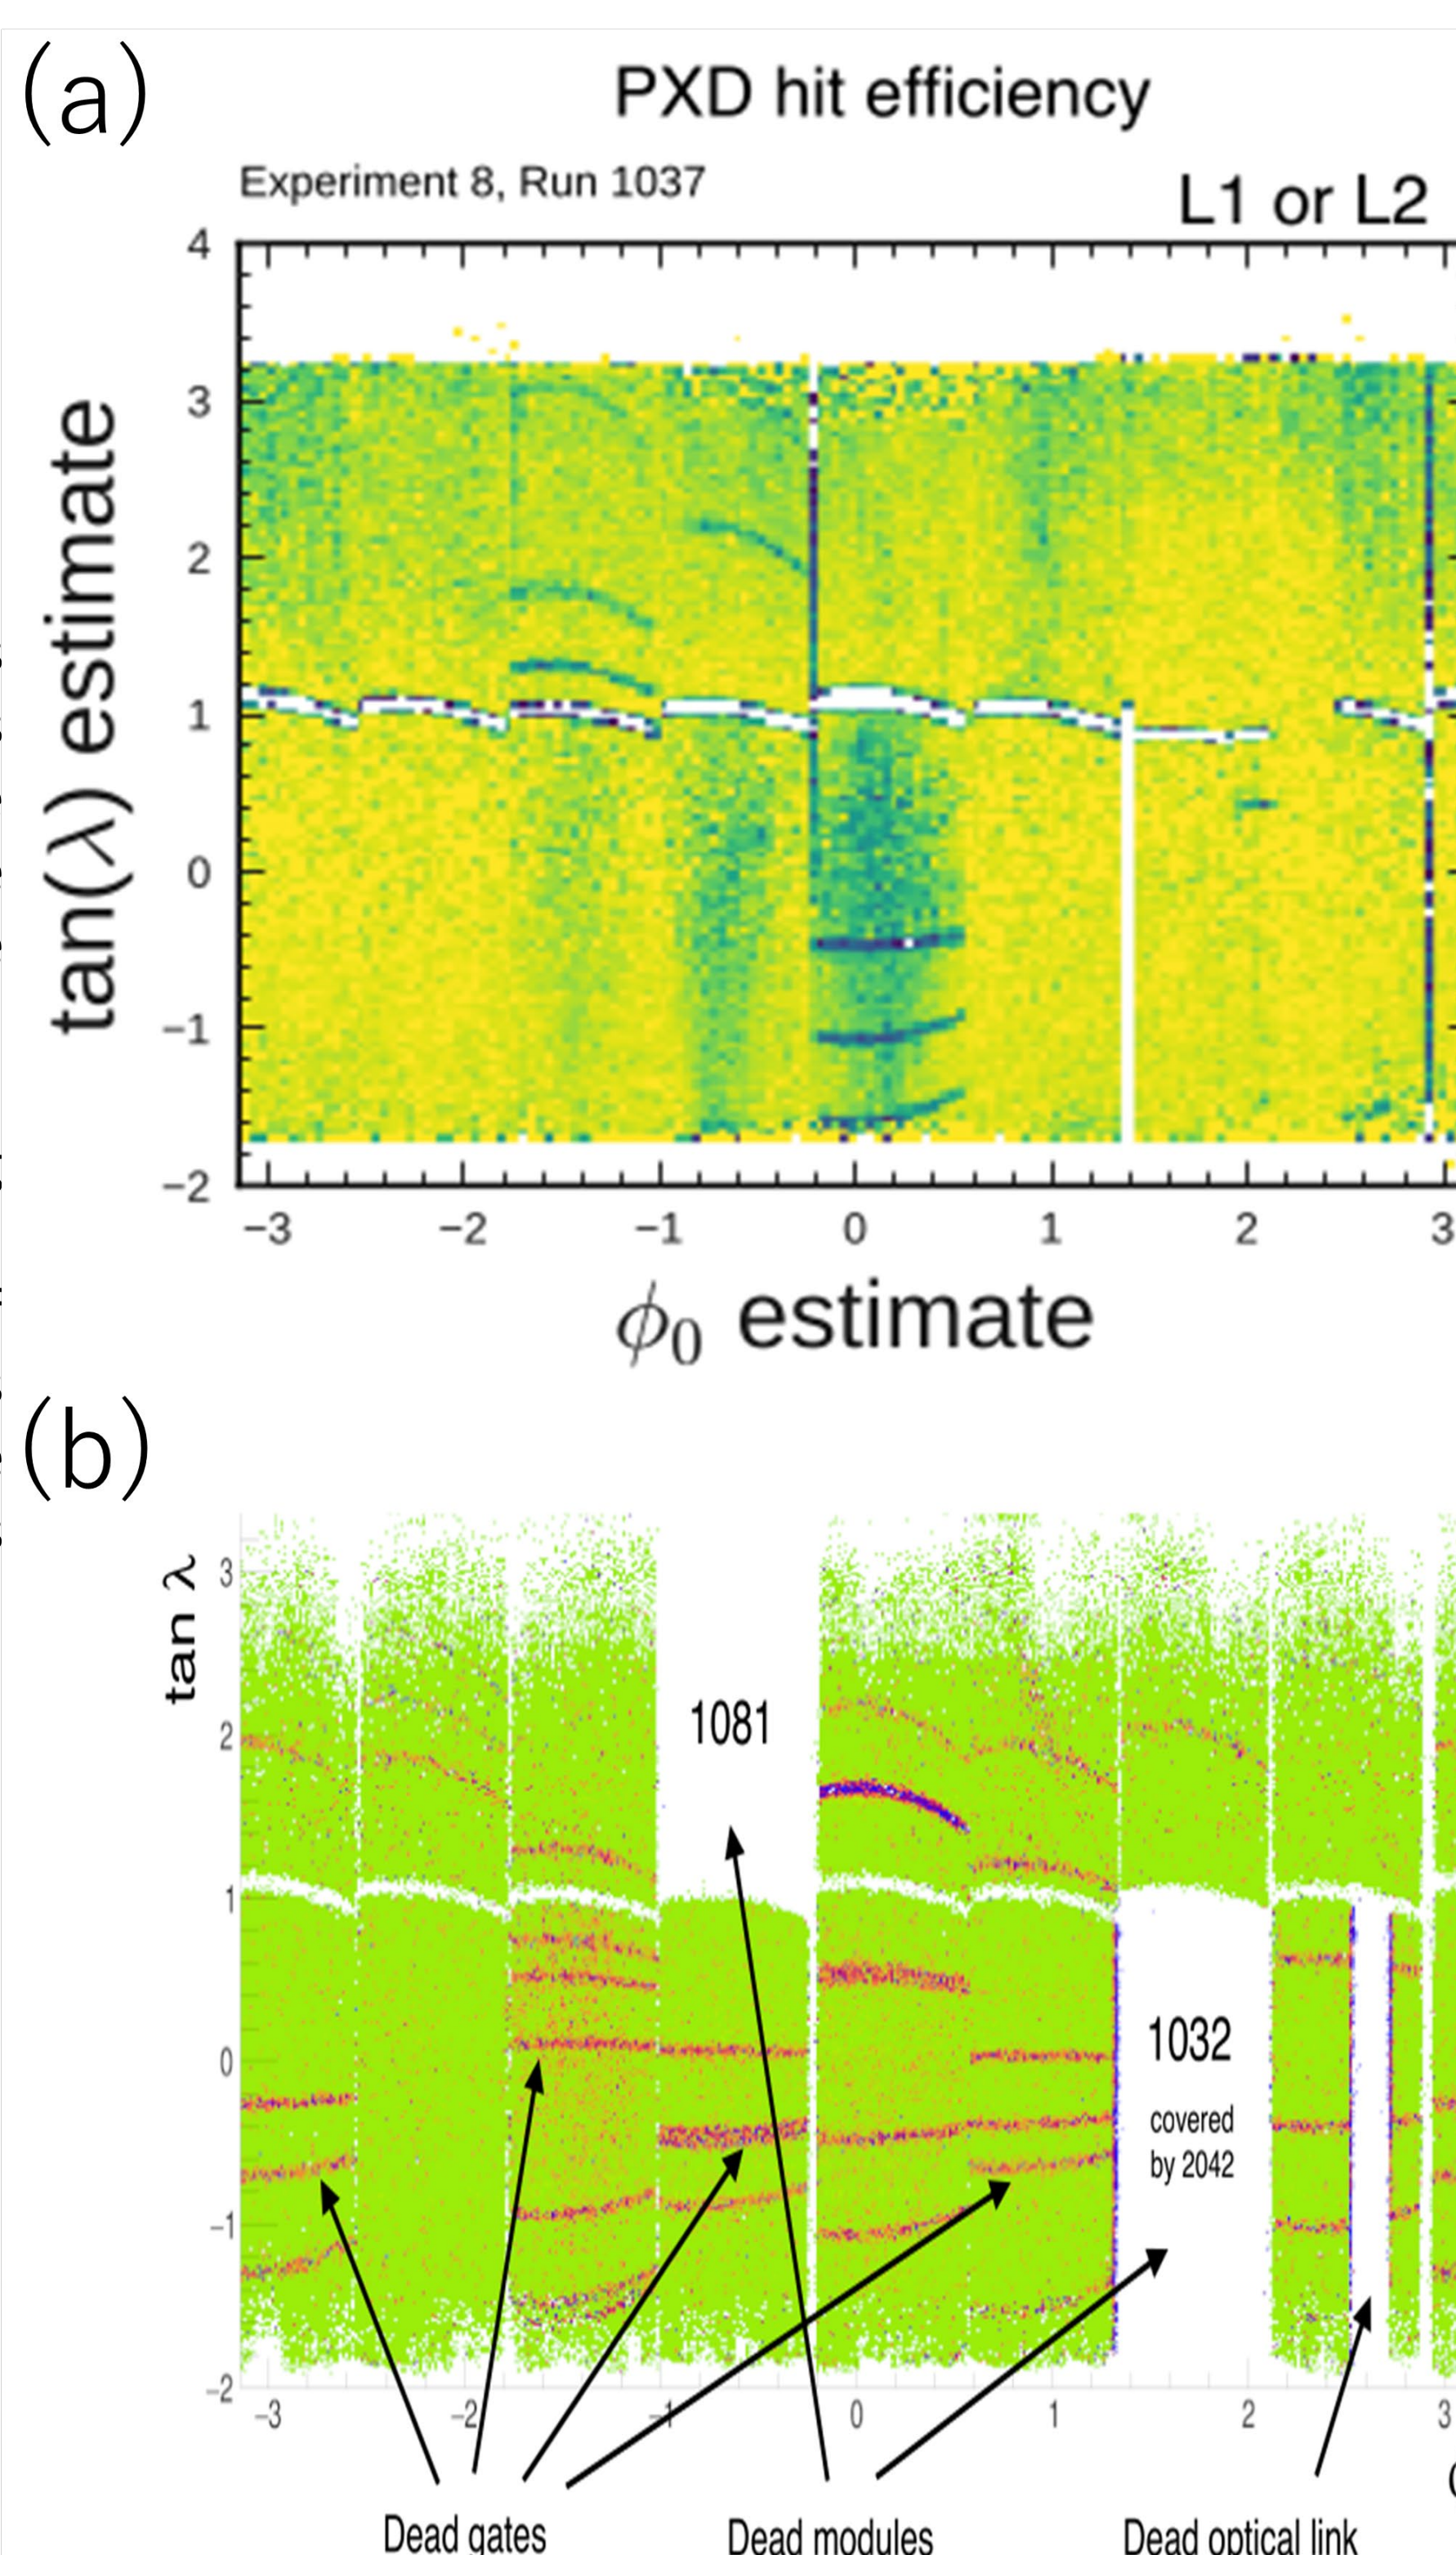
Figure 3: Soundness of the PXD (a) before and (b) after the jaw damage event that occurred.

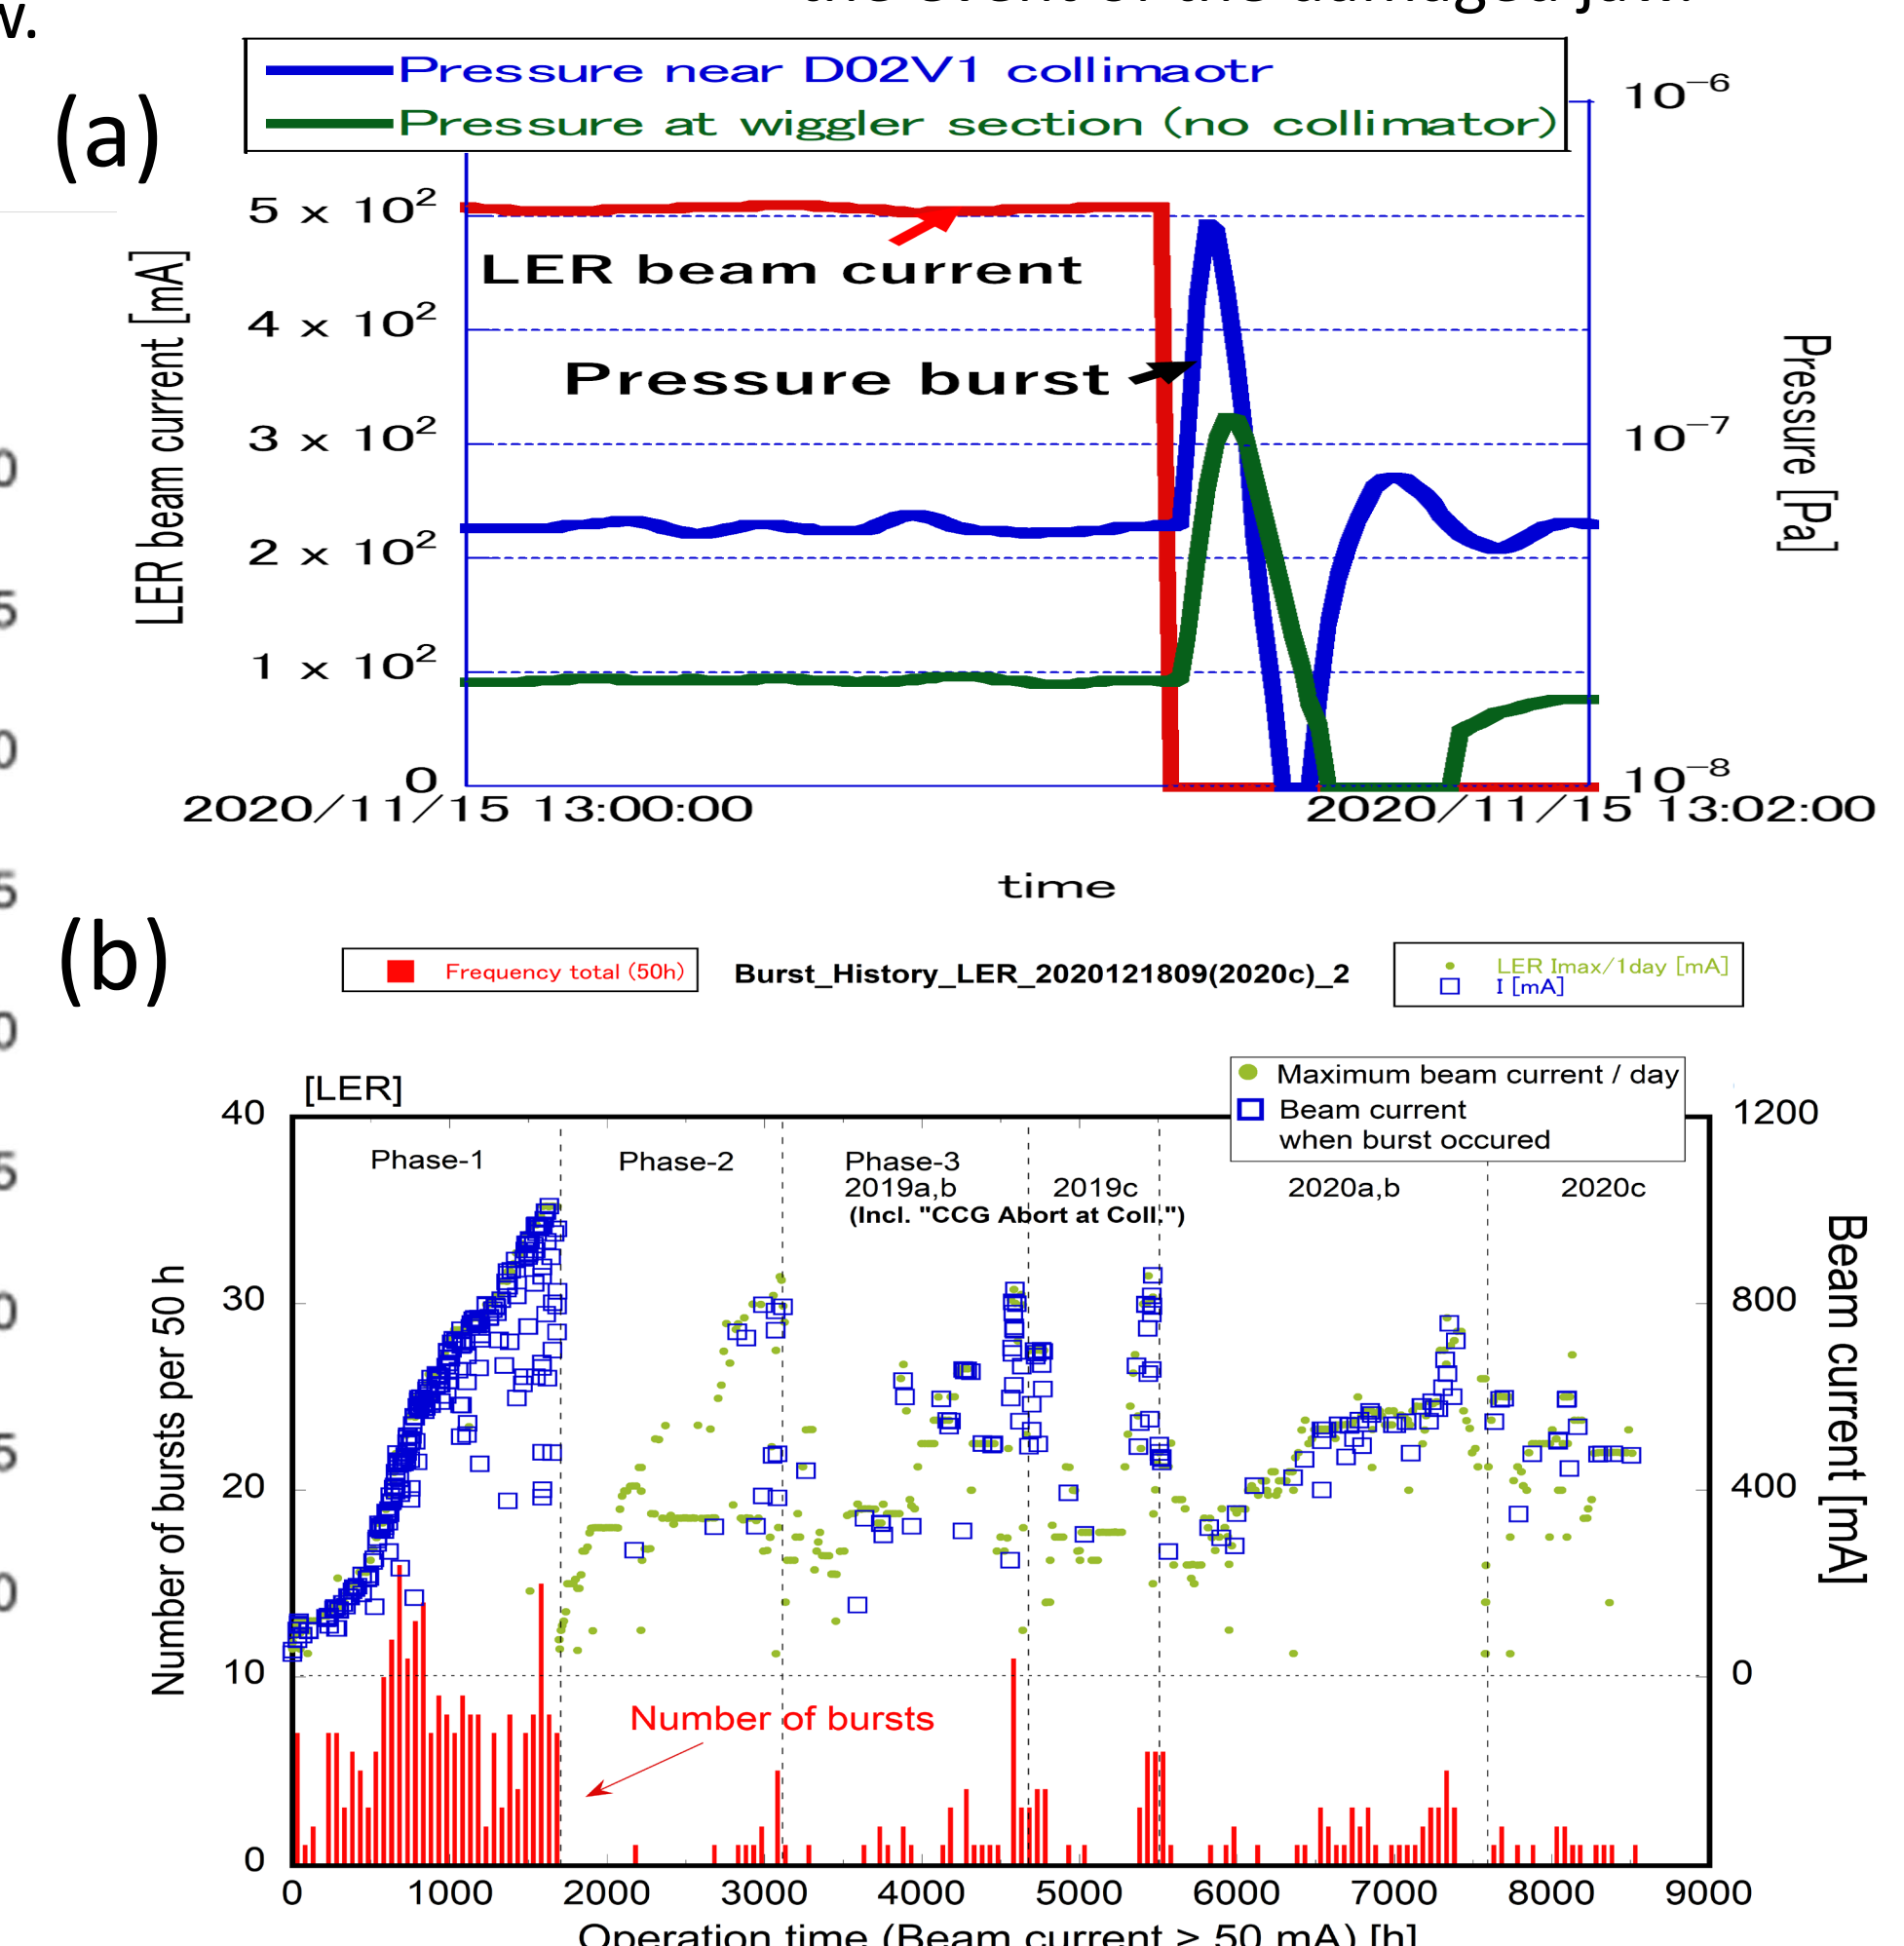
In this event, the pressure burst near the collimator (blue line) with the beam abort is shown in Fig. 4(a). In addition, a smaller pressure burst (green line in Fig. 4(a)) was observed at a location different from the location at which the collimator was installed. It is believed that the pressure burst at the green line was caused by the beam interacting with the dust. We consider dust to be the cause of these events because of two reasons.

The frequency of pressure bursts increased when the beam current exceeded the recorded value, whereas it tended to decrease when the beam current remained almost constant (Fig. 4(b)). Thus, we decided to perform a normal physical run just below the maximum beam current.

Figure 4: (a) Pressure burst when a jaw damaged, (b) pressure burst history.

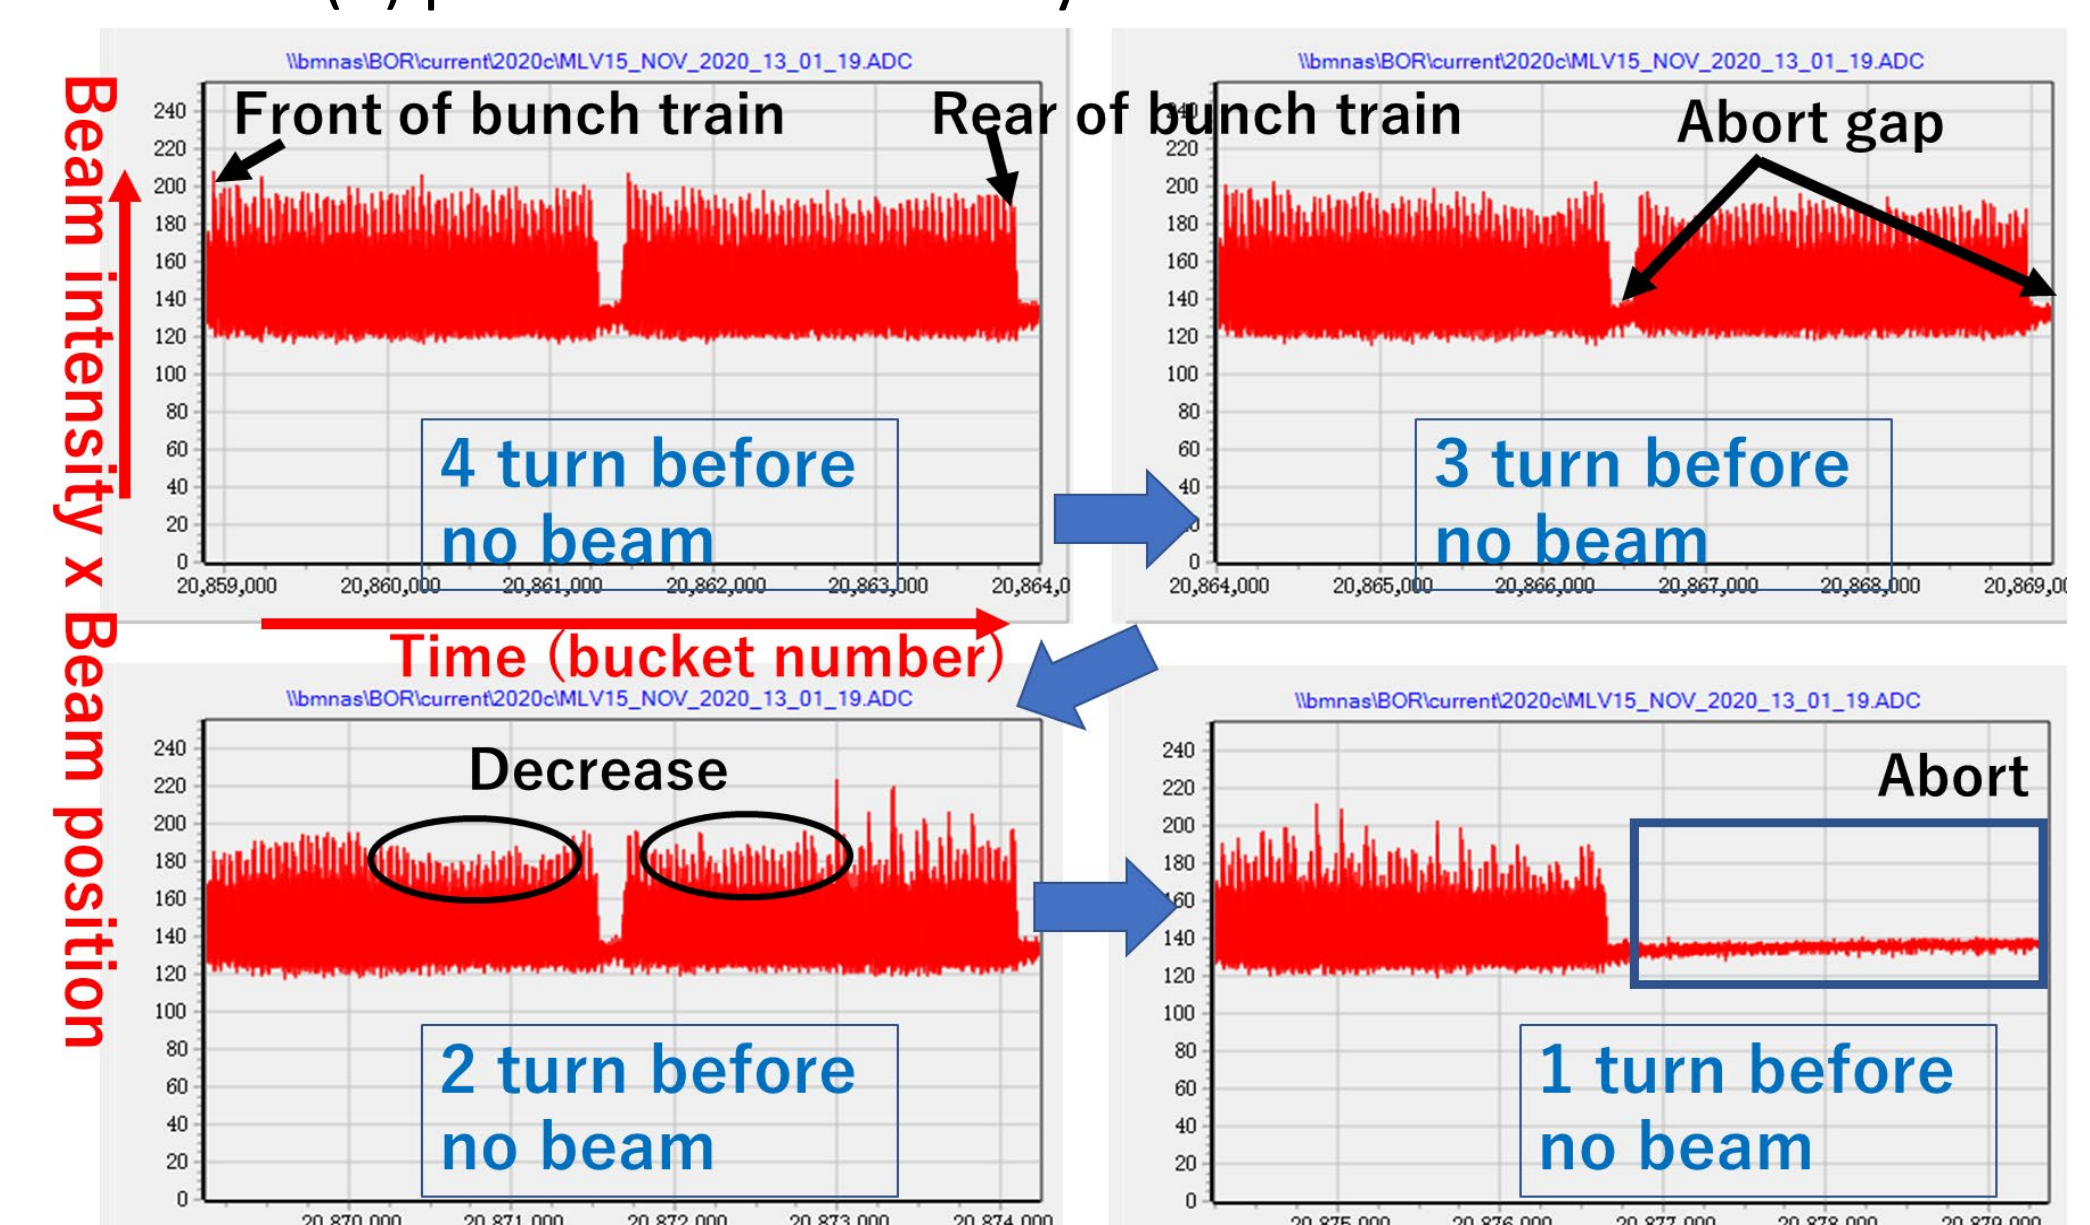
We describe the second reason. We illustrate the data obtained using the bunch oscillation recorder (BOR) (Fig. 5), where the horizontal axis represents the bucket number, and the vertical axis represents the product of the beam intensity and vertical beam position. In conclusion, when this event occurred, **there was no sign of oscillation indicating beam instability, and the data indicated that the intensity of the part of the bunch train suddenly decreased a few turns before the abort**. We consider that part of the bunch train was abnormal upon interacting with the dust particles.

Figure 5: Plot observed using BOR when a jaw was damaged.

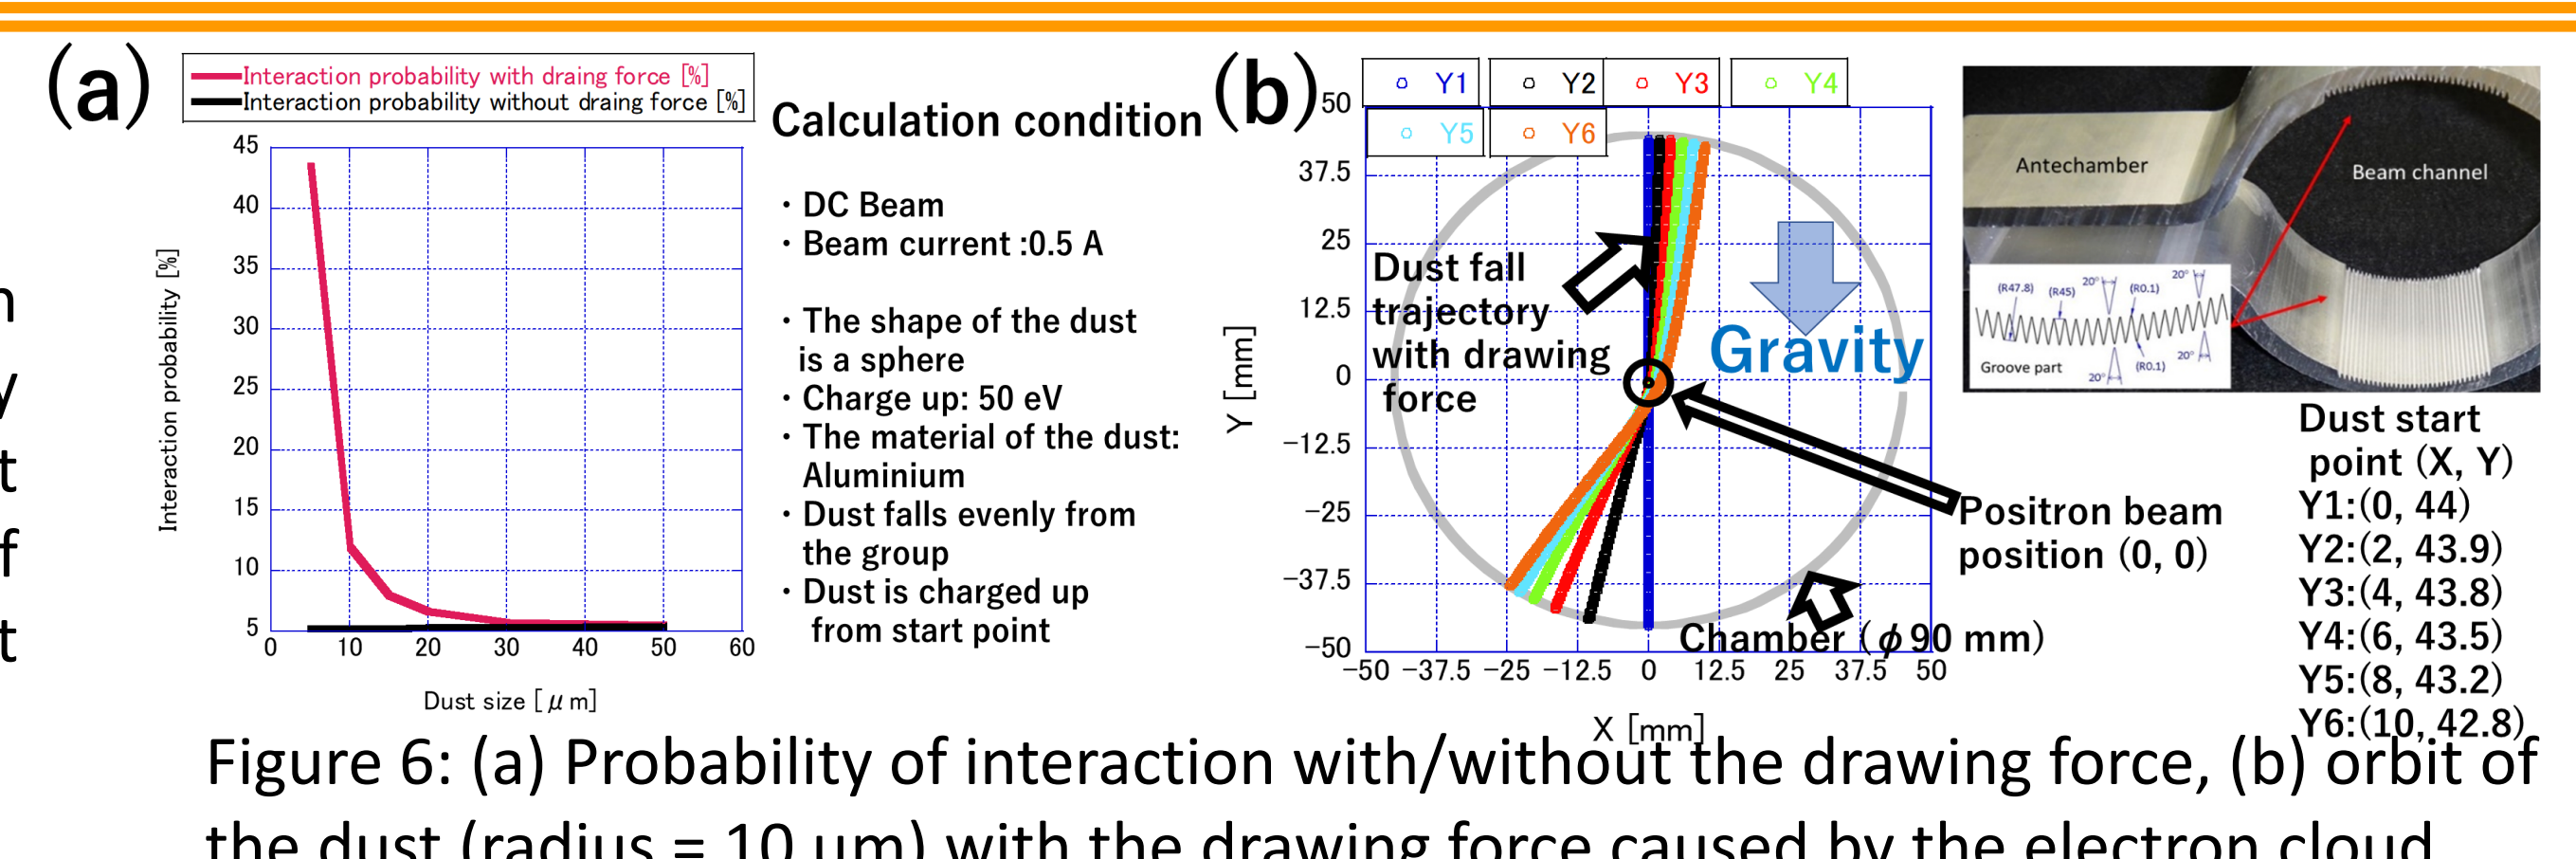
Assuming that the dust causes this event, a question arises as to why the phenomenon of the interaction between the beam and the dust occurs several times even though the beam size in SuperKEKB is very small. When the dust falls out of the groove, it almost does not interact with the beam if it is not attracted to the beam. Assuming that the beam has a circular transverse cross-section with a diameter of 2 mm and the material of the dust particles is aluminum, the probability of interaction between the dust falling from the groove and the beam is very low (see the black line in Fig. 6(a)).

The mechanism is believed to be the charging of the free-falling dust when it passes through the electron cloud. Thereafter, the charged dust is drawn to the positron beam. Figure 6(b) shows the orbit of the dust with the drawing force caused by the electron cloud, assuming that the energy of the charged-up dust is 50 eV and the dust radius is 10 μm.

Figure 6: (a) Probability of interaction with/without the drawing force, (b) orbit of the dust (radius = 10 μm) with the drawing force caused by the electron cloud.

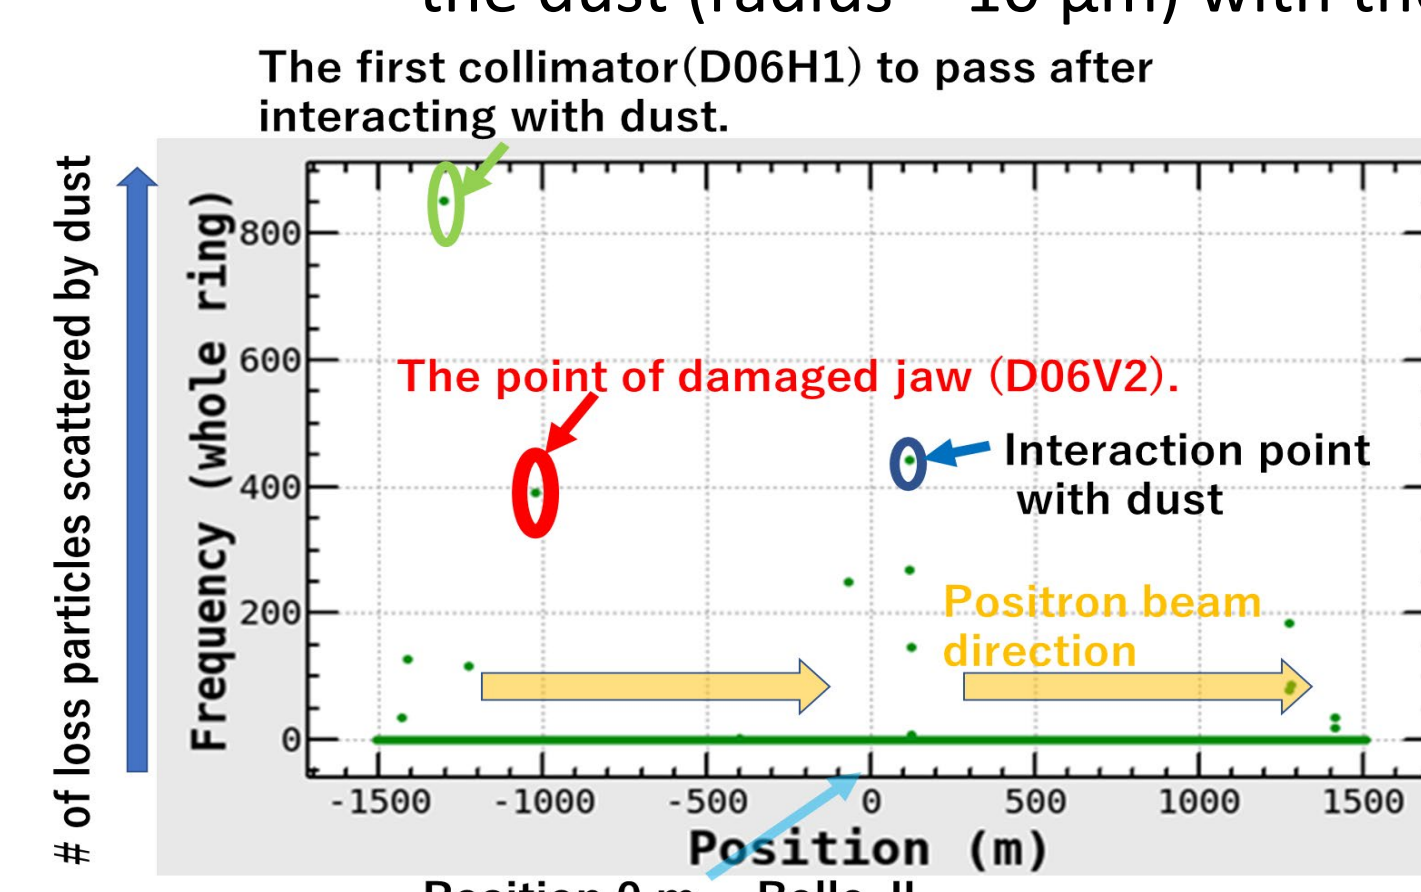
Figure 7 shows the results of beam tracking when the D06V2 collimator jaw was damaged. Figure 8 shows a comparison of the scatter plots of particles that collided with D06H1 and D06V2. We observed that the particles were concentrated within a narrow range in D06V2.

Figure 7: Result of tracking the scattered beam that interacted with dust using PHITS and SAD.

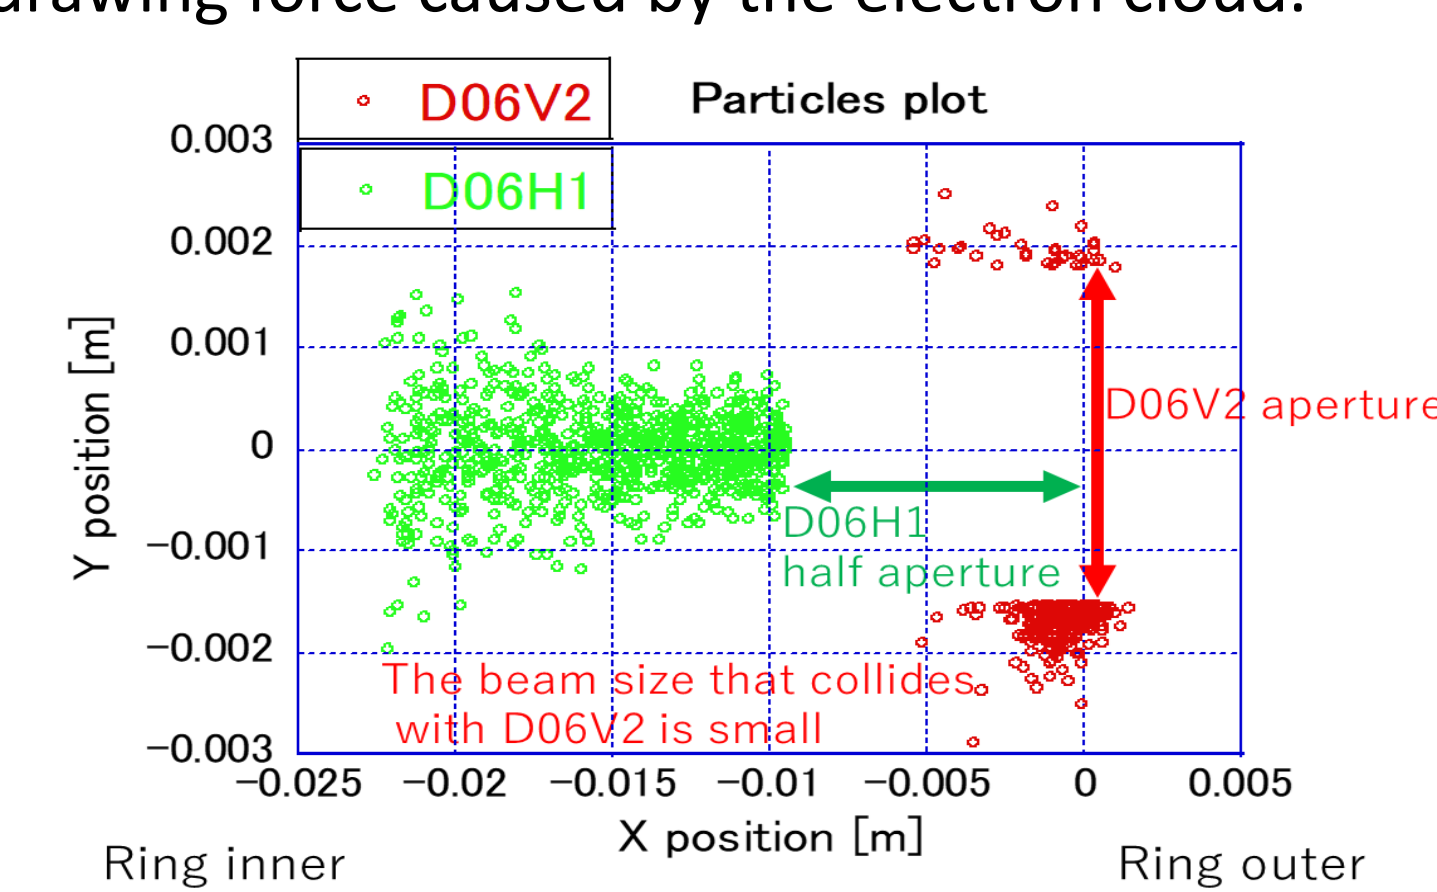
Figure 8: Comparison between the sizes of beams that collided with D06H1 and D06V2.
