SOLVING THE USB COMMUNICATION PROBLEM OF THE HIGH-VOLTAGE MODULATOR CONTROL SYSTEM IN THE EUROPEAN XFEL

M. Bousonville*, S. Choroba, S. Göller, T. Grevsmühl, A. Hauberg, T. Weinhausen
Deutsches Elektronen-Synchrotron, Hamburg, Germany

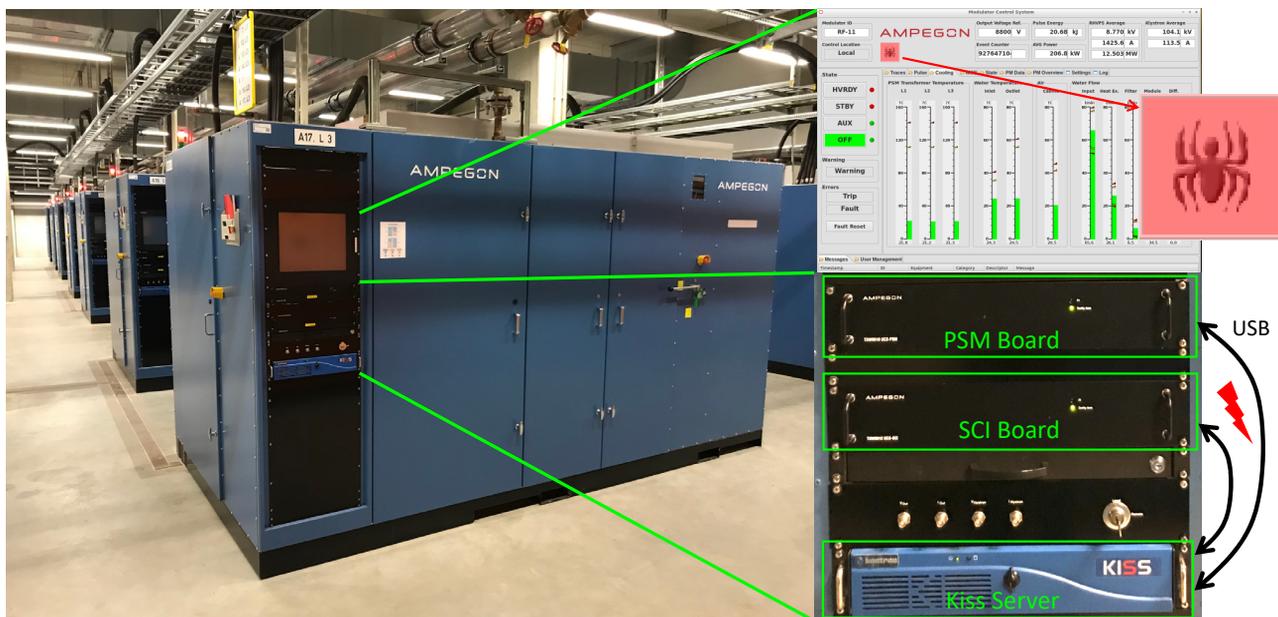
Each RF station consists of a multibeam klystron, high-voltage pulse modulator and pulse transformer, RF waveguide power distribution and several other subsystems. While a number of childhood diseases were eliminated after the commissioning of the European XFEL in 2016 [2], a fault that occurred from time to time in the high-voltage modulators played only a minor role. The modulators generate the high-voltage pulses for the klystrons with an amplitude of 6.3 to 9.2 kV, which are transformed upwards by a factor of 12 by a pulse transformer. So, 75 to 110 kV are available for the klystron operation. The initially unknown error led to the failure of a modulator, which could be fixed by a manual power cycle of the control system. When the error occurred, the GUI of the control system displayed a red spider, which is why this error was internally called the red spider. This error message is always displayed when the communication between the two electronic boards and the server controlling the modulator is disturbed (Fig. 1).

Figure 1: High voltage modulator, GUI and control system.

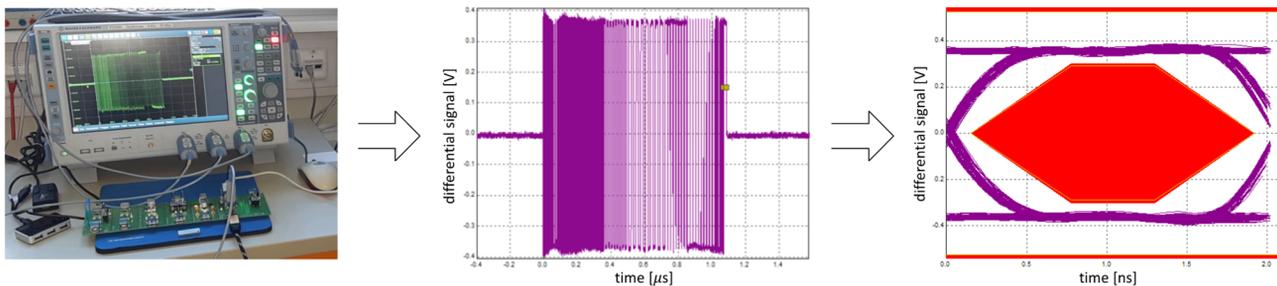
Such an eye diagram consists of the superposition of several hundred to several thousand bits recorded by an oscilloscope. Basically, one can say that the wider the eye is open, the better the signal quality. Theoretically, the eye opening of a USB 2.0 signal should be 800 mV. But due to amplitude noise, the eye opening is reduced in practice. If you also consider the attenuation of a connected USB cable, the vertical eye opening is further reduced. We compared different USB devices and noticed two things. First, the eye diagram of the modulator server and the boards is 5 to 9 % less wide open vertically than other typical USB devices. Secondly, the cable used at the time reduced the eye opening, by a further 8 to 11 %. As a general rule, reducing the eye-opening leads to an increased bit error rate. For a typical USB application, the resulting bit error rate would probably not be a problem, as it does not have to run error-free for a long time.

Figure 2: USB signal measurement setup, recorded bit test sequence and the corresponding eye diagram.

In our case, however, it led to a communication error every one or two months, which caused the failure of a modulator and thus the entire RF station. This results to a MTBF of 2 days for 26 RF stations. The USB analyser opened the eye so much that no more bit errors occurred. The same effect can also be achieved by reducing the cable attenuation.

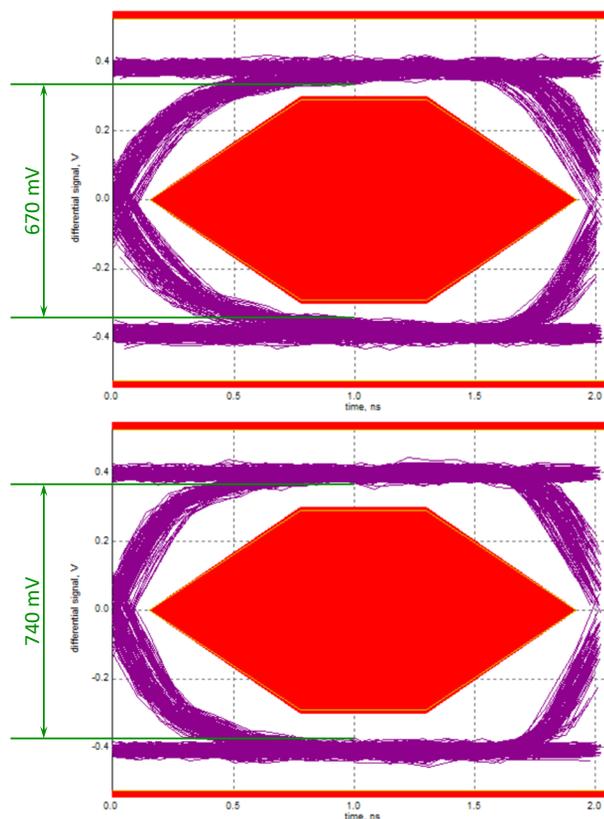
However, the repeaters are active components with unknown lifetime and which therefore carry a potential risk of failure. Therefore, we looked for a USB cable with lower attenuation to achieve a large eye opening without repeaters that could fail. This was not easy, as most manufacturers do not specify the attenuation, but we finally found a cable that has a barely measurable insertion loss. Figure 3 shows an eye diagram of a USB signal at the end of the transmission with the original cable at the top and with the new cable at the bottom. The eye is about 10 % more open vertically.

Figure 3: Top - Eye diagram with the USB cable previously used in the modulator control system. Below - Eye opened wider due to the much lower attenuation of the new USB cable.

In December 2020, all modulators were then equipped with these cables. In the next 4 months, no more errors occurred and the problem seemed to be finally solved, but the problem showed up again 7 times between May and August.

We then took another measure. We used a USB repeater that can transfer data at a maximum of full speed (Table 1). This forces the USB 2.0 interfaces in the electronic boards and the server to reduce the data rate and increase the level. Each bit thus becomes longer by a factor of 40 and the voltage level is increased by a factor of 4.125. This makes the eye correspondingly larger and thus the signal-to-noise ratio is significantly improved, which makes a bit error much less likely. The data rate of 12 Mbit/s is sufficient for the communication within the control system. In August 2021, the USB 1.1 repeater was installed in all modulators and no red spider has been seen since in operation.
