SUMMARY OF Cs₂Te PHOTOCATHODE PERFORMANCE AND IMPROVEMENTS IN THE HIGH-GRADIENT, HIGH-CHARGE AWA DRIVE GUN

E.E. Wisniewski, M. Conde, D.S. Doran, W. Gai,
W. Liu, J.G. Power, and C. Whiteford, ANL/HEP, Argonne, IL USA
S.P. Antipov, C.Jing, Jiaqi Qiu ANL/HEP Argonne, IL; Euclid TechLabs, LLC, Solon, OH USA

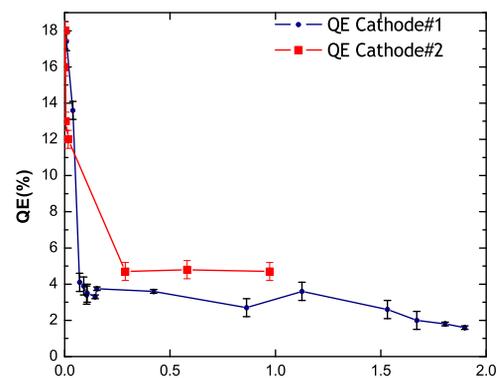
Figure 1: QE vs. time for the two AWA drive gun photocathodes installed since August 2013. QE drops sharply during RF conditioning to 88 MV/m and stabilizes to about 4% during subsequent operation.

Twenty-three months after installation, the same photocathode was still operating, with QE around 2% (see Fig. 1.) However, the cathode started arcing uncontrollably (the gun could no longer sustain RF) and the cathode had to be replaced (see Fig. 2).

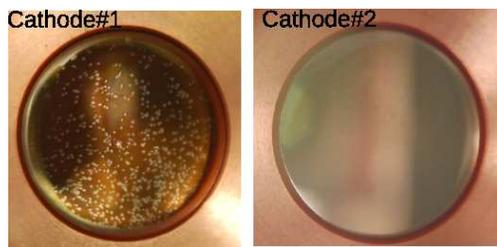
Figure 2: Pictures of Cathode1 (left) and Cathode2 (right) in the gun. On Cathode1, an estimated 600 spots developed, mostly during the month-long RF conditioning to 88 MV/m. Despite the appearance of the spots during RF conditioning, the photocathode performed fairly well for nearly 2 years of operation. However, the cathode started arcing uncontrollably and had to be replaced. Cathode2 is the replacement and has operated for 1 year with high QE, fast conditioning, and no arcing problem.

A post-mortem of Cathode1 yielded the following. Pros: Lifetime 23 months with QE $\geq 1.5\%$ Cons: 1. Slow conditioning (> 4 weeks) 2. Occasional arcing problems requiring re-conditioning (became more frequent in the last 3 months of operation). 3. End-of-life continuous arcing in the gap.

1. Slow conditioning/spots/frequent breakdowns are thought to be related to the photocathode plug surface history of sandpaper polishing during the early testing stages. This has been found to introduce silicon impurities into the Mo surface and possible particulate contamination.
2. As the cathode aged, at times there were occasional arcing problems requiring re-conditioning. This and arcing in the gap as the cathode neared the end of its useful life seems to have occurred due to the enhanced field at sharp edges on the cathode near the spring.
3. White light interferometry performed on the used plug before and after removing the cathode film by wiping with alcohol showed that the spots are primarily damage to the thin film, rather than the Mo substrate. The difficult RF conditioning seemed to arise as emitters were processed on the cathode, blowing holes in the film.

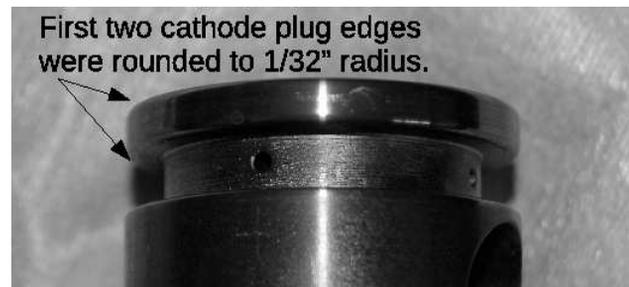
Figure 3: The rounded edges (radius 1/32 in.) eliminated the arcing in the gap.

The problem of arcing in the gap was solved by rounding the outer and inner plug edges (see Fig. 3.) This completely eliminated the arcing in the gap. From examination of the plug, it appeared that the inner edge was the problem, based on the evidence that copper from the gun had been deposited near that edge as a result of arcing. The original design included a radiused outer edge, but not the inner.

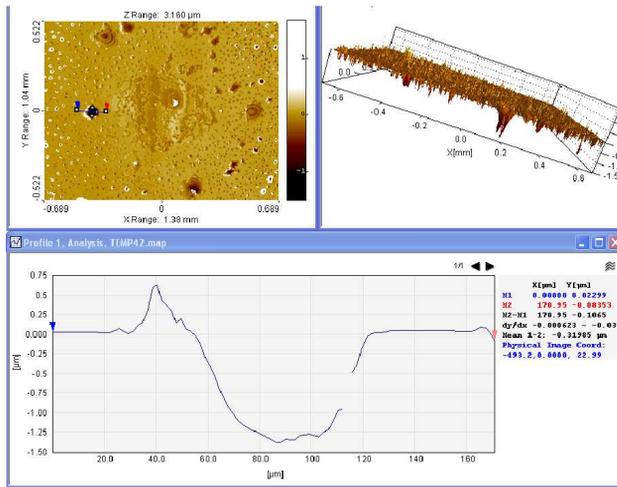
Immediately after removal, the Cathode1 plug surface was examined twice using white light interferometry (see Figs. 4 and 5). Initially, $S_v=1505.79$ nm, $S_p=2041.89$ nm. After wiping the surface with ethanol to remove the Cs₂Te layer: $S_v=606.308$, $S_p=231.332$ nm. The S_v and S_p values correspond maximum valley depth and maximum peak height, respectively. Hence the maximum surface roughness was in the film. This indicated that the thin film sustained most of the damage and suggests that the visible spots are places that the cathode film was damaged during conditioning and arcing.

Unfortunately, it has not been possible to measure the thickness of the cathode. However, the values of S_p and S_v suggest an upper bound to the thickness of 2600 nm. A lower bound of 220 nm is set by the Te thickness which is monitored during the deposition.

Figure 4: Cathode1 plug surface analyzed in the white light interferometer, before wiping off the surface. Micron scale pits and features.

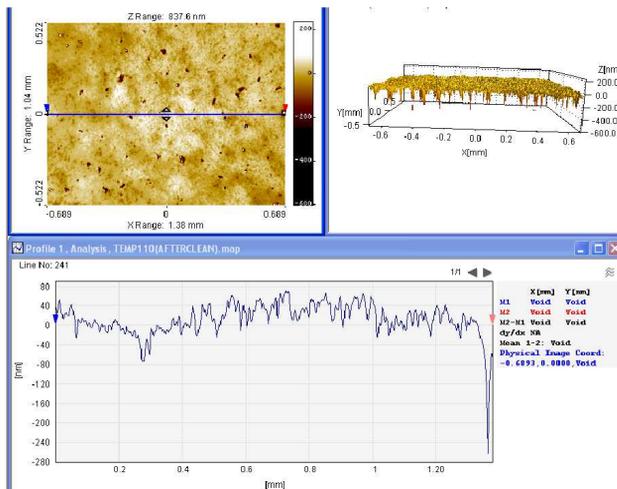
Figure 5: Cathode1 plug surface analyzed in the white light interferometer, after cleaning. Features are now on the order of 100s nm in scale. This suggests that the spots are places that the cathode film was damaged, in some cases removed down to the Mo surface.

The problem of slow conditioning was addressed by carefully grinding the surface of the plug flat, removing 10s of microns of material to eliminate embedded Si particles. After this the plug was polished using polycrystalline diamond in stages from 6 micron down to 0.05 micron to a mirror finish. To address the possible problem of particulate contamination, an effort was made to clean particles out of the deposition chamber and the cathode plug was thoroughly ultrasonically cleaned after each polishing step.
