Abstract

During high power tests of the 1.3 GHz LCLS-II cavity on the test stand at Fermilab an anomalous rise of temperature of the pickup antenna in the higher order mode (HOM) coupler was detected in accelerating gradient range of 5-10 MV/m. It was suggested that the multipacting in the HOM coupler may be a cause of this temperature rise. In this work the suggestion was studied, and the conditions and the location, where multipacting can develop, were found.

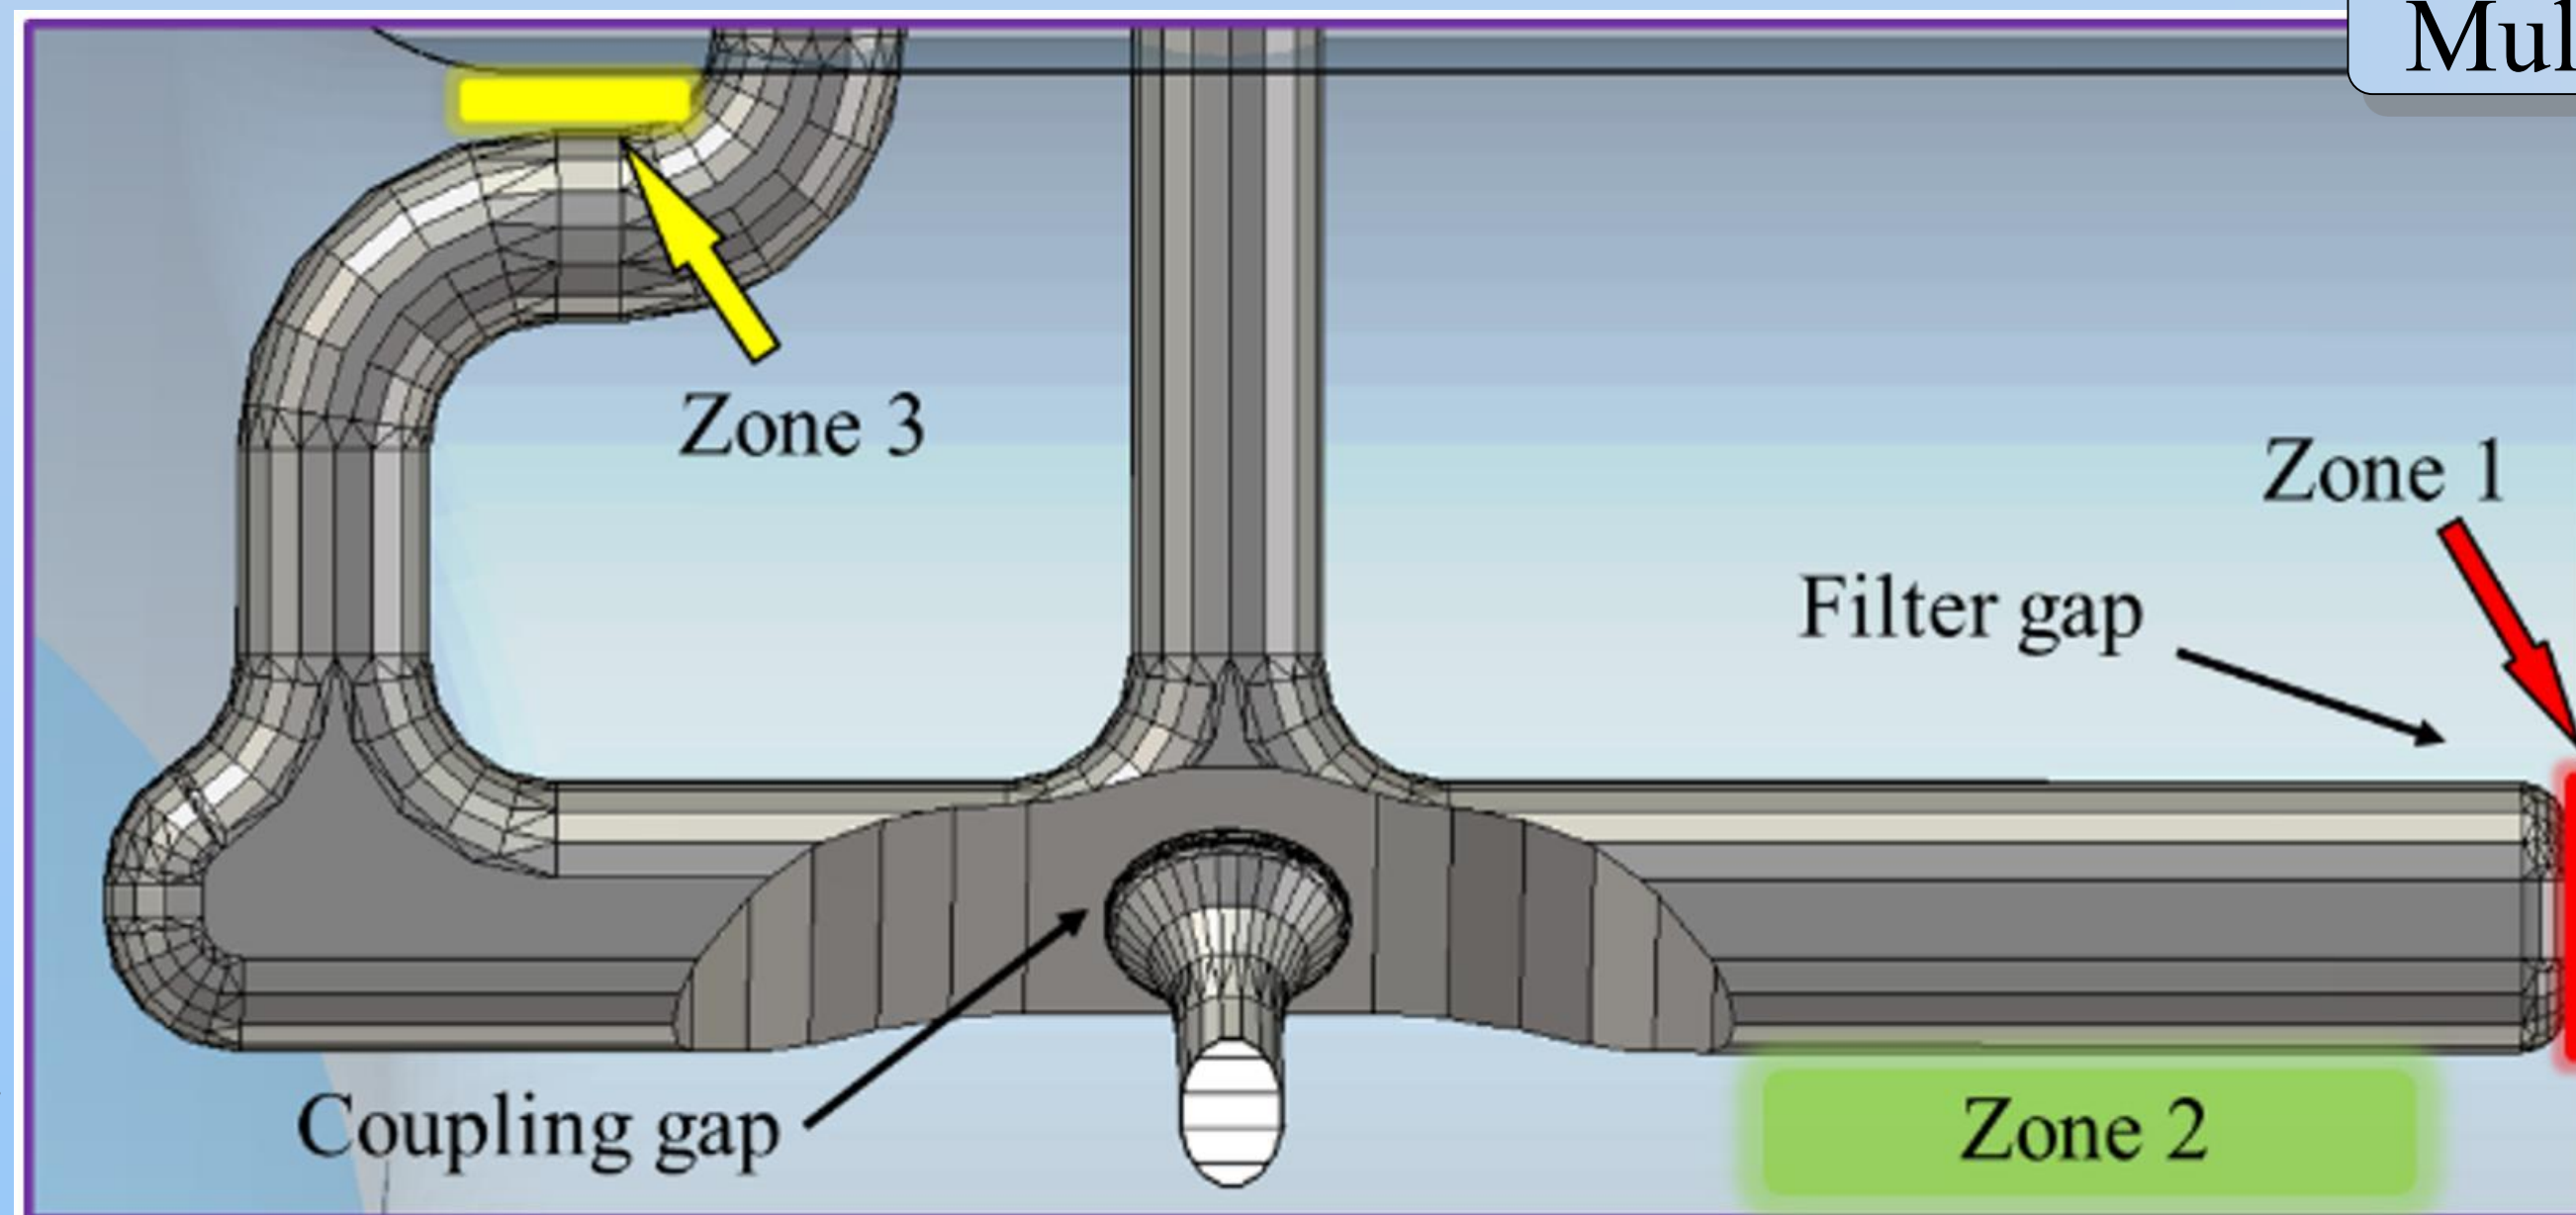
Secondary emission from multipacting in these well known zones 1,2 and 3 do not generate sufficient power deposition on the pickup antenna that could explain thermal runaway during high power tests. Less than 0.1% of total collision power falls on the antenna from these multipacting sites.

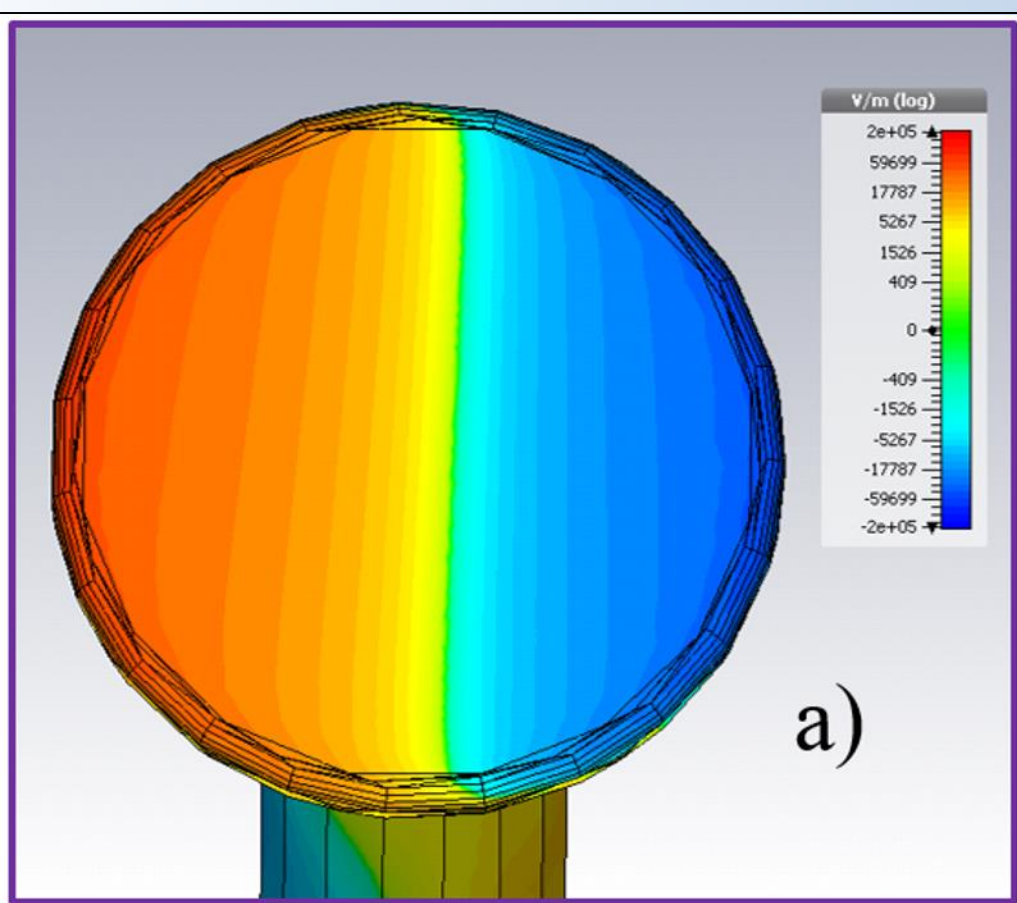
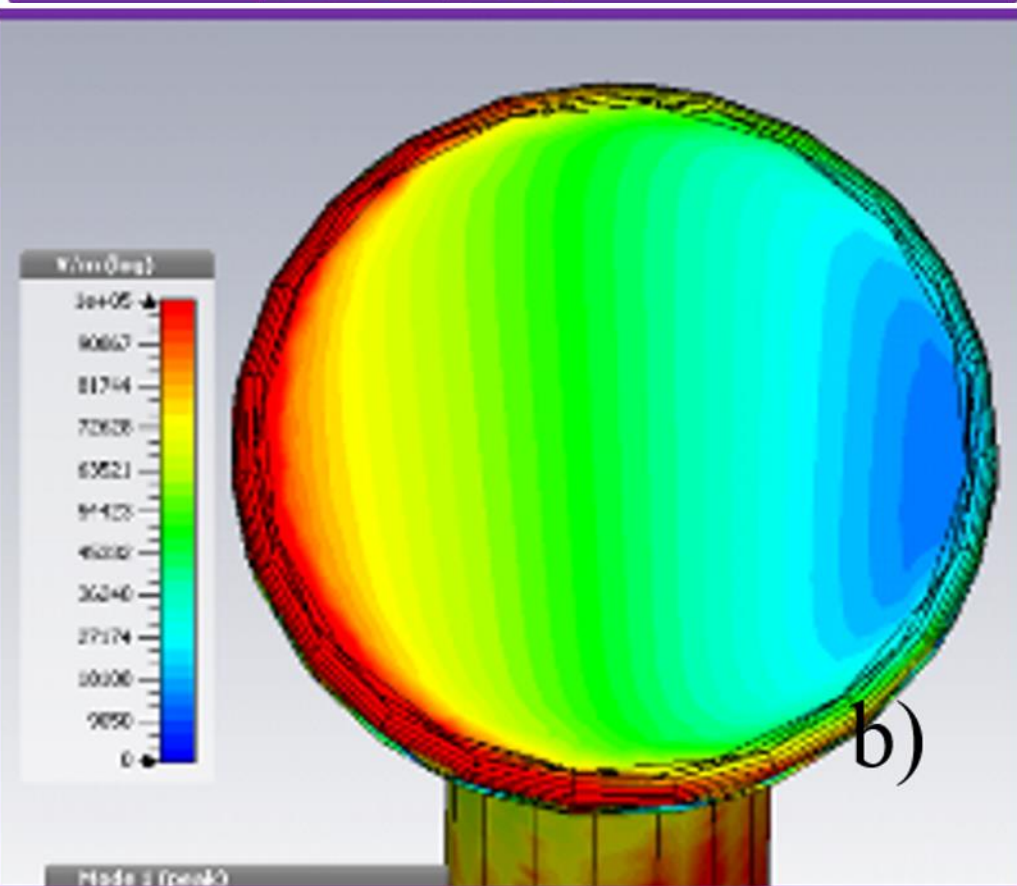
Distribution of electric field component normal to surface on the antenna tip for properly tuned coupler a) and detuned coupler b).

The MP process that could explain the antenna heating would be multipacting directly in the coupling gap. But normally for nominal gap size of 0.5 mm there is no conditions for multipacting, since parameter $f \cdot d < 80-90$ MHz·cm. On the other hand, parameter $f \cdot d$ is very sensitive and exceeds the threshold already at $d=0.615$ mm. It is possible that such small deviation can happen due to inaccurate assembly or misalignment. Additionally a deviation of the filter gap size from optimal value redistribute the fields and increases uniformity and average level of electric field component normal to the antenna tip surface.

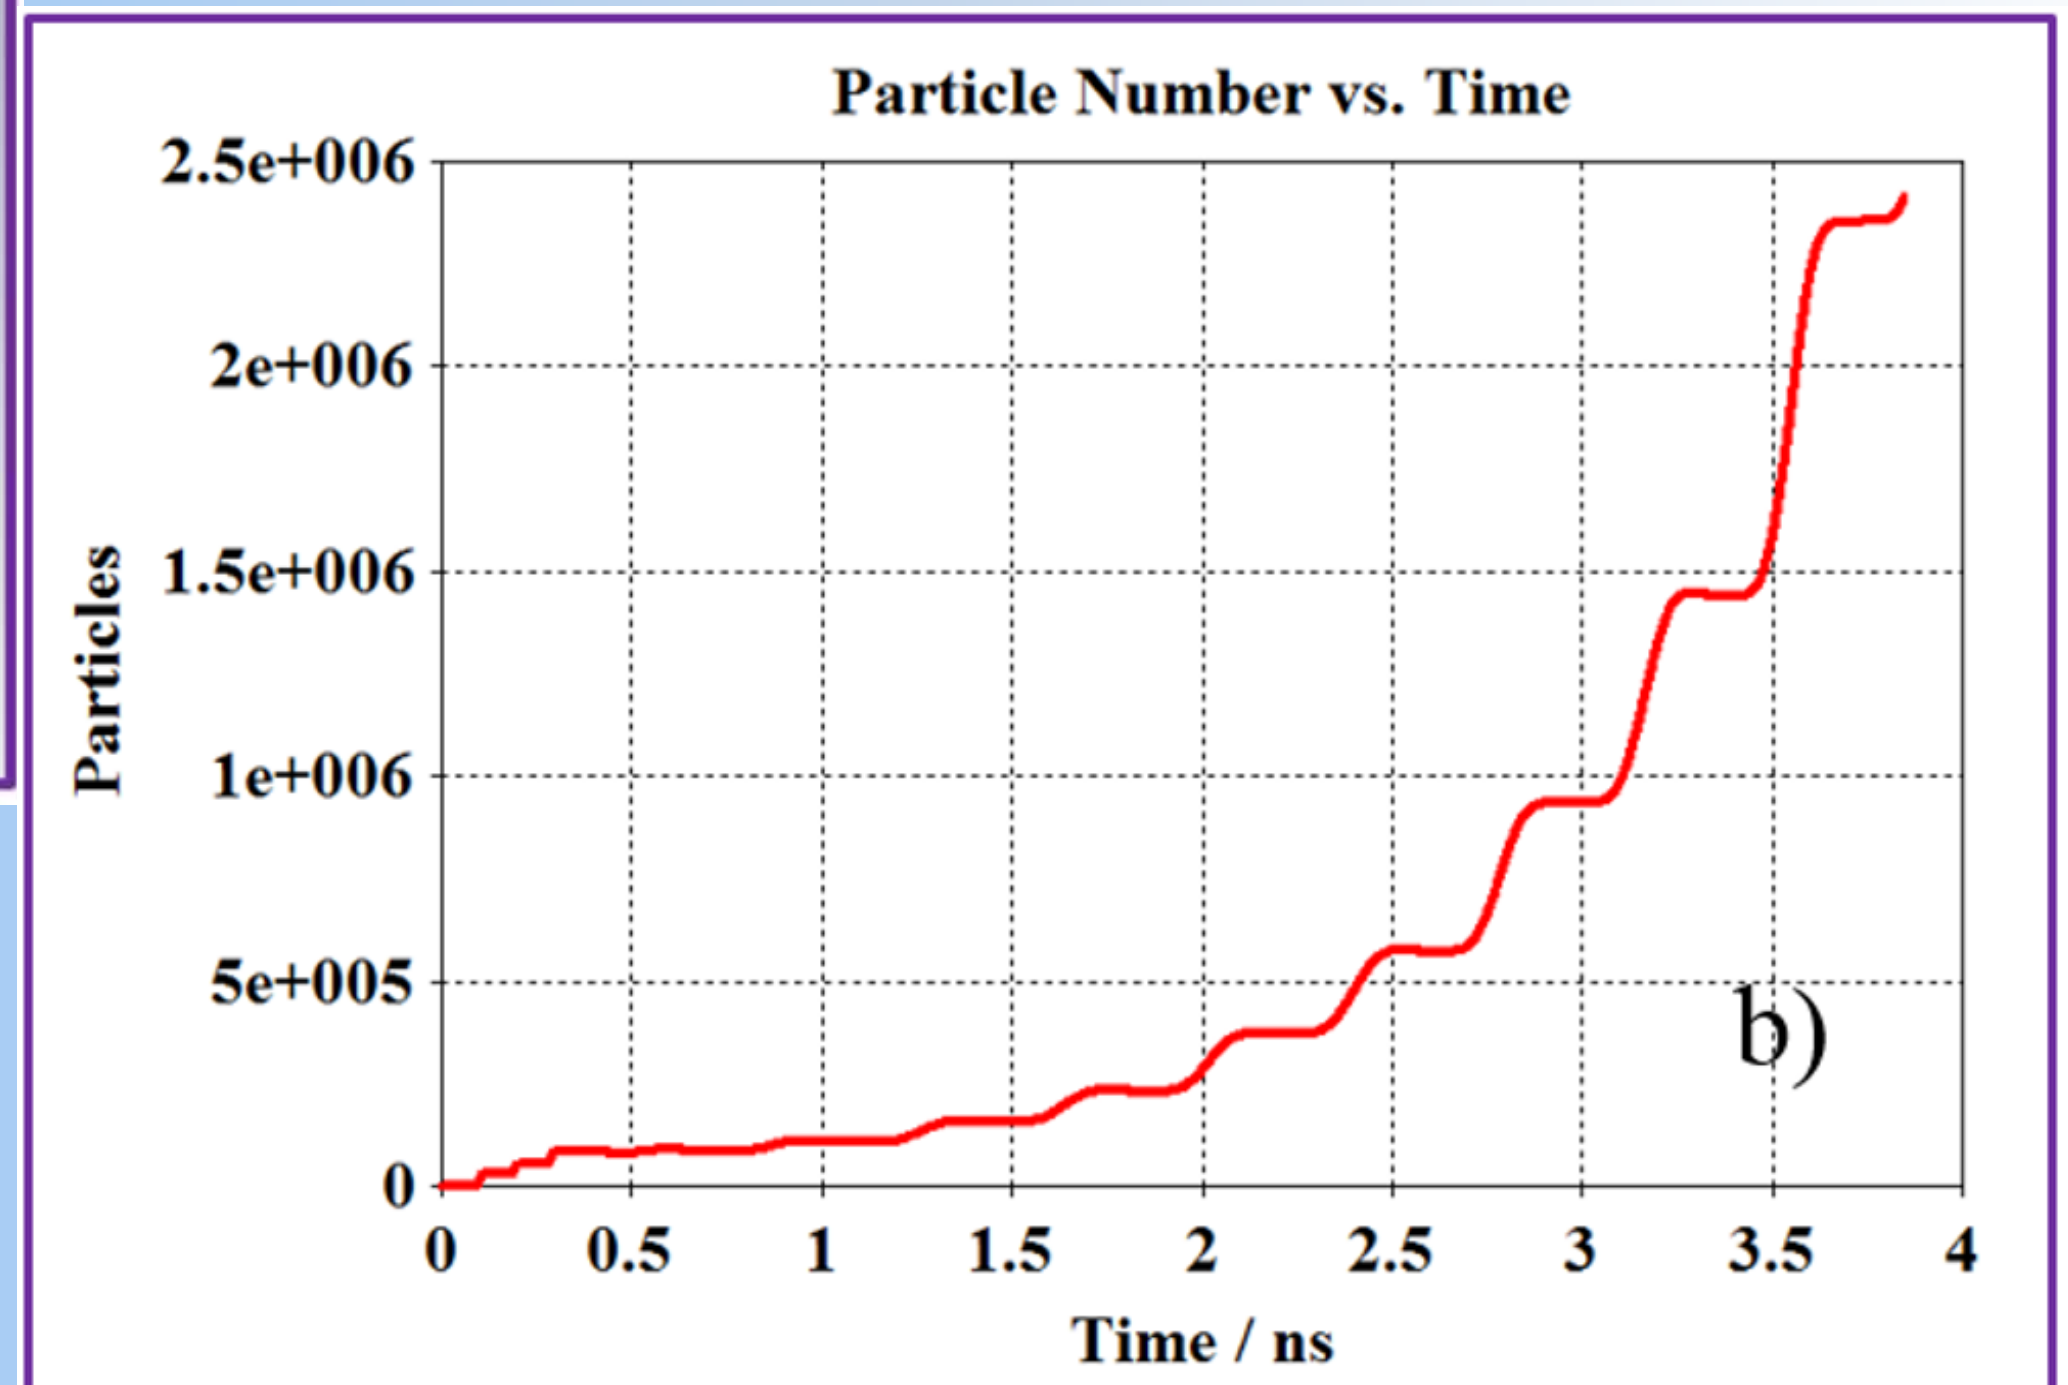
Particle number vs time at the accelerating gradient of 12.7 MV/m for properly tuned coupler.

In a properly assembled and properly tuned HOM coupler the known multipacting cases do not heat the pickup antenna. At the same time a combination of coupling and filter gaps deviations can create conditions for specific multipacting in the coupling gap. This multipacting can be responsible for the antenna heating.

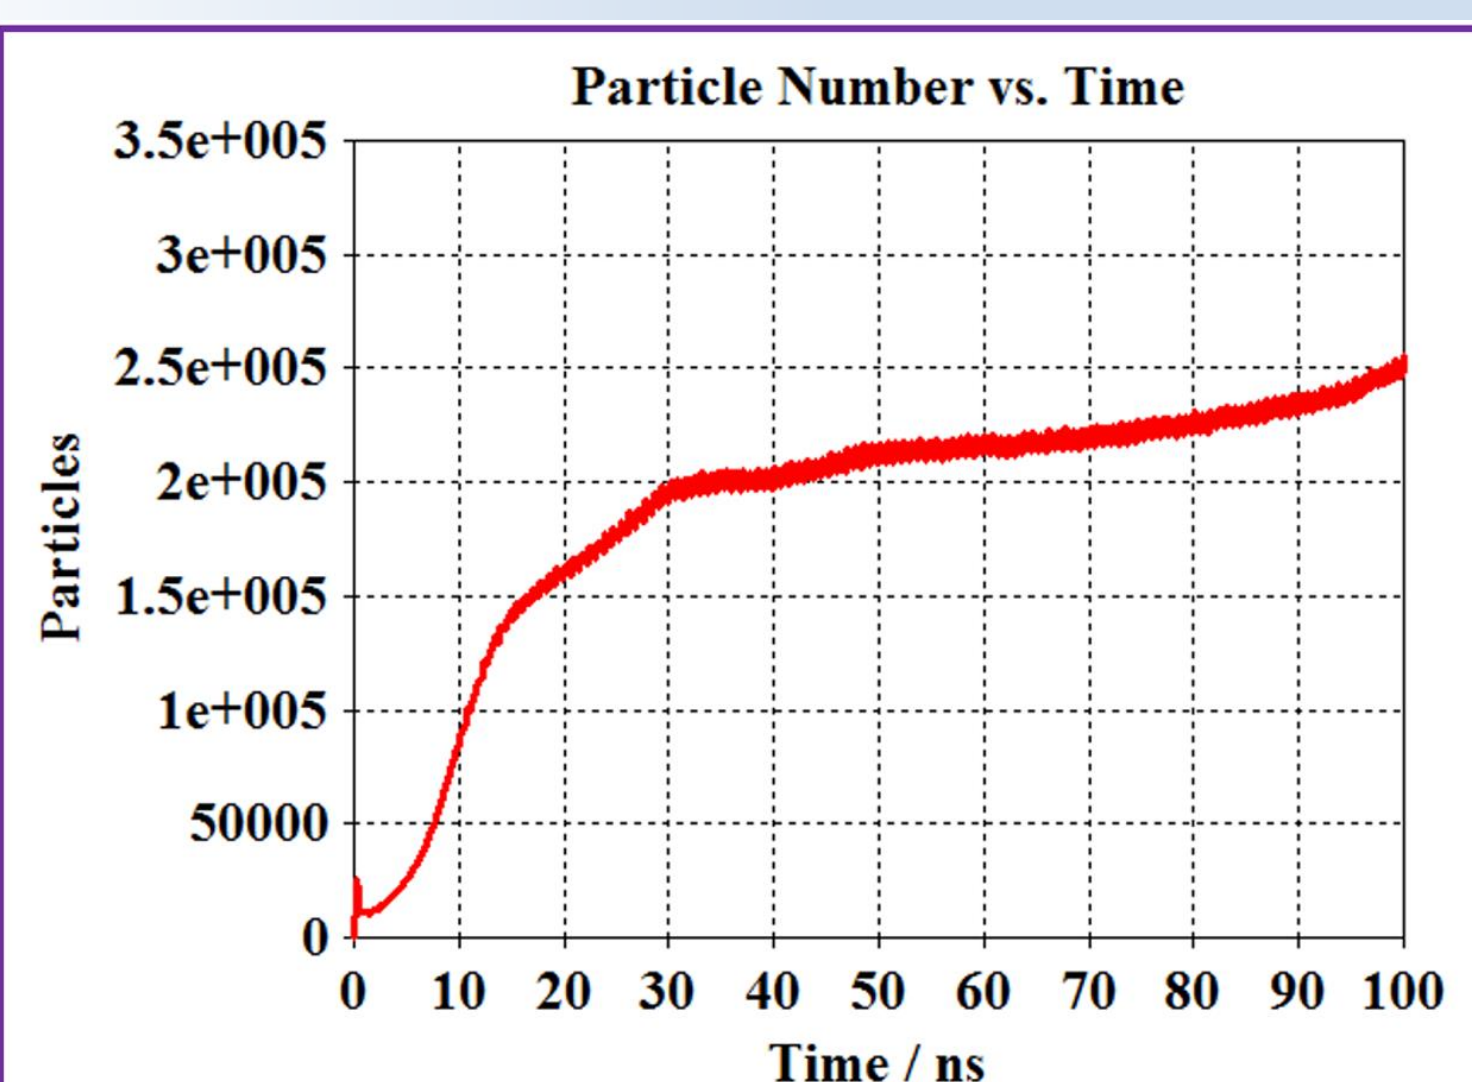
Saturation of particle number.

The electrons generated by multipacting in the HOM coupler do not enter the first cells of the neighboring cavities. Therefore the multipacting that may occur in the HOM couplers of 1.3 GHz cavities cannot contribute to or initiate the dark current.

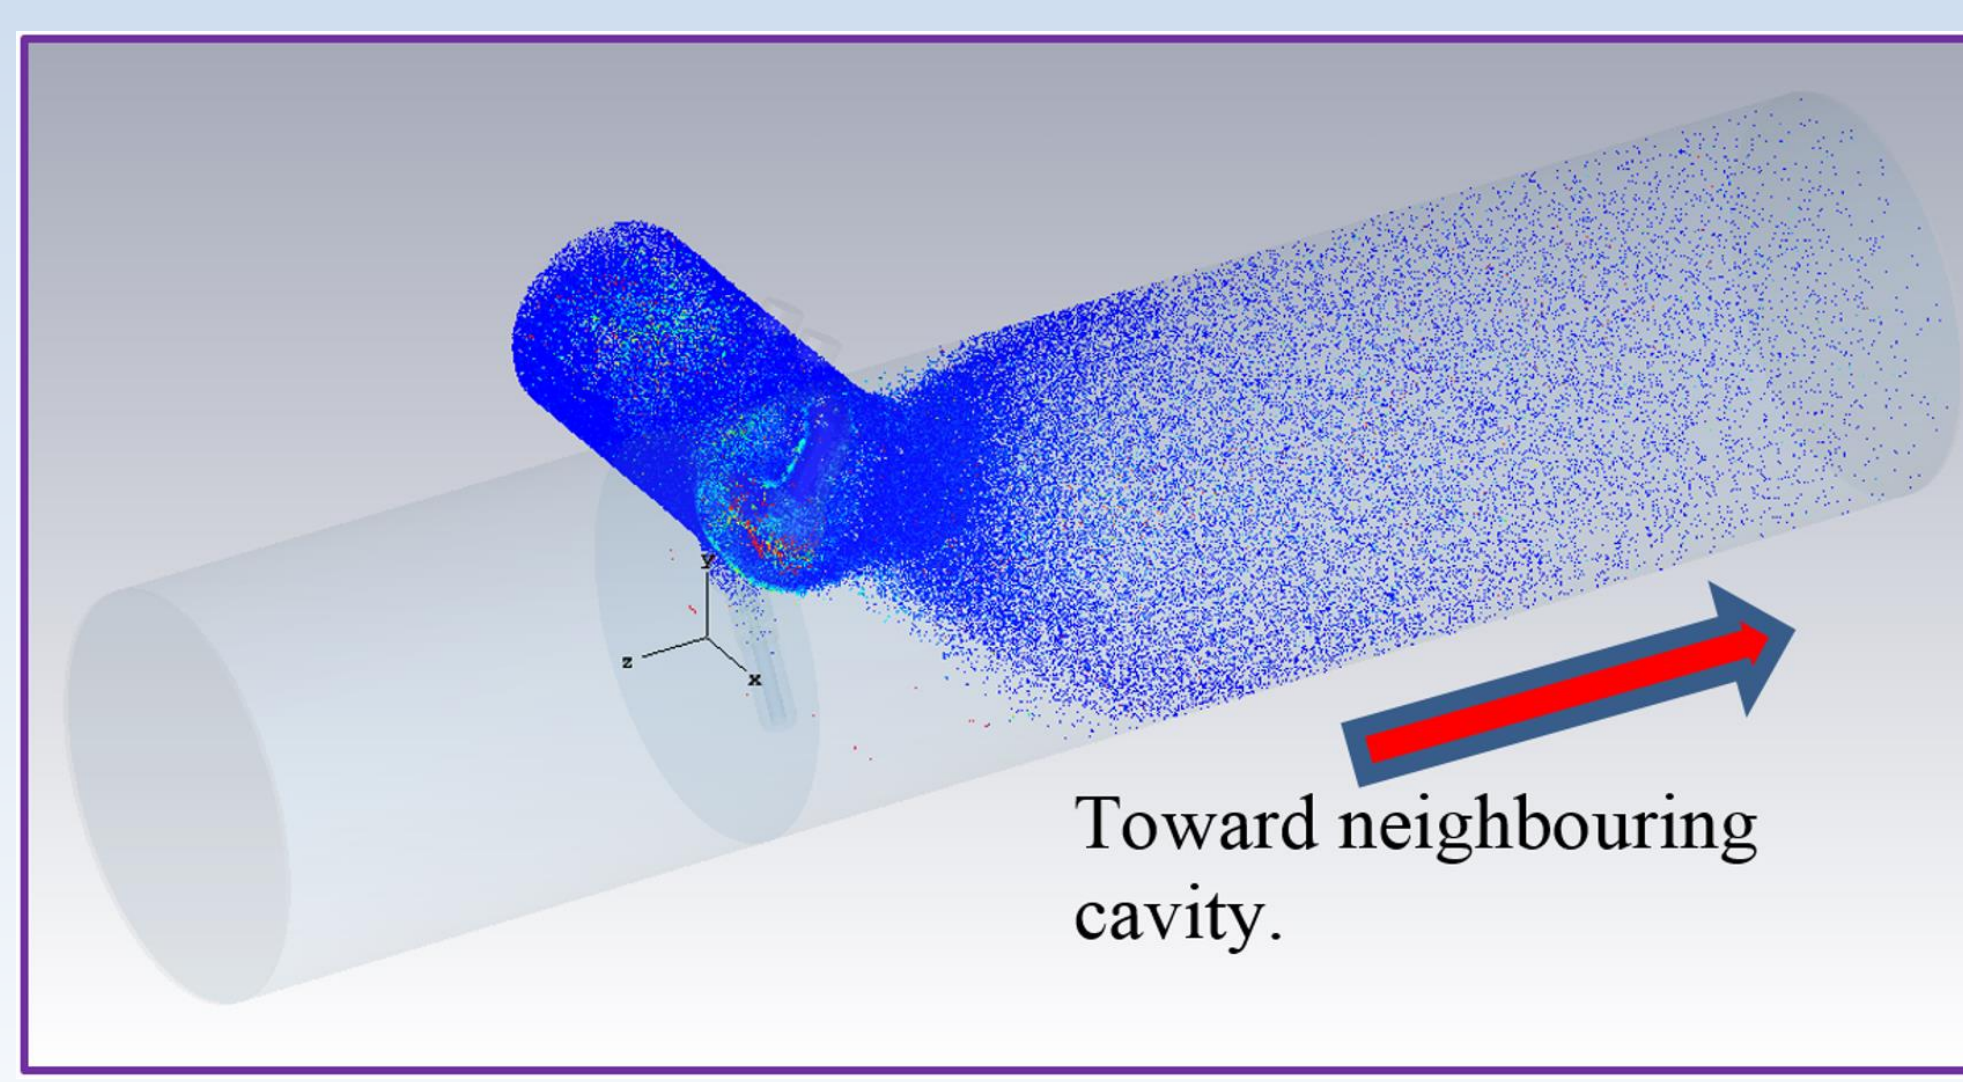
Snapshot of the multipacting in the saturated regime.
