AUTOPSY RESULTS OF FAILED LITHIUM COLLECTION LENSES AT THE FNAL ANTIPROTON SOURCE*

P. Hurh[#], A. Leveling, FNAL, Batavia, IL 60510, USA

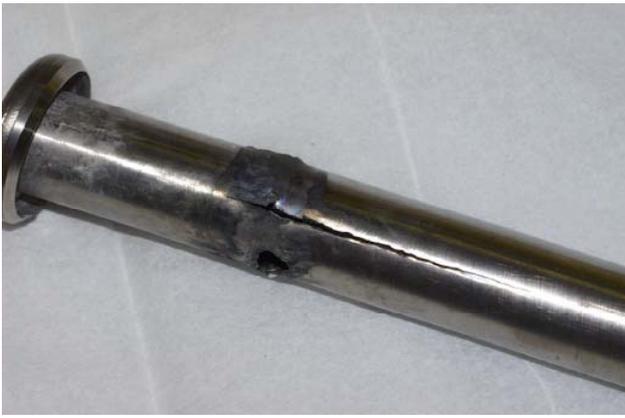
Fig. 2: Lens 21 septum conductor tube showing longitudinal crack and melted through area.

Figure 2 shows the conductor tube from Lens 21 with the longitudinal crack which is presumed to have occurred first. In addition Figure 2 shows a badly burned and, in places, melted region at one end of the longitudinal crack. The region is continuous around the circumference of the tube. The tube wall is actually bulged out in this damaged region presumably from internal pressure or a small explosion. The titanium alloy appears to have local areas of melting (Ti 6Al-4V melting point is 1650 °C). The conductor tube from Lens 20 appears very similar to that of Lens 21 (including the longitudinal crack) except for the absence of the bulged out region.

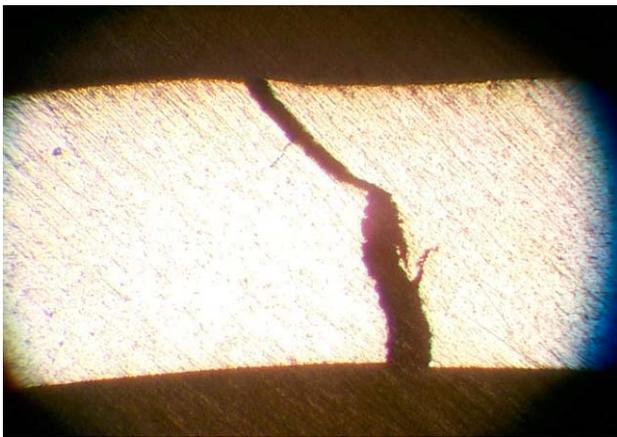
Fig. 3: Lens 20 conductor tube crack profile. ID surface at bottom of picture. Tube wall thickness: 1 mm.

The conductor tubes of both Lenses were prepared into cross-section samples. Figure 3 shows a typical profile of the through wall crack. Most of the profiles studied show two distinct crack propagation regimes, a region of seemingly brittle cyclic crack propagation near the ID surface and a region of ductile fracture near the OD surface. This indicates that the crack originated on the ID surface and progressed cyclically outward. Once the crack had progressed far enough to weaken the wall sufficiently, the crack progressed rapidly in a ductile fashion to the OD surface. In addition in many of the profiles, some reduction of area (or necking) can be observed at the OD surface indicating considerable plastic deformation before complete failure.

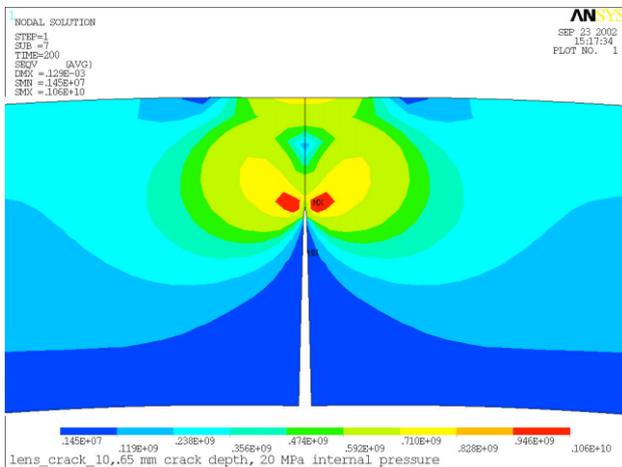
Fig. 4: Von Mises stress equivalent in crack area of ANSYS® model.

Estimations of the loading just prior to the final ductile failure can be made by observing the remaining wall thickness just before final rupture. Using a 2-D ANSYS® [2] finite element model and a crack depth of 0.65 mm, various load magnitudes were investigated. Figure 4 shows the equivalent stress in the crack area of the model under 20 MPa of internal pressure (equivalent to 200 MPa of hoop stress). The stress pattern and deformation shape are in agreement with the photographed cross-sections. Using an ANSYS® routine, KCALC, the stress intensity factor for this geometry and loading was calculated to be $64.5 \text{ MPa}\cdot\text{m}^{-1/2}$. This can be compared to the fracture toughness of mill annealed titanium alloy (6Al-4V) of $64.9 \text{ MPa}\cdot\text{m}^{-1/2}$ [3]. For comparison, hoop stress in the conductor tube pulsed at normal operating gradient (745 T/m) predicted by a full Lens FEA [4] is 343 MPa.

Although loads predicted by FEA are large enough to agree with observations of the final ductile failure, they are not high enough to explain the initial, brittle crack propagation. The threshold stress intensity factor for Ti 6Al-4V below which fatigue crack propagation does not occur is $7 \text{ MPa}\cdot\text{m}^{-1/2}$. Using a similar FEA crack model, it is predicted that an initial crack would have to be 0.15 to 0.25 mm deep before propagating at a rate high enough to fail in the 10^6 cycles range.

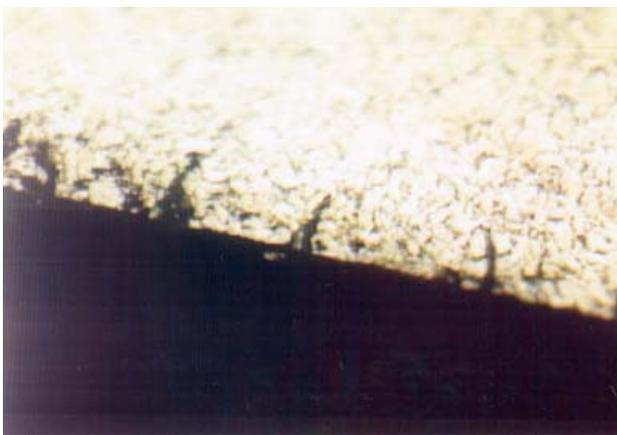
The cross-section samples were examined under high magnification. Micro-cracks on the order of 10 to 20 microns deep can be seen in Figure 5. The cracks appear to be inter-granular and fairly blunted. In addition, there are locations near the opening of the large, through crack that appear pitted with rice grain shaped voids. All of the micro-cracks are on the ID surfaces of the samples.

The cause of these micro-cracks is not readily apparent, although the role they play in initiating fatigue failure may be critical. Their appearance may indicate some sort of corrosive or embrittlement mechanism, however drawing conclusions from such minute indications is difficult. In fact the micro-cracks may have been caused by chemical reaction and/or electrical arcing after the failure of the septa.

Fig. 5: Lens 21 conductor tube crack profile. Shows micro-cracking on ID surface. 1000x.

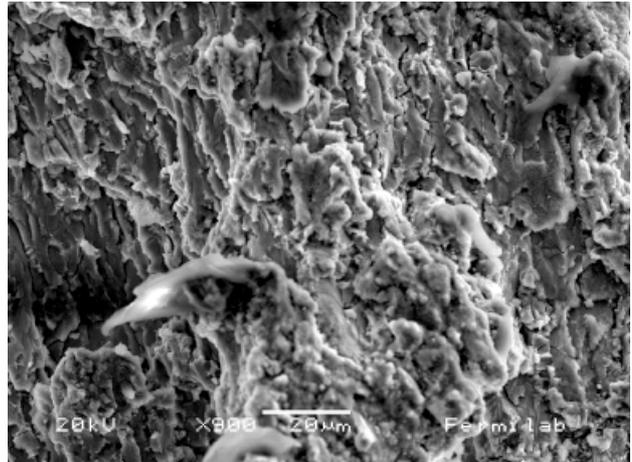
The fracture surfaces of Lens 20 were examined with a SEM. Figure 6 shows a portion of surface in the brittle fracture zone. Note the extremely stratified appearance and pervasive micro-cracking. Figure 7 shows a portion of the surface in the ductile fracture zone. Note that the characteristic ductile dimples are disrupted with a maze of micro-cracks. These surfaces appear to be abraded or corroded after the original failure, possibly by pulsing, arcing, or chemical reaction. Future studies are planned to explain these curious features.

Fig. 6: Lens 20 conductor tube brittle fracture surface.

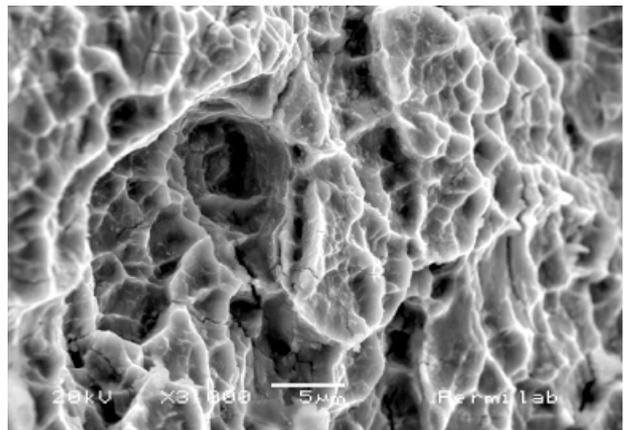
Fig. 7: Lens 20 conductor tube ductile fracture surface.
