PERFORMANCE OF COTS I/O MODULES IN AN ACCELERATOR CONTROL SYSTEM*

S. M. Hartman[†], FEL Laboratory, Duke University, Durham, North Carolina 27708-0319, USA

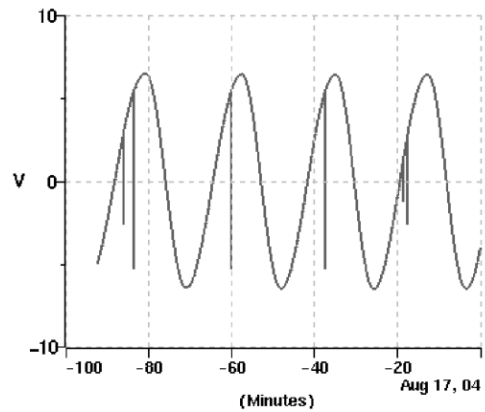
The testing of another power supply indicated acceptable performance in all respects. However, when we attempted to calibrate the power supply's internal readback circuit as measured by the ADC module to the DCCT readings as measured by the precision digital voltmeter, we had a poor fit for the data. Reviewing the data revealed problems in the transients during the slow step-ramp portion of the power supply testing. Since the current as measured by the DCCT did not indicate this problem and no problem appeared to exist in the power supply's readback circuitry, separate testing of the ADC was undertaken to isolate the problem. Since this ADC is primarily used for slow measurements, a test was set up consisting of a function generator producing a sine wave at approximately 0.6 mHz. As can be seen in Figure 1, the ADC module occasionally produced a misread when the input voltage was increasing in the range of four to six volts. The error did not occur on the down ramps, nor was it measured every cycle (though some cycles recorded multiple errors). Further study indicated that the misread is a sign error of the value as returned by the ADC module. The manufacturer is currently still investigating this issue. Since this error does not directly impact accelerator performance, the modules are still in use. The limitations of the readback are kept in mind, particularly with regards to our operational power supply performance monitoring program [2].

Figure 1: An ADC module recording a waveform generator produced sine wave showing a transient sign error during increasing voltage input. Data were recorded at 1 Hz.
