RADIATION DAMAGE TO ADVANCED PHOTON SOURCE UNDULATORS*

Shigemi Sasaki, Maria Petra, Isaac B. Vasserman, Charles L. Doose, Elizabeth R. Moog, APS, Argonne National Laboratory, Argonne, IL 60439, U.S.A.

Abstract

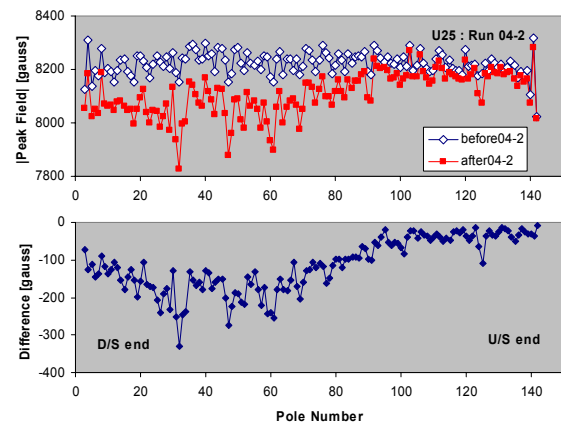
Figure 1 shows examples of peak field degradation in the Sector-4 undulator during a run in 2004. The undulator is a hybrid permanent magnet undulator with a 33-mm period. Measurements of radiation doses were done by alanine dosimeters placed on the surface of magnets in the undulator. Magnetic field measurements at a gap of 11.5 mm were done with a Hall-probe

measurement bench before and after each run. The difference curve in the bottom panel shows the damage increasing as one moves from the upstream end. The damage then peaks and decreases somewhat through the last part before the downstream end. The profiles of peak field degradation were very similar for other runs.

Fig. 1: Peak field comparison of the undulator before and after the May-August 2004 run. Bottom graph shows the difference before and after the run. Pole number is numbered from the downstream end. Open diamond: before user run, solid square: after user run.

Dose monitoring along the length of the undulator revealed significant dose non-uniformities. The doses are higher in the downstream (DS) end of the ID by almost an order of magnitude than the recorded doses in the upstream (US) end of the ID. The magnetic measurements shown in Fig. 1 also reveal that the radiation damage is higher in the DS end of the ID.

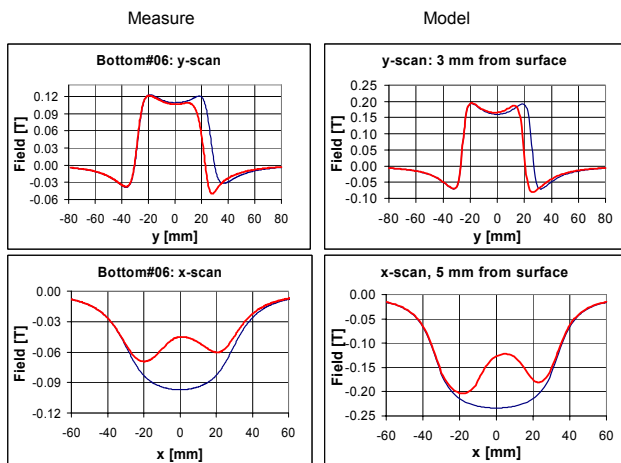
Figure 3 shows a comparison of measured magnetization profiles of a magnet extracted from a 27-mm-period undulator and profiles of model calculation. The magnet shown here was near the upstream end of the undulator. The undulator was installed in the upstream end of the Sector-3.

Fig. 3: Comparison of measurement and modeling. Thick red curves represent damaged magnetization profiles after irradiation. Thin blue curves represent profiles of the remagnetized magnet block. The magnetization levels of the two demagnetized regions in the model shown in Fig. 4 are -0.03T at the surface and 0.1T deeper in the magnet.

Simple modeling was done using the magnetic calculation code RADIA [6]. Measurements found that the demagnetized area was on the side closest to the beam, so the simple model shown in Fig. 4 was chosen. For simplicity, only two layers of damaged region were assumed. The thickness (in y) and width (in x) of each layer were assumed to be 3 mm and 25 mm, respectively. It was found that a gradual decrease in magnetization with depth into the magnet would introduce a different slope in the damaged curve at $y \approx 20$ mm, so a sharp edge to the demagnetization was necessary. Also, it was found that setting the magnetization of the surface layer of magnet to zero would not reproduce the dip in the damage profile seen at $y \approx 25$ mm. Instead, the magnetization at the surface had to be slightly negative. Apparently, the

radiation has allowed the demagnetizing field the magnet is in to cause a slight remagnetization of that section of magnet in the opposite direction.

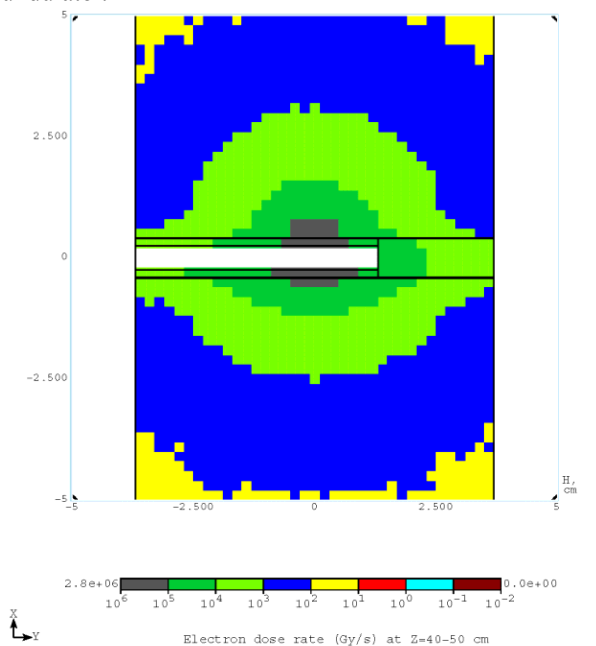
Simulations of the radiation dose to the undulator were carried out using the MARS code [7]. The model included the undulator magnets and poles, the vacuum chamber, and APS electron beam parameters. It was found that electron loss in the wall of the vacuum chamber induces electromagnetic showers coupled with photo-hadron production. The corresponding absorbed dose is highest near the beam axis, and may cause radiation damage to regions of undulator magnets nearest the beam. Figure 5 shows electron dose isocontours in the undulator.

Fig. 5: Electron dose distribution in the undulator. 6.25×10^{14} e/s loss at 7 GeV was assumed for the simulation.

As can be clearly seen, the maximum dose rate is localized near the electron beam axis. Dose distributions from gamma-rays, charged hadrons, and muons all show

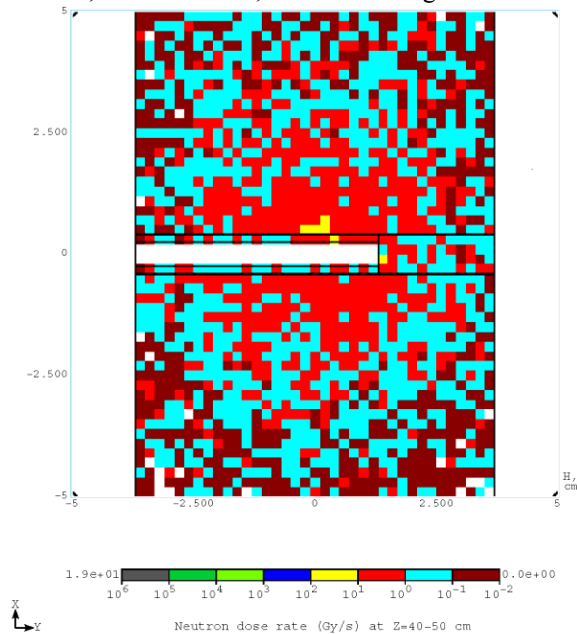
very similar patterns. The neutron dose distribution, however, is rather broad, as shown in Fig. 6.

Fig. 6: Neutron dose distribution in the undulator. 6.25×10^{14} e/s loss at 7 GeV was assumed for the simulation.

Although it is too early for final conclusions about the cause of damage in magnets, the neutron dose appears to be too widely distributed to be primarily responsible for the localized damage observed experimentally.
