QUALITATIVE EFFECTS OF RADIATION DAMAGE ON EQUIPMENT AND COMPONENTS AT THE R.P.I. LINAC*

R. R. Fullwood, E. R. Gaerttner and R. Krasse
Department of Nuclear Engineering and Science
Rensselaer Polytechnic Institute
Troy, New York

A summary of difficulties due to radiation induced damage in neutron producing targets and components is presented. Surprisingly little difficulty has been experienced considering the power levels at which the R.P.I. Linac has been operated.

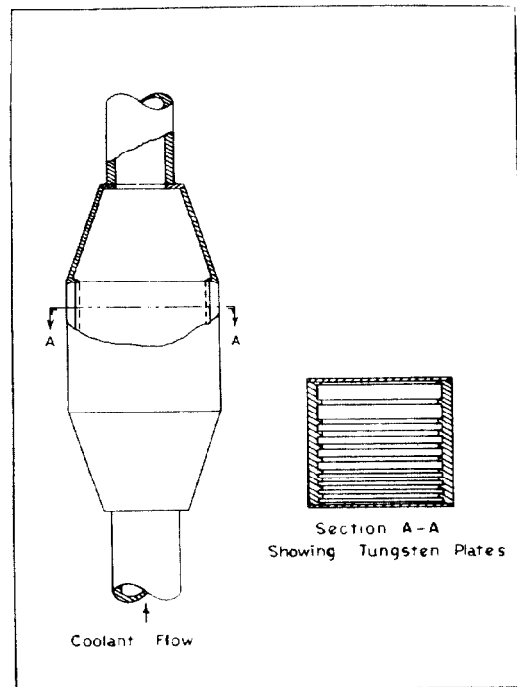
The most persistent trouble we have experienced has been the failure of the water jacket on the tungsten e- γ -n targets (Fig.1). This target design was based upon heat transfer considerations and not on neutron production. Unclad tungsten metal plates 2" x 2" and thicknesses varying from 1/16" to 1/4" are enclosed in a 304 stainless steel water jacket. A water flow of 25 g.p.m. is forced through the 1/16" cooling channels between the tungsten plates. Unfortunately the tungsten tends to slough off into the cooling water resulting in undesirable radioactive contamination in the event that it is spilled. Radioactivity of the cooling water was in the range of 0.01 to 0.1 μ c/ml and the isotopes of tungsten predominated.

The most common way this target design has failed is by "rusting" of the stainless steel. Discussions with metallurgists here and at other facilities has determined that 304 stainless steel is subject to a condition of chromium precipitation at elevated temperatures as would be expected when an electron beam of 20-30 megawatts of 5 μ sec duration is incident upon the target. It has also been pointed out by Mr. L. R. Lucas of Stanford and observed at Oak Ridge³ that carbide precipitation in the lower sensitizing temperature range can completely surround a grain boundary thus reducing its strength and corrosion resistance. To the nuclear physicist this appears as rust on the targets at the place of beam impingement and it is at this point that the failure of the water jacket occurs. The records on this are not detailed but failure seems to occur at about 300 beam impingement hours at 20 kw of average power.

Fig. 1. Cross Section of the R.P.I. LINAC Water-Cooled Standard Tungsten Target.

The design of Fig.1 has been replaced by a similar version replacing the 304 stainless steel with an aluminum

jacket. This target has been in operation for the last six months without any signs of failure. It should also be pointed out that a target based on the design of Fig. 1 in a stainless jacket and used on short pulses (low average power) is still operating after over 1000 hours of service. The problem is definitely a function of the energy per pulse delivered.
