IEEE Transactions on Nuclear Science, Vol. NS-26, No. 3, June 1979
A REPORT ON THE OPERATIONAL RELIABILITY OF THE FERMILAB MAIN RING MAGNETS
Rodney E. Gerig*†

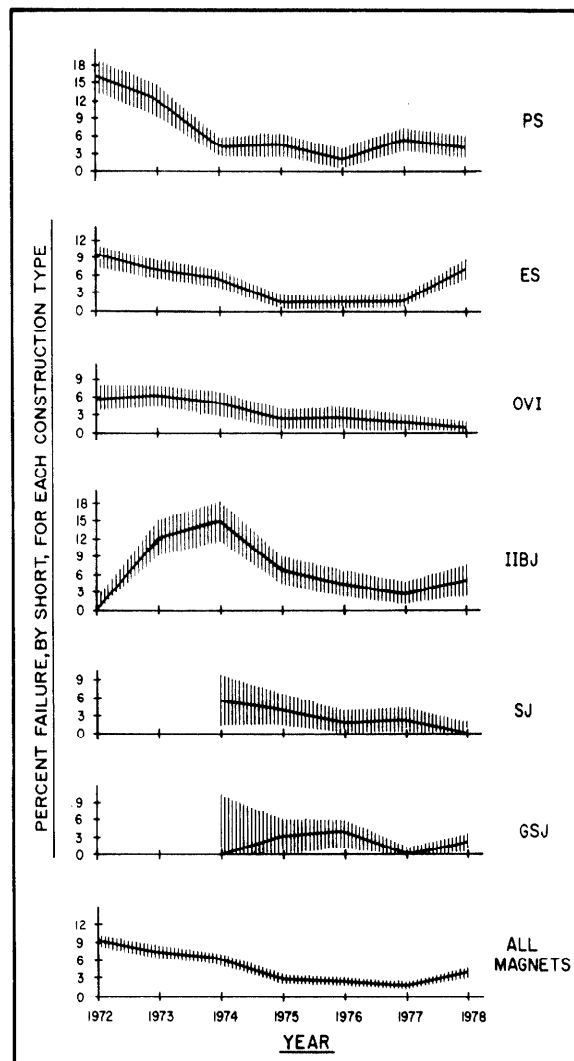
Magnets can be removed from the ring for a variety of reasons. Several of the reasons which have little to do with the magnet itself are buckled vacuum chambers, and vacuum leaks. Both of these problems can be caused by beam. The overwhelming majority of magnets removed from the ring have shorts. Figure 1 shows the percentage/yr of each type of magnet which have failed with shorts since 1972.

Rigorous conclusions cannot be drawn from this data, but a few observations, can be made. Plaster Stick failures have stayed constant since 1974. To this point there is no sign of them weakening from old age. Epoxy sticks on the other hand, show an increase in shorts in 1978. This may be attributed to factors discussed later. Original Vacuum Impregnation appear to have been a considerable improvement over PS and ES, and also, show no signs of weakening. Integrally Impregnated Butt Joint magnets looked very promising on January 1, 1973. Over 100 of them had been installed without a single failure. However, in 1973, fifteen failed with shorts, and in 1974, twenty. It was felt that the greatest problem with these magnets was that the impregnation technique which holds the coils very tightly in this construction type does not allow the coil package to move with temperature variations. Hence tremendous forces are placed on the butt joints of the inner coils, particularly on cool downs when the forces are acting to pull the joints apart resulting in water leaks and eventual shorts to ground.

In 1975 through 1977, the percentage failures of IIBJ were greatly reduced, possibly indicating that the magnets which survived were built better and had survived the "weeding out" process. In 1978, the percentage failures of IIBJ was up almost a factor of 2 over 1977. This may be only a statistical variation, but a possible explanation is given later.
