EXPERIENCES ON RETREATMENT OF EU-XFEL SERIES CAVITIES AT DESY

A. Matheisen, B.v.d. Horst, N. Steinhau-Kühl, N. Krupka, P. Schilling, S. Saegebarth
DESY Hamburg, Germany

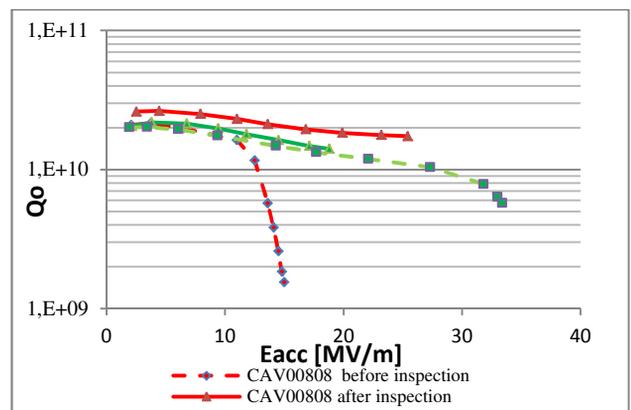
Figure 1: RF test result of qualification retreatment for pass 4 (Obacht optical inspection).

On Cavity CAV00808, limited by field emission loading at 12 MV/m, and Cavity CAV00809, limited by breakdown at 19 MV/m without indication of electron loading, no information of any significant surface problems [7] was found. In addition to the optical inspection a so called replica [7] of the surface was applied for analysis of cavity CAV00809.

Both cavities completed the pass RP4 and retreatment by HPR (RP1) before second RF test. Performance in test two showed no degradation (Fig. 1). The increase of gradient observed for these two resonators can be explained by removal of origin of limitation by HPR applied at the end of pass RP4. It is unlikely to assume that the limitation is influenced or was removed by the inspection.

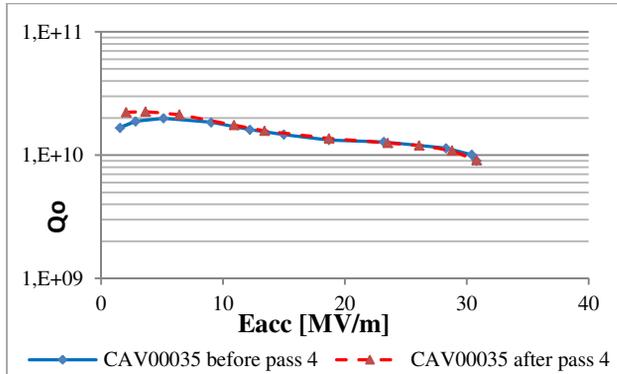
Figure 2: Test results of high grade cavity before and after retreatment by applying pass RP4 processing.

For CAV00035 from the high grade program [8] inspection and replica of iris 2 were done. Also here no degradation of usable gradient of 30 MV/m was observed (Fig. 2).

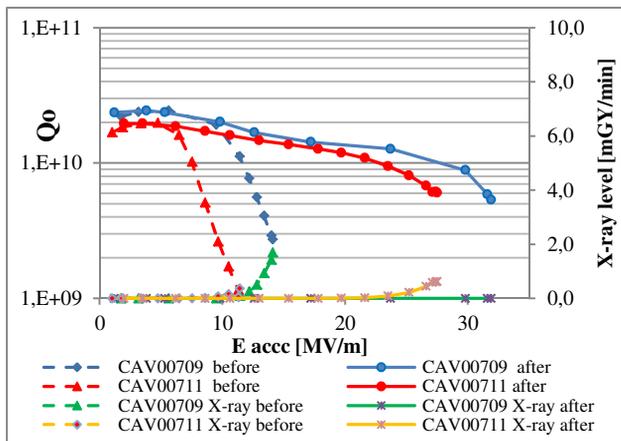
During the first year of retreatment and test it was found that several cavities showed typical behavior and limitation during test. About 2 % of the cavities tested showed maximum usable gradients below 10 MV/m,

independent from manufacturer. After HPR applied to these cavities, nine out of ten cavities with low gradient recovered (Fig. 6) and were acceptable for string installation at CEA Saclay. In average the usable gradient improved by 26 MV/m ranging from 22 to 32 MV/m.

The crosscheck of all processing data and interviews with operators did not give any hint for the low gradients. It was agreed on with industry that a non-detected fatal error might have happened during final treatment for test. Companies mostly accepted that cavities showing very low gradients are sent back to industry for retreatment by HPR.

Figure 6: Examples for recovery by HPR of cavities with very low usable acceleration gradient and low gamma loading.

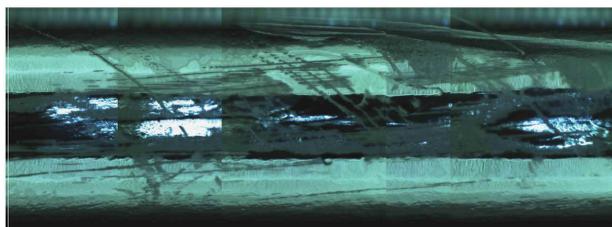
For several cavities not recovering after BCP treatment in pass RP2, inspection by Obacht optical system [9] identified surface irregularities like for instance scratches on the irises (Fig. 7). These types of defects were most probably the reason for the high field emission loading during RF test that could not be cured, even if 10 μm of surface was removed in pass RP2 (Fig. 5). They were sent back to the companies after RP4 (Fig. 8).

Figure 7: Example for scratches on iris observed by Obacht inspection on Cavity AC 155 – Iris 8 / 190°-250 °

The company removed the cavities from the helium tank and repaired these areas [10]. Usable gradients up to 35 MV/m without field emission loading are reached after repair of the defects at the company [10].

The optical inspection system in use at one company did not allow adequate inspection of that area during production. After this feedback of information a new high resolution camera [11] was installed and the problem was solved for the following up part of the production.
