# ACCELERATOR MODULE REPAIR FOR THE EUROPEAN XFEL INSTALLATION

E. Vogel, S. Barbanotti, F. Hoffmann, K. Jensch, D. Kostin, L. Lilje,  
W.-D. Moeller, M. Schmoekel, H. Weise, DESY, Hamburg, Germany  
S. Berry, O. Napoly, CEA, Irfu, DACM, Centre de Saclay, France  
M. Sienkiewicz, J. Swierblewski, M. Wiencek, IFJ PAN, Krakow, Poland

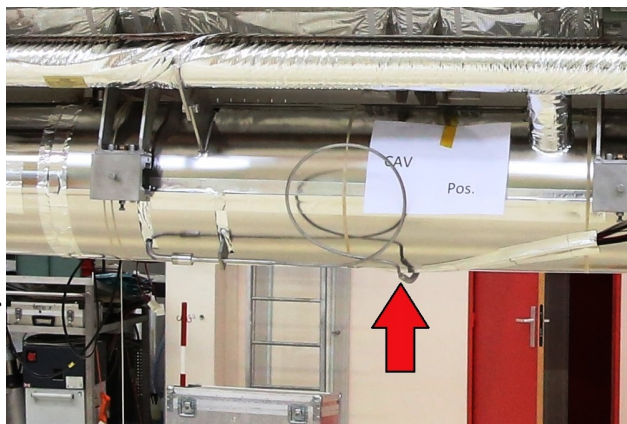
XM8 has been assembled at CEA in spring 2014, when the module assembly was still in the ramp up phase. Nevertheless, the 2 K circuit consisting of the 2-phase pipe itself, the warm-up cool-down line and the cavity tanks was never suspicious-looking for any leaks. Connecting the module to the AMTF test stand two leaks appeared. One in the bellows of the coupler 5 push rod and one at the 2 K circuit with a leak rate of  $8 \cdot 10^{-8} \frac{\text{mbar l}}{\text{s}}$ . In situ exchange of the coupler push rod bellows cured the coupler leak. Separating the process lines to enclose the area where the leak is located revealed the leak location somewhere at 2-phase line and warm up pipe. In October 2014 the module was removed from the test stand without cold test, wrapped to guaranty low humidity and put aside for later investigation and repair as personnel was tight during the ramp up phase. In October 2015 the module has been brought to "Halle 3" for further investigations. Motivated by the experience with leaks at the magnet current leads of XM21 the magnet current leads were examined first without finding a leak in this area. Then XM8 was disassembled to make the 2 K circuit accessible. The leak was found at the capillary on the warm-up cool-down pipe connection at cavity 6 (Fig. 4). The weld was repaired and the following leak check at warm showed no anomalies. The repair took 38 days. In March 2016 the cold test resulted in an average usable gradient of 26.3 MV/m. After the warm up a  $10^{-9} \frac{\text{mbar l}}{\text{s}}$  leak has been found again in the 2 K area. The module was put aside for further investigation, presently still ongoing.

Figure 4: Position of the leak at the XM8 Helium filling line. The photograph shown here was taken at a different module at the CEA assembly line.

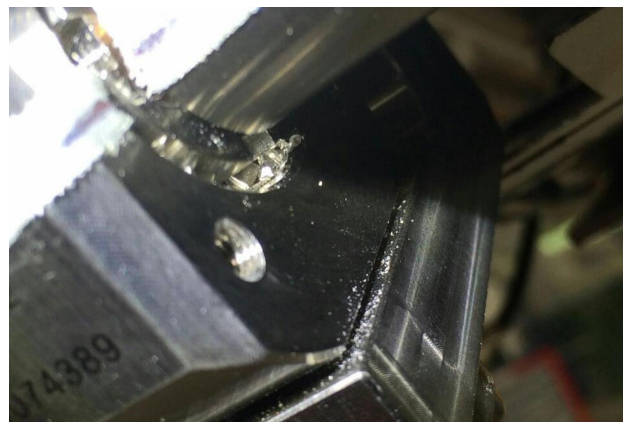
Different problems arose while testing the module XM93: two helium leaks appeared at the 2 K and 70 K area respec-

Figure 5: Multi-layer insulation trapped in the XM93 ball bearing of the tuner motor.

tively and cavity 1 could not reach its nominal frequency of 1.3 GHz nor go back to its nominal warm up position once the module was cold. All the problems were solved without disassembling the module; the leaks required some re-welding of the end pipe connections outside the module, while the frequency tuning problem needed some part exchange: the optical inspection performed after warm up revealed multi-layer insulation (from the test stand) trapped in the ball bearing of the tuner motor (Fig. 5). The drive unit was exchanged and the tuner performances measured to verify the results of the repair work. The frequency change operating the tuner motor was within the acceptance values.

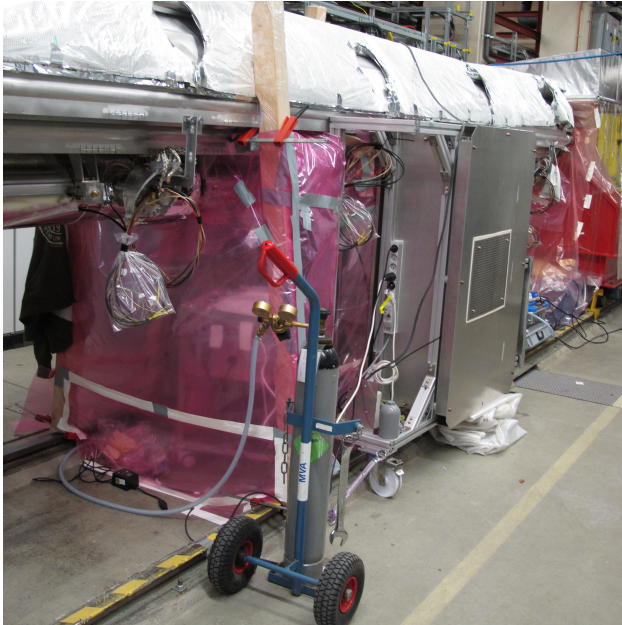
In January 2015 testing of module XM22 started. A leak found at the A-flange of coupler 2 was repaired in situ by exchanging the O-ring. Due to a leak venting the insulation vacuum caused by a loose fastening nut at a coaxial feed-through the testing had to be interrupted and the module warmed up. The flange with the leaky feed-through was exchanged. After the next cool down a heat load 10 times nominal has been found and the module warmed up for investigation. Finally, a  $10^{-9}$  to  $10^{-7} \frac{\text{mbar l}}{\text{s}}$  leak at the beam line appeared. Due to the time delay between the spraying of Helium and the detection inside the beam vacuum volume the leak was expected somewhere at an inner position. We removed the module from the test stand without being tested and stored it in the XFEL tunnel, which was still quite empty at this time. In January 2016 the module was brought back to the AMTF for warm coupler disassembly and subsequently to "Halle 3" for disassembly of the thermal shields permitting access to the string. In March 2016 the HOM #2 feed through of cavity 7 has been found leaky. We decided to try an exchange in a local clean room with the string of cavities still hanging at the cantilever (Fig. 6). To provide access

Figure 6: Local clean room at XM22 hanging at the cantilever for HOM antenna exchange.

to the feed through the tuner was uninstalled. The local clean room has been qualified with particle counters and the feed through exchanged. After reassembly XM22 has been fully tested for the first time in April 2016: All cavities kept their performance w.r.t. the vertical test providing an average gradient of 15.8 MV/m and the heat load measured was within the specification. The module has been installed.
