Abstract

101 European XFEL-Modules

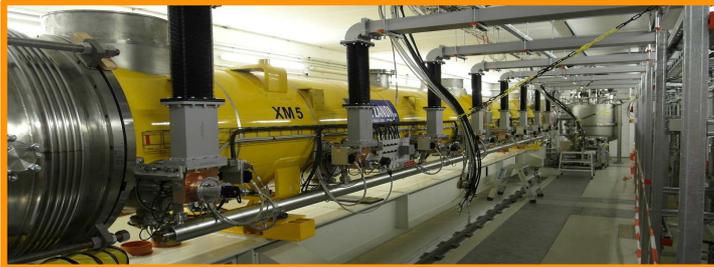
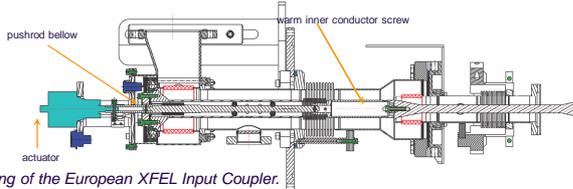
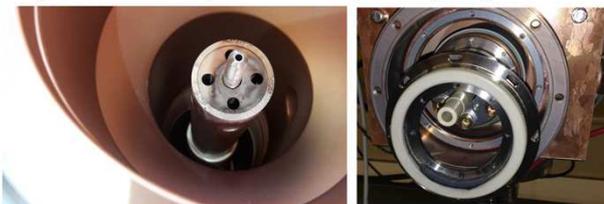
Figure 3: Burnt main input coupler parts

Cold part after disassembly

Cold part after grinding

Inner cond. after disassembly (exchanged)

Burnt capacitor

Because of a loose inner conductor screw (connection between the warm part inner conductor and cold part antenna) we observed burnt surfaces on both sides. Normally it's necessary to change both parts (cold and warm part). That means a complete disassembly of the module. That was not possible in a short time. So we changed the warm parts and cleaned the cold part antenna with fine grinding, citric acid and alcohol as dust free and clean as possible.

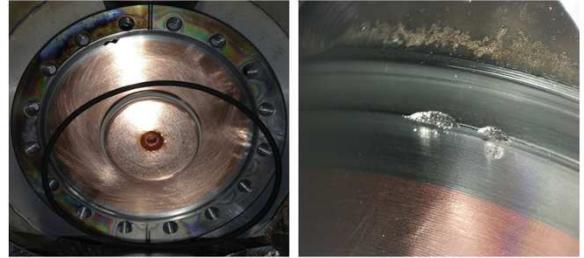
Figure 4: Partly destroyed knife of Cold Part

Burnt CF gasket knife edge (not repairable), repair done with a special gasket

Leak check with both gaskets before RF test was ok. Because of a forgotten O-ring (on top of serial metal gasket) we faced a vacuum break down, when switching RF power on. After disassembly of warm part we faced the damaged knife of CF-100 flange on cold part. After cleaning all parts we put a special repair gasket and made a new assembly.

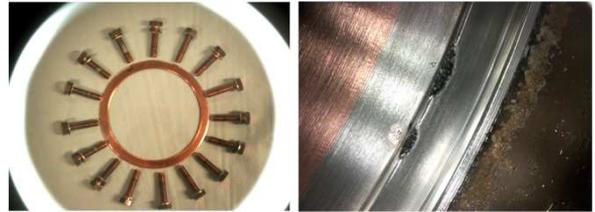
Damaged CF100 flange screws (leftover of a rubber seal and stainless steel on the threads)

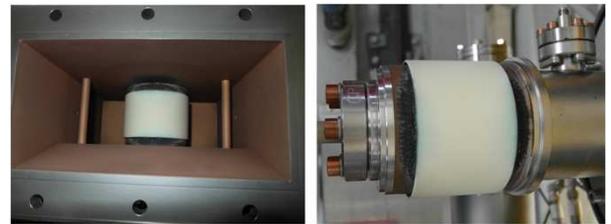
Figure 5: Burnt Warm Part

Burnt w. window and transit to waveguide-box, both parts had to be changed.

During the warm conditioning at module XM82 we faced a lot of activities in all couplers, especially in coupler #1. For investigation the spark interlock was disabled, all other were enabled. After test and disassembly of waveguide-box and warm part we discovered the damage caused by the pronged operation with light emission.
