Accelerator Module Repair for the European XFEL Installation

Abstract

Repair actions of different extent have been performed at 61 of the 100 accelerating series modules for the European XFEL to qualify them for tunnel installation. Four modules could not be repaired in time. CEA Saclay managed to perform three major repairs in parallel to the series module integration, the residual repair actions took place at DESY Hamburg. We give an overview on the various technical problems to be fixed before the tunnel installation.

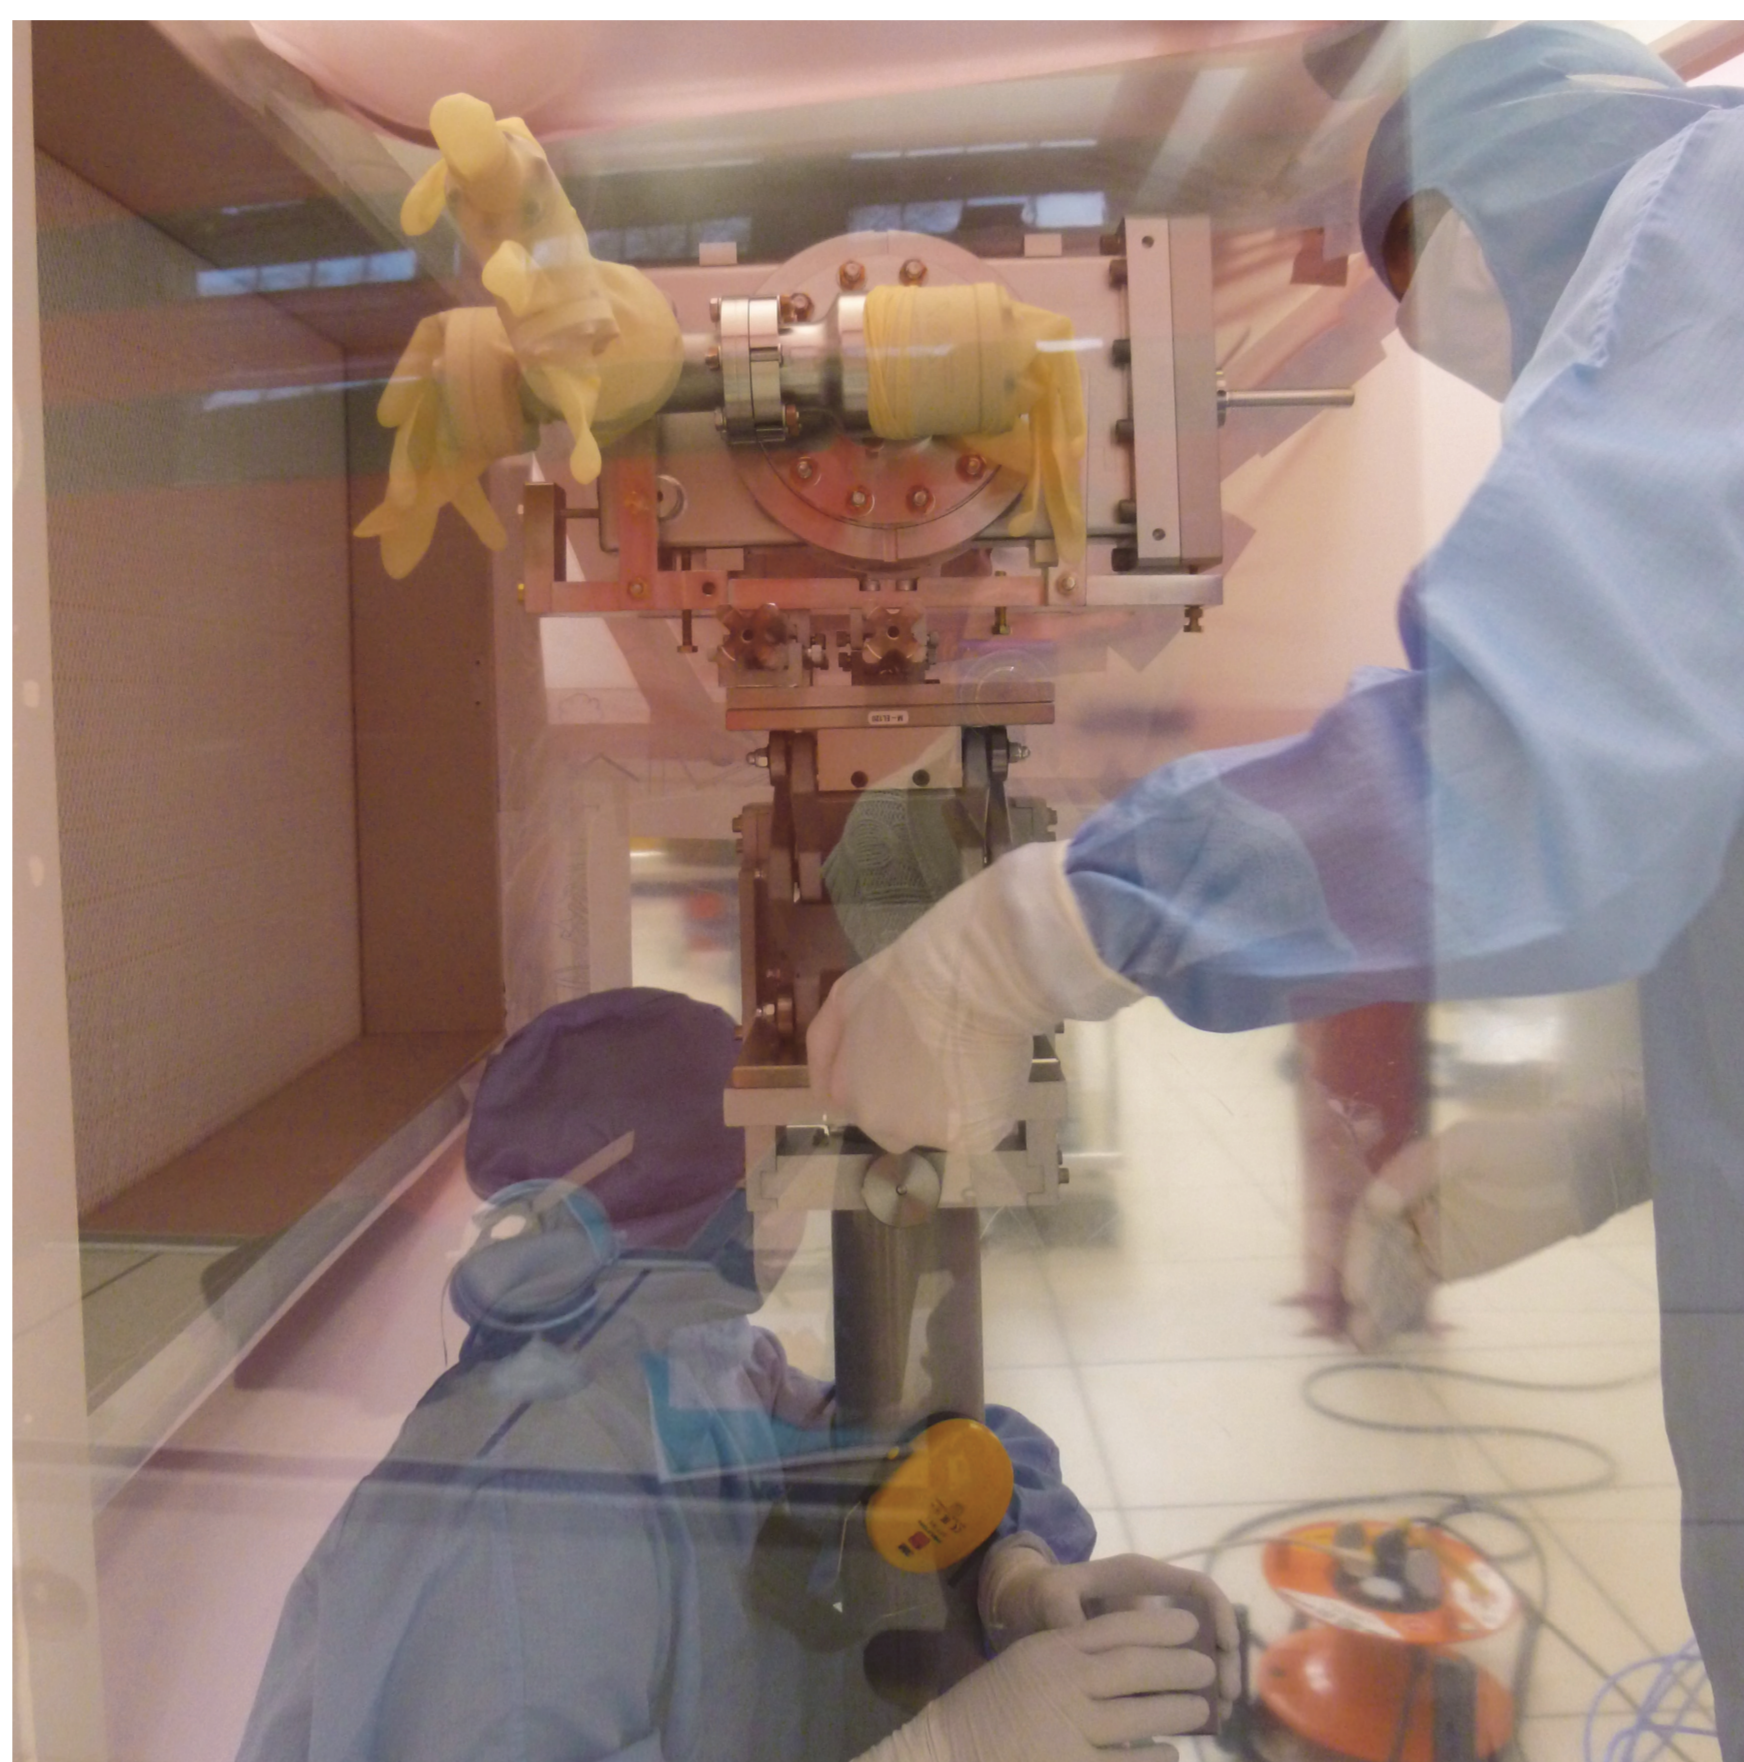
- beam line leaks
 - XM46: leaky cold coupler connection
 - XM50: leak at DN16 valve and gauge, after AMTF test again leaky at beam line
- defect upstream gate valve

- XM54: exchanged in local clean room, with good performance in XFEL installed

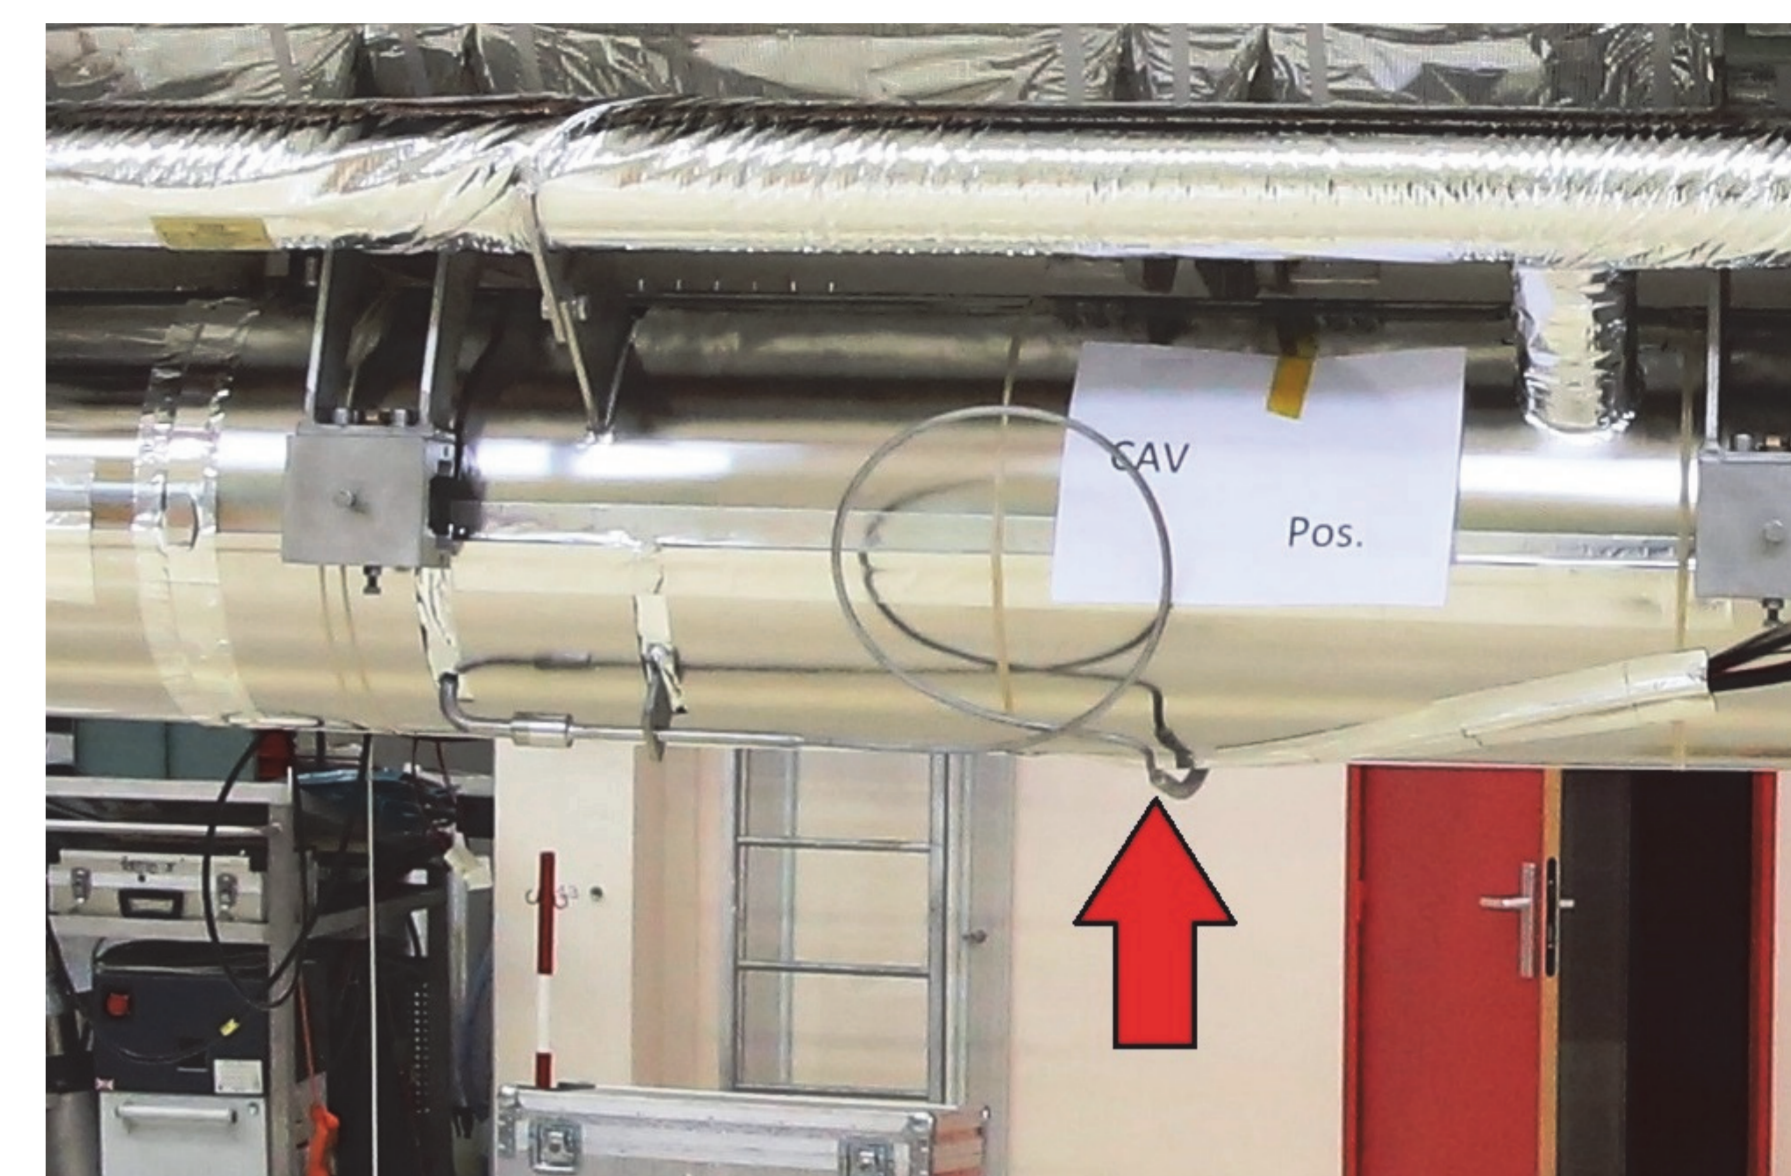
- XM-2: process lines x-rayed for PED re-qualification
- XM8: leaky Helium filling line repaired

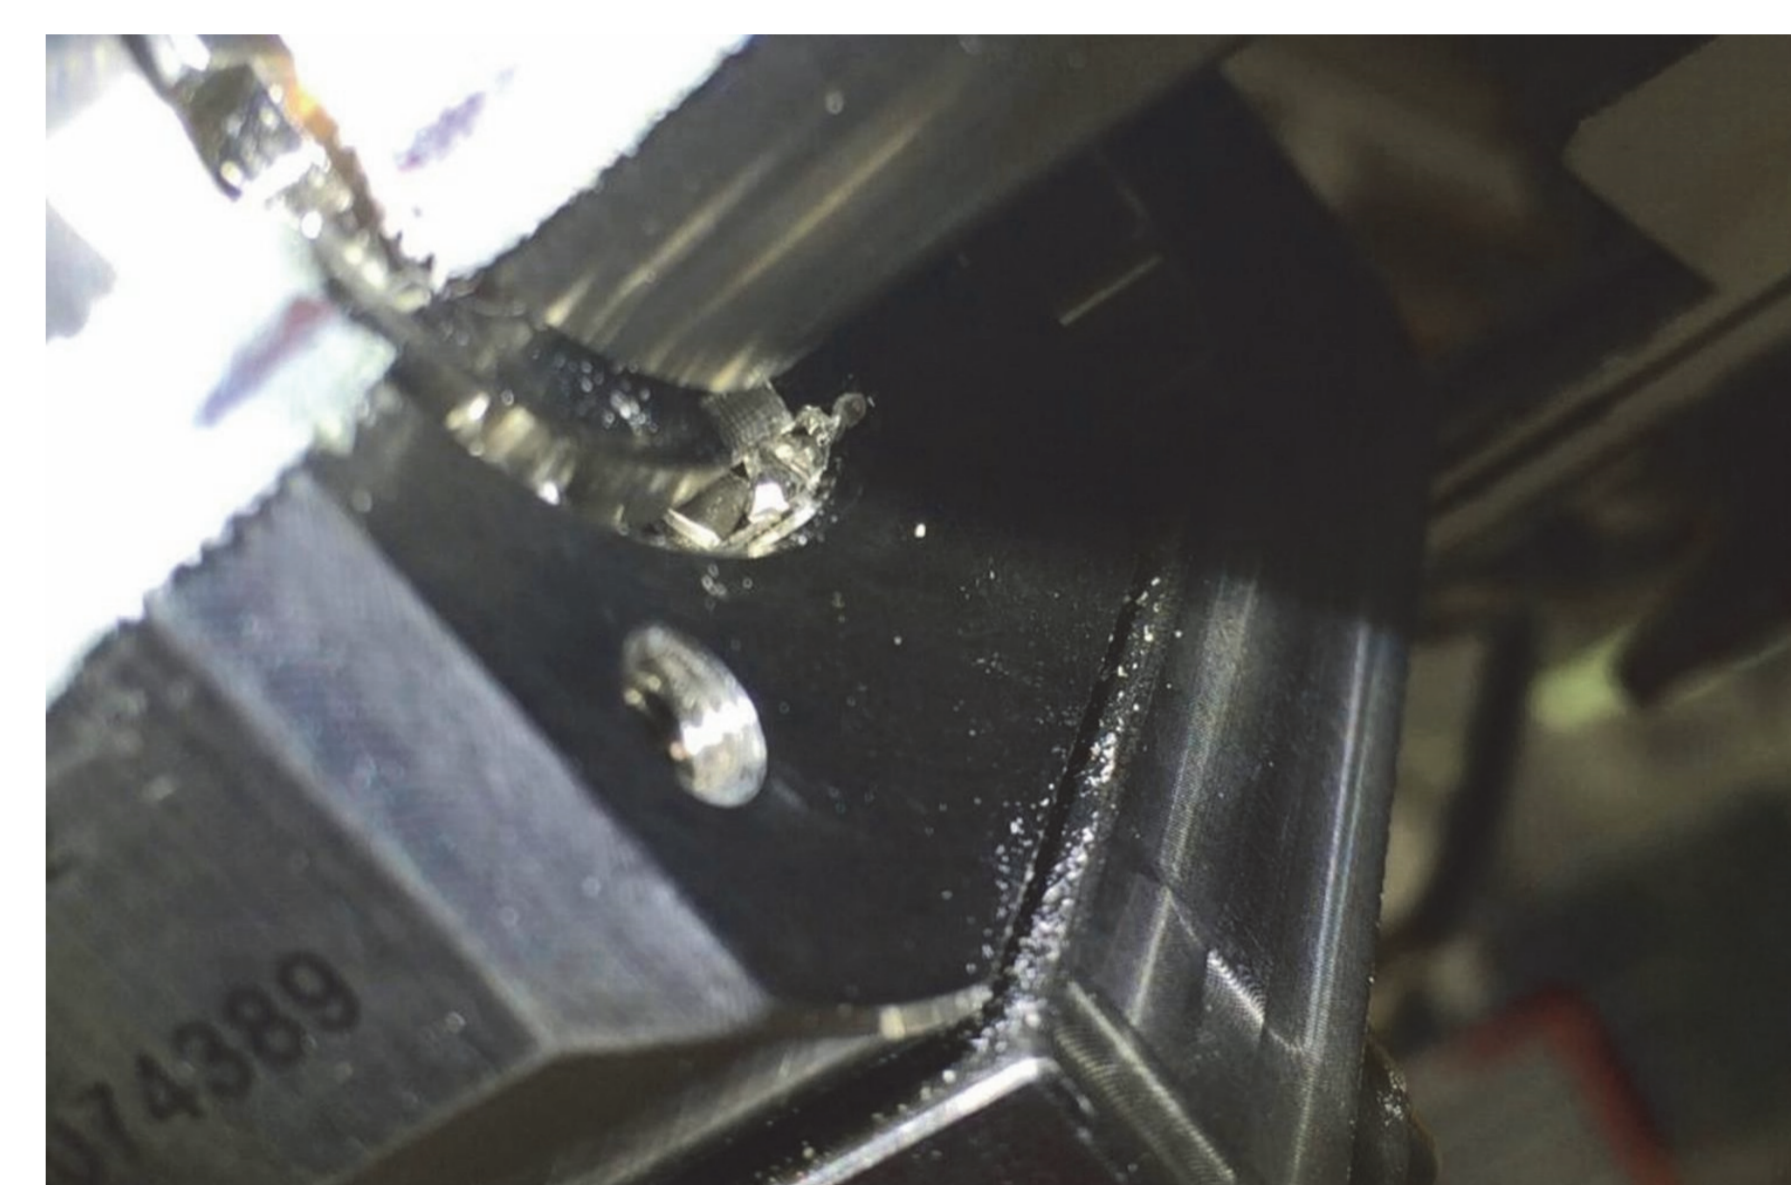
- XM69: loose pins at center post fixed
- XM93: (from test stand) trapped MLI

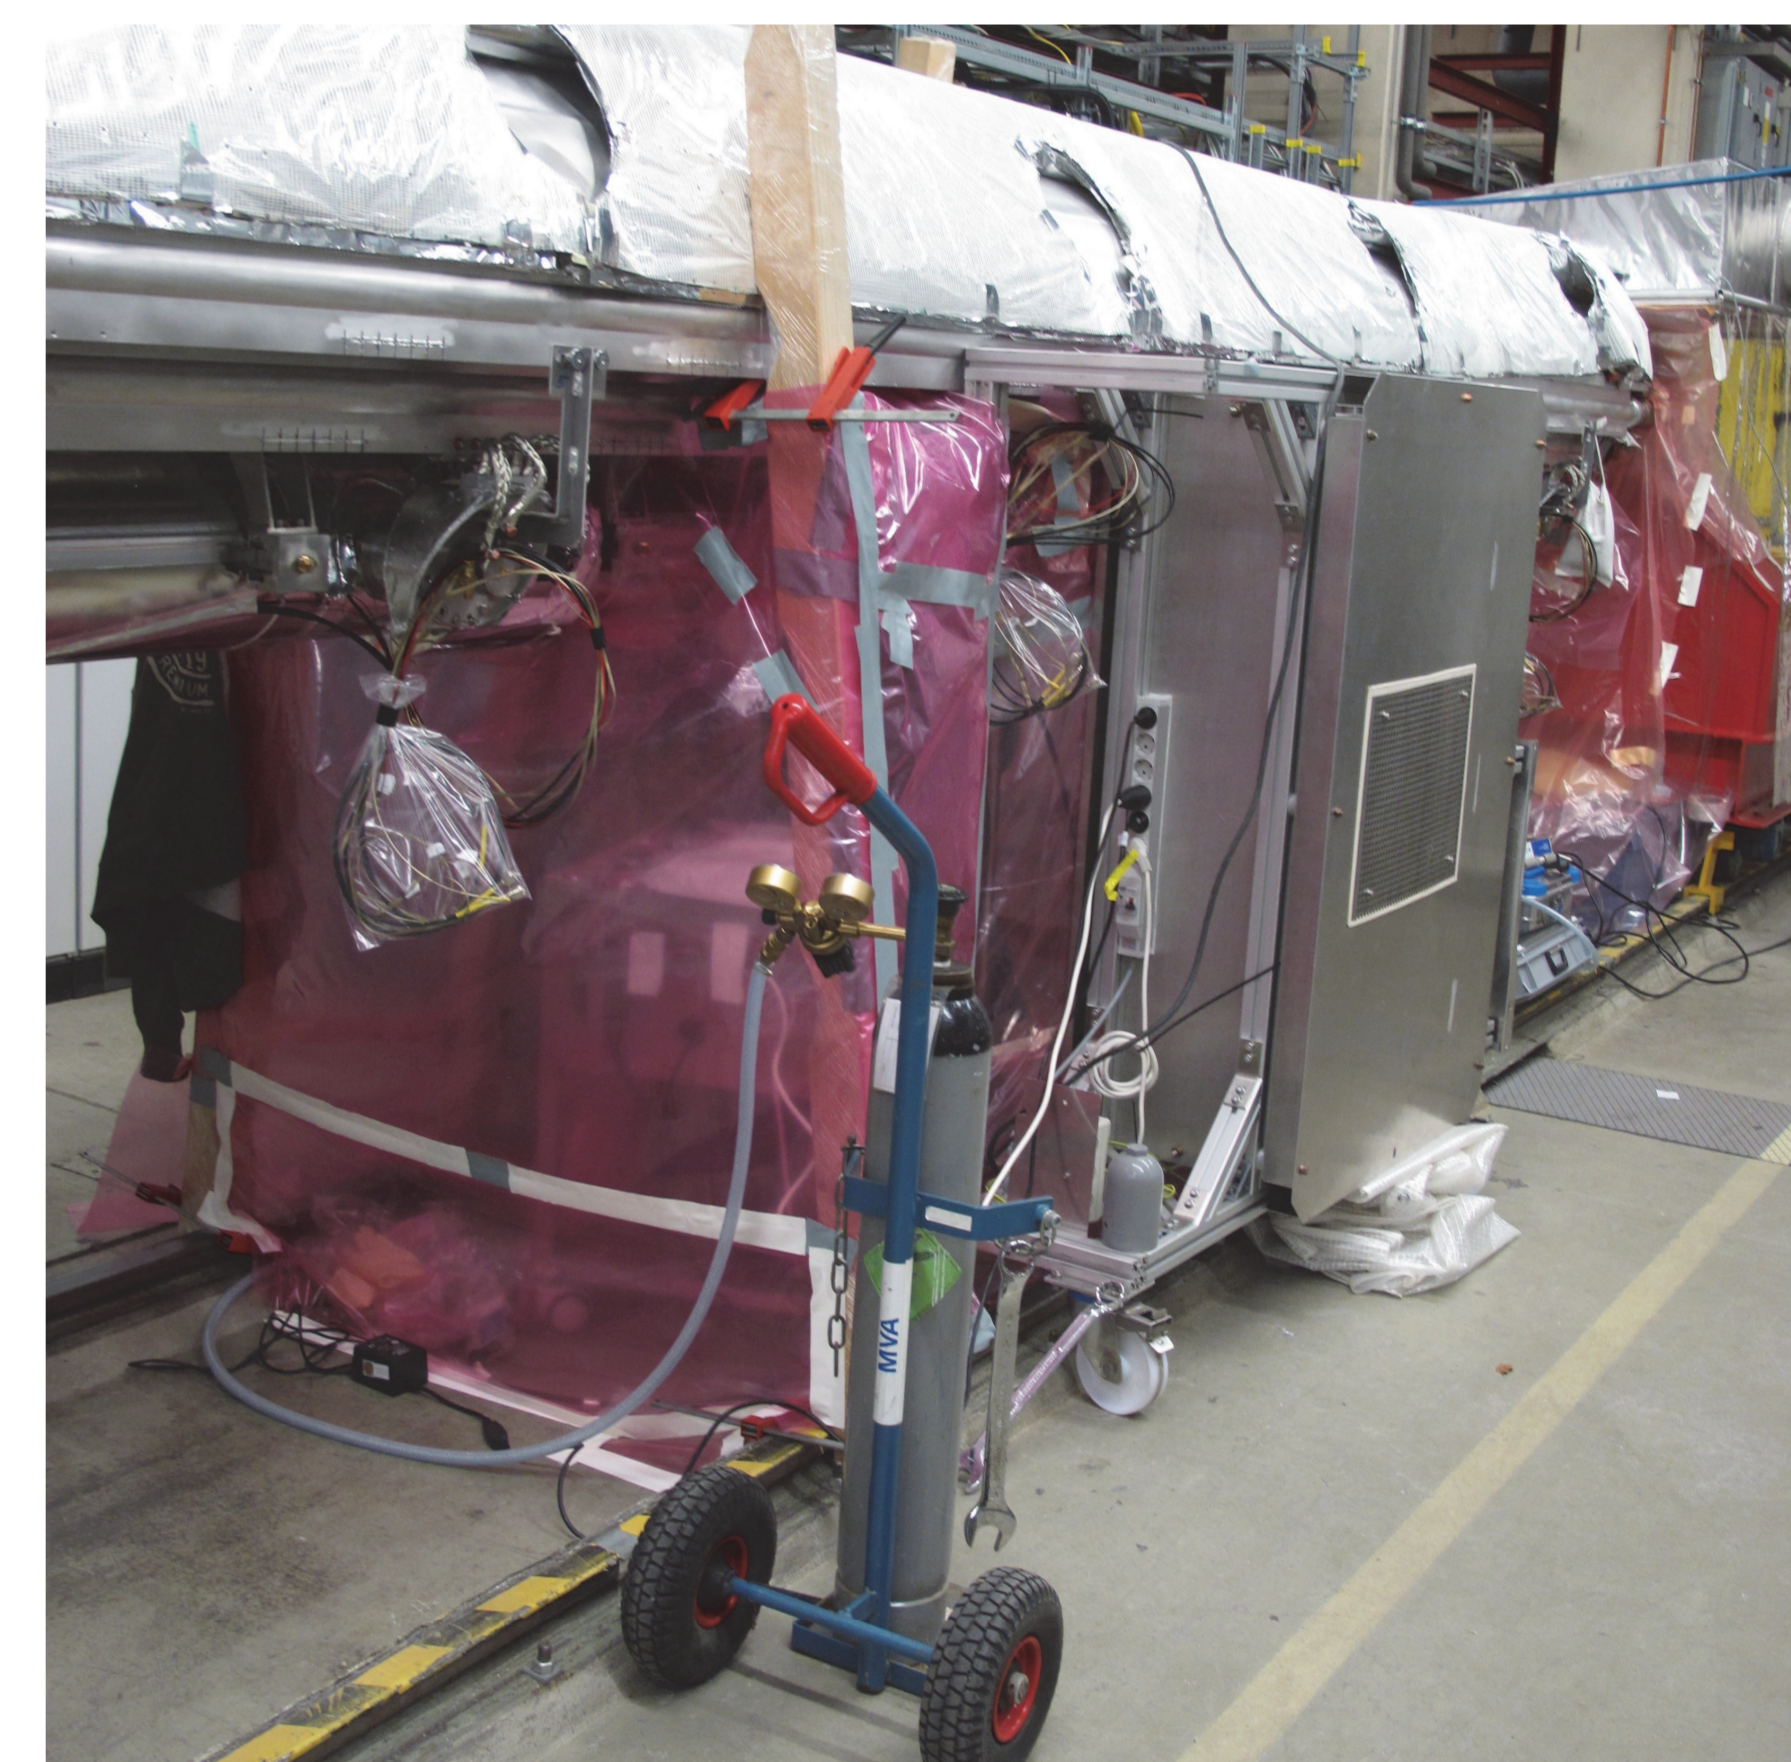
- beam line leaks repaired with local clean room below cantilever [7]

- XM22: leaky HOM antenna exchanged
- XM24: leaky pick up antenna exchanged
- XM91: leaky HOM antenna exchanged
