European XFEL: Accelerating Module Repair at DESY.

D.Kostin*, D.Reschke, S.Sievers, M.Wiencek, N.Krupka, S.Saegbarth, J.Schaffran, M.Schalwat, P.Schilling, M.Schmoekel, N.Steinhou-Kuehl, B.v.d.Horst, J.Eschke, K.Jensch, E.Vogel, H.Weise, DESY, Hamburg, Germany.

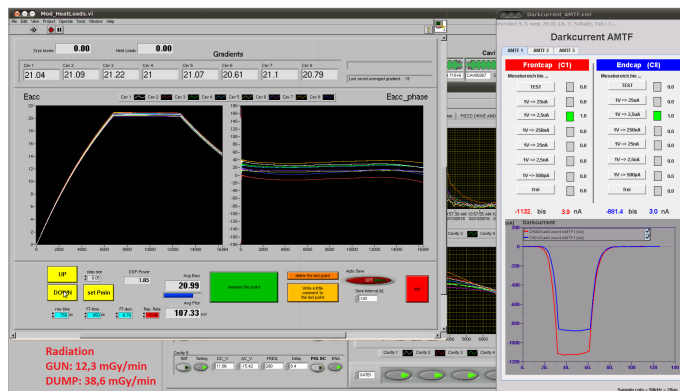
XM50 Limit: Dark Current

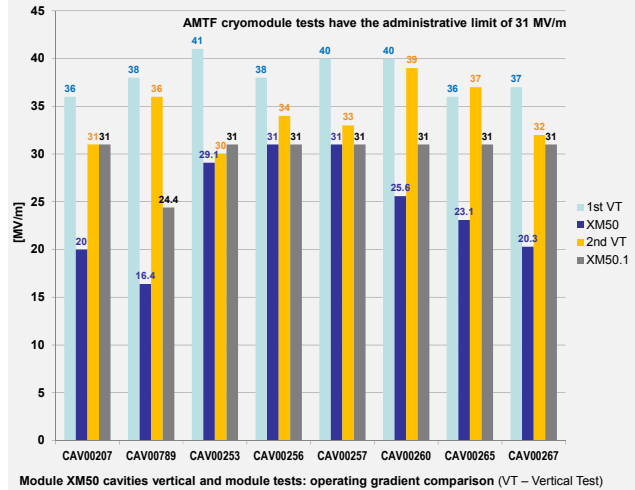
SRF Cavities Performance: Operating Gradient

Module XM50 cavities vertical and module tests: operating gradient comparison (VT – Vertical Test)

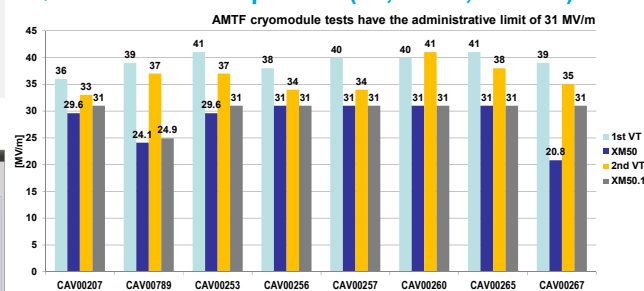
Quench Limit Comparison (VT, XM50, XM50.1)
