REPAIR TECHNIQUES OF SUPERCONDUCTING CAVITY FOR IMPROVEMENT CAVITY PERFORMANCE AT KEK-STF

Ken Watanabe*, Hitoshi Hayano, Eiji Kako, Shuichi Noguchi, Toshio Shishido, Yasuchika Yamamoto, KEK, Ibaraki, Japan; Yoshihisa Iwashita, Kyoto ICR, Uji, Kyoto, Japan

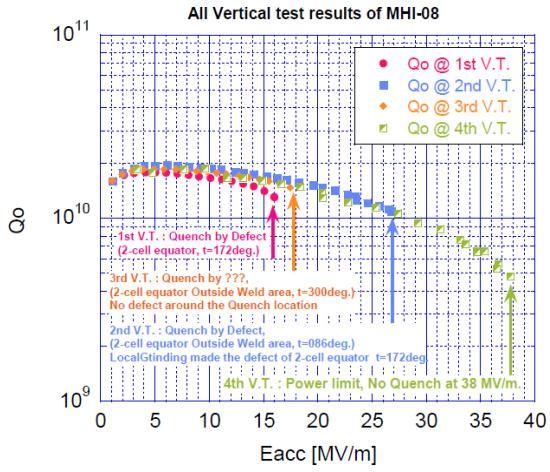
Four vertical tests with temperature mapping [6] of MHI-08 were carried out from June 2009 to Feb 2010. The result of four vertical tests shows in Fig. 4 and 5. The gradient was limited by quench at 16 MV/m in pi-mode at 1st test. The T-mapping detected the quench location at 2-cell equator (t=180deg). After vertical test, the defect was found near the quench location. Before final EP and 1st vertical test, there was no defect at quench location (see Fig. 6). The defect was made after final EP. The shape could not measure by Kyoto camera system due to the wall gradient of the defect has steep angle. The replica method used to measure the detailed shape. Fig. 7 is 3D profile of the defect measured by laser microscope. The defect was about 700 x 500 μ m, the depth was about 115 μ m.

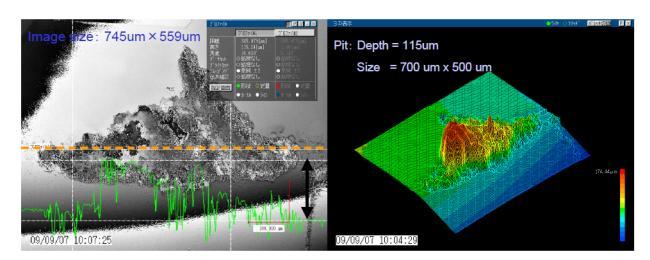
Figure 7: 3D profile of defect at 2-cell equator (172deg.).

The pit type defect (size: 0.7 mm x 0.5 mm, depth: about 115 um) was found by optical inspection at the quench location of MHI-08 cavity at 16 MV/m after 1st vertical test at June 2009. The location of defect was boundary between EBW seam and heat affected zone at 172 degree of 2-cell equator. If a cause of field limitation is really this pit type defect, then the cavity can repair to remove the defect by mechanical grinding method. This defect was removed completely by the special grinding machine. After mechanical grinding, electric polishing process and optical inspection were carried out to check the surface condition at grinding area. The 2nd vertical test of MHI-08 was carried out at October 2009. The accelerating gradient was improved from 16 MV/m to 27 MV/m. The gradient was limited by quench due to defect at other location. The bump type defect found after 2nd vertical test at outside weld area from 40 mm away from joint point of 2-cell equator (the angle is 86 degree). The cavity performance was reached at 38 MV/m in 4th vertical test. The recent result of the cavity repair of MHI-08 by a series of techniques of Kyoto-camera, replica and grinding will be reported in this paper.

machine with diamond sheets was used to remove the defect. The process of local grinding is shown in Fig. 8. The location of defect is boundary between EBW seam and heat affected zone (red circle (0) in Fig. 8). To grind the defect in a short time, the diamond sheet #400 was used until removed the defect. The diamond sheet #1000 was used for polishing to make a smooth surface and edges. The field flatness was kept after local grinding and EP. The progress work before 2nd test is summarized following as,

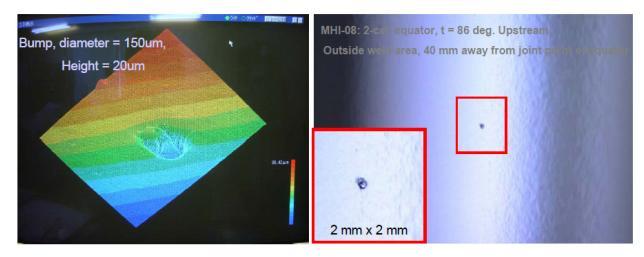
Figure 9: 3D profile of defect at outside weld area of 2-cell equator (86deg.).

2^{nd} test was done at Oct 2009. The gradient was improvement from 16 MV/m to 27 MV/m. The location of local grinding was no heating in vertical test. The reason of limitation was quench by other defect at outside weld area form 40 mm away from joint point of 2-cell equator (86deg.). This defect was bump, the diameter is 150 µm and height is about 20 µm. This defect also had steep wall gradient around edge. Our grinding tool can't apply this location due to the mechanical structure of grinding machine. Fortunately, the type of this defect is bump. It is possible to remove the defect by EP process.

07 Accelerator Technology T07 Superconducting RF reached at 38 MV/m in pi-mode. The reason of limitation was power limit by field emission. The optical inspection made after 4th test. The defect at outside weld area of 2-cell equator (86deg.) was removed by EP (the material removed 20 + 20 μ m after 2nd test). The shape of defect was changed from bump to flat plane. Total removed material is 235 um. The gradient of all cells was reached > 40 MV/m in passband measurement.
