# **Study of the Lead Evaporation from the Oven of the GTS-LHC Ion Source**

## **The GTS-LHC Micro Oven**

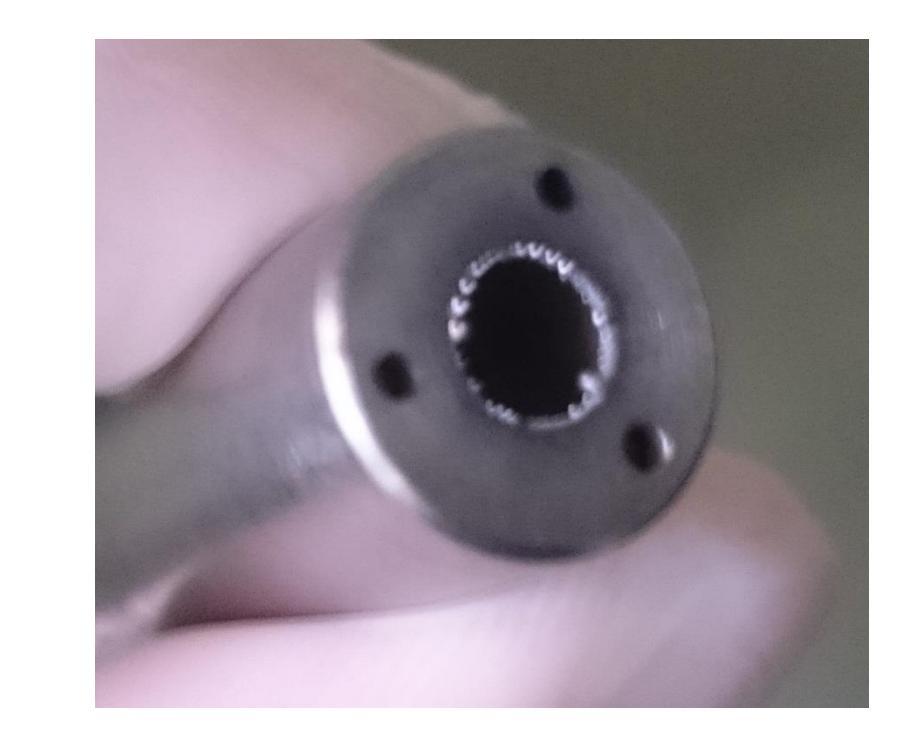
- Oxygen is used as a buffer gas in the GTS-LHC ion source.
- Lead oxide formations at the oven tip can be regularly observed at the Linac3 ion source. They are believed to be a possible failure mechanism of the oven.

Measurements at the test stand in vacuum or with a nitrogen atmosphere showed no oxide formation.

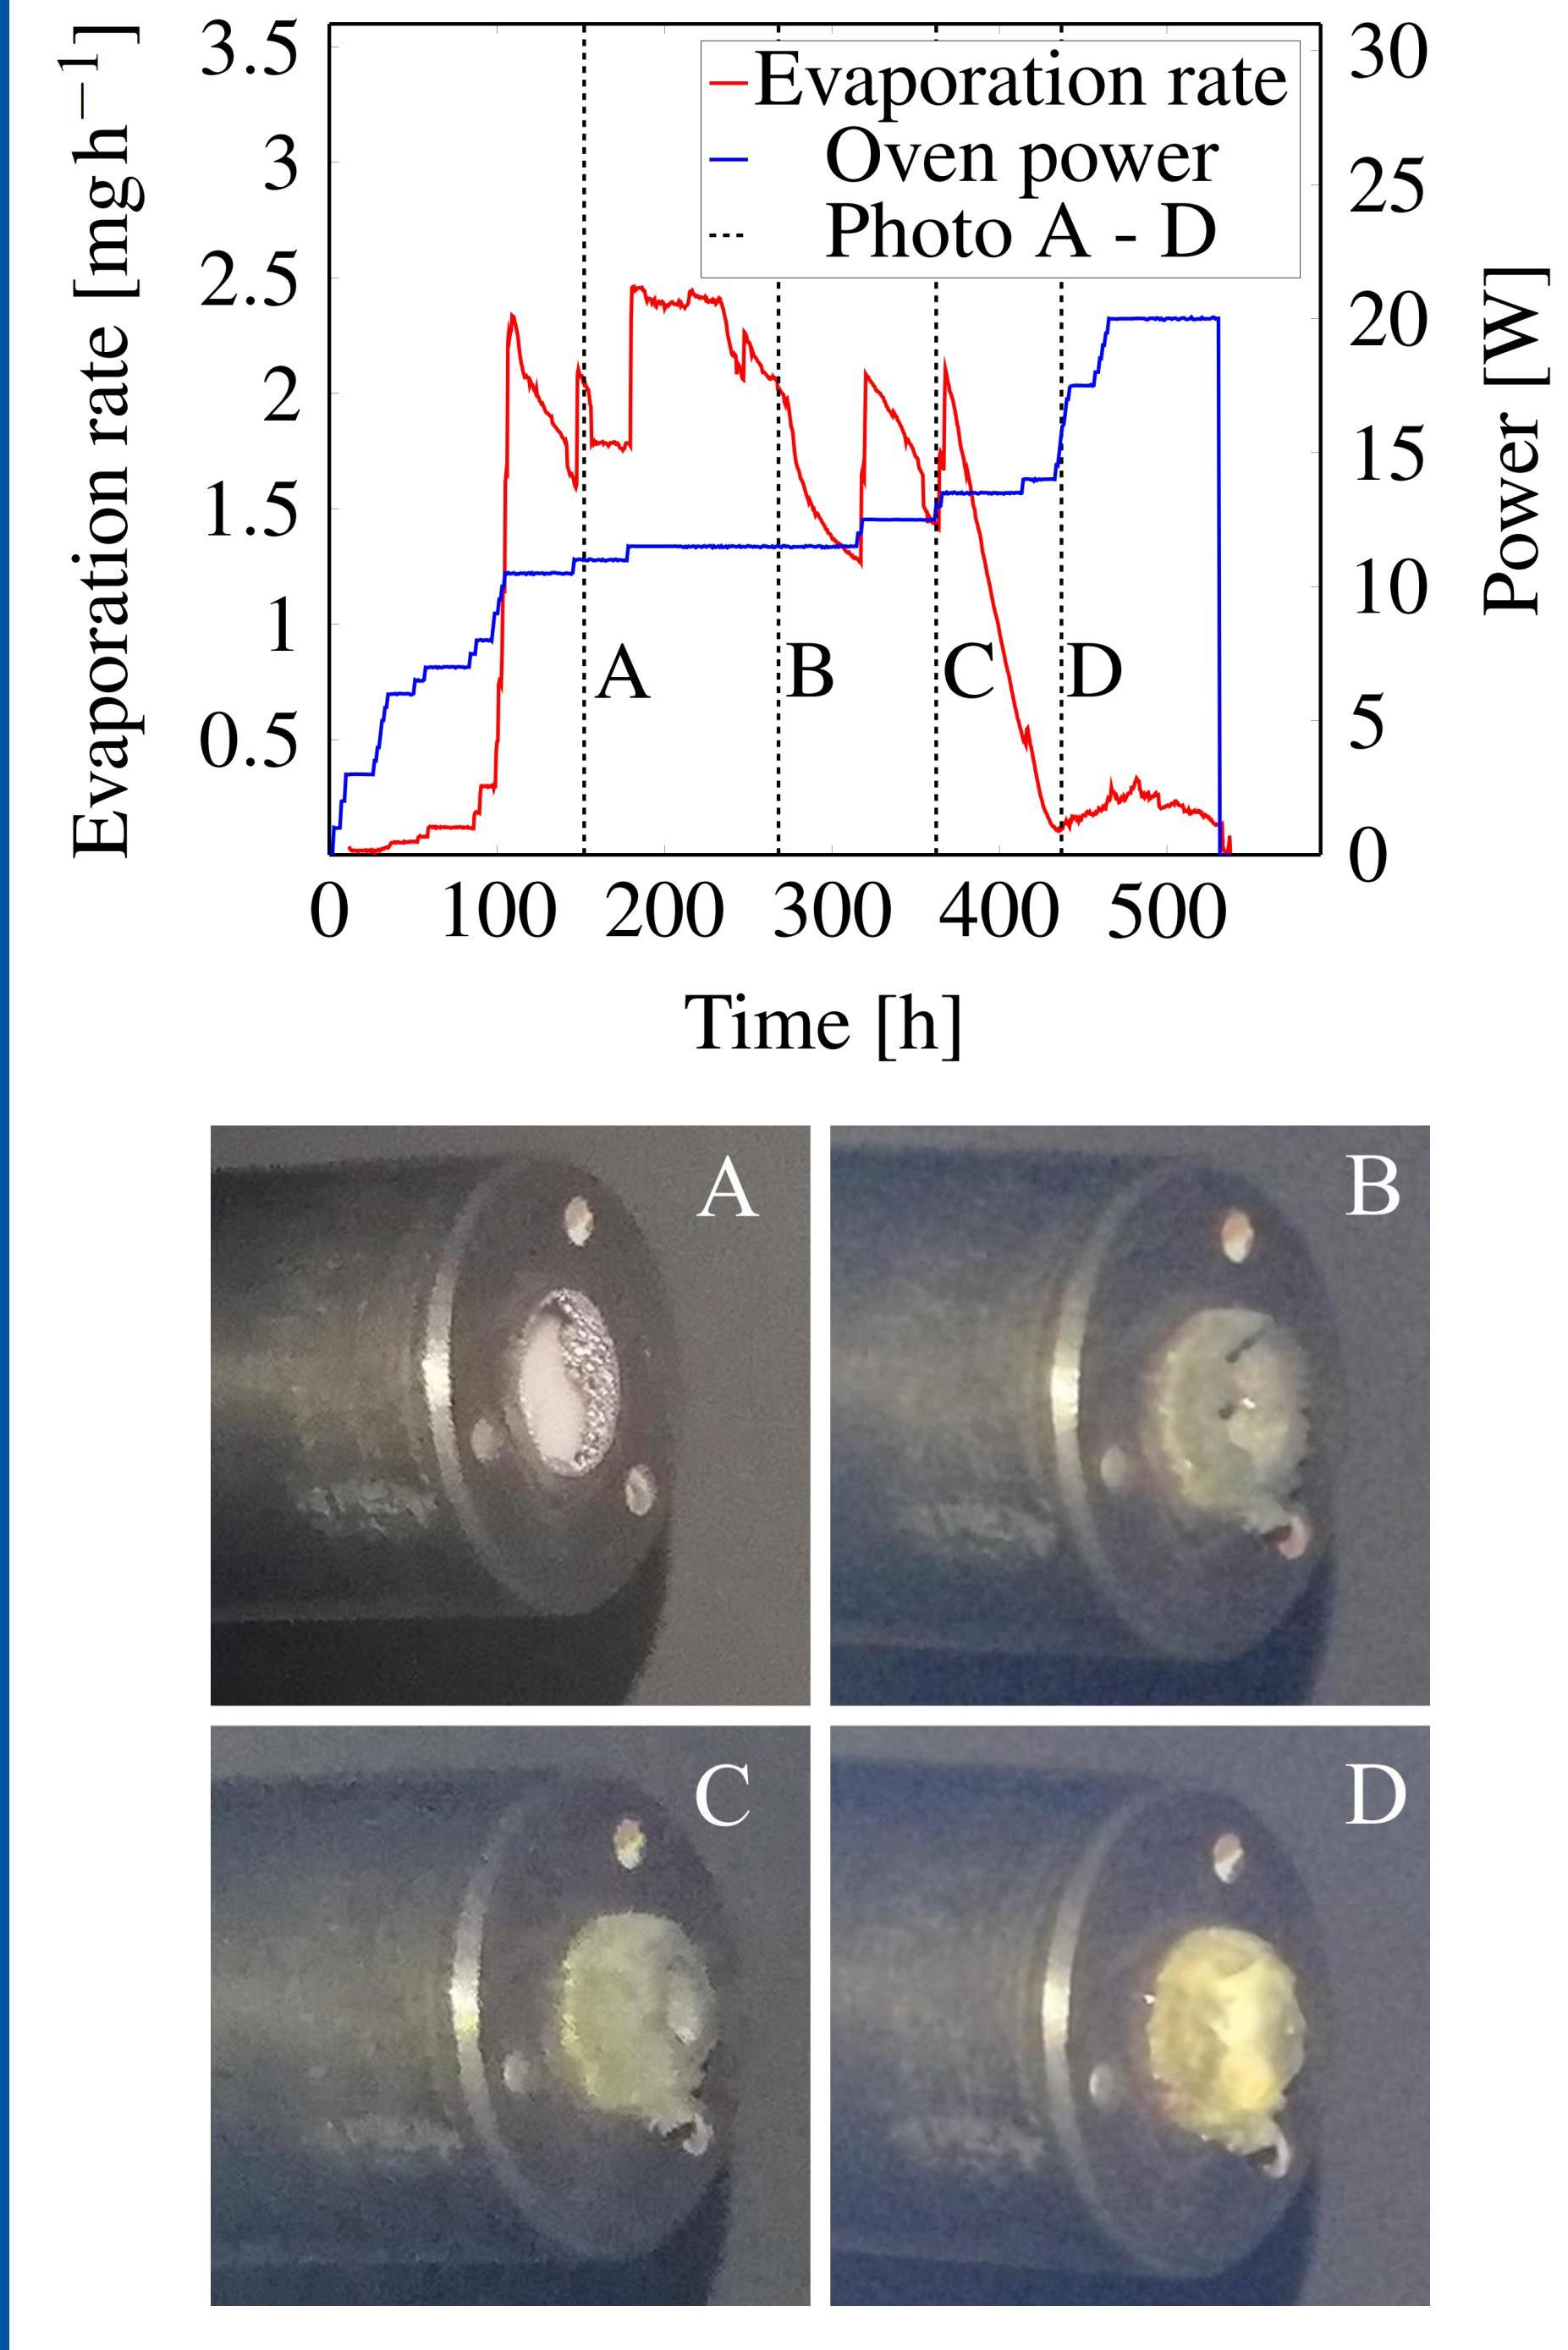
Injecting oxygen at the OTS could recreate the formation of oxide blockages.
