FRONT END PHOTON SHUTTER WATER LEAK TO VACUUM AT THE CANADIAN LIGHT SOURCE

G. Henneberg*, G. Barkway, M. J. P. Adam, Canadian Light Source Inc., Saskatoon, Canada

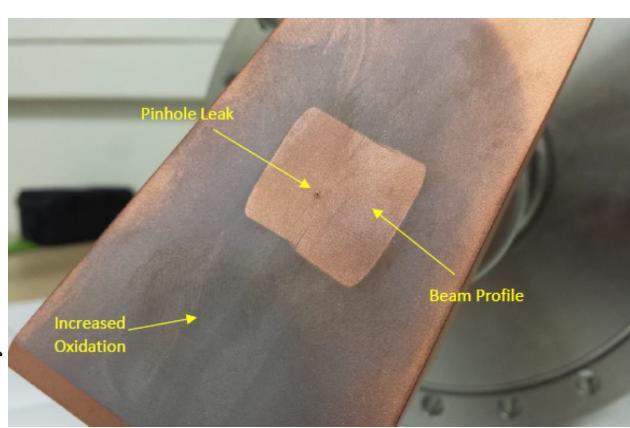
A collaborative decision was made to wait to find the exact location of the leak. The mechanical technicians first activated a scroll pump in an attempt to pump down the affected section. Water was discharged from the exhaust of the scroll pump, which indicated the water leak. After determining that the leak had originated in the HXMA FE, the technicians identified which components may have failed. By the afternoon, they had discovered a small pinhole leak on the absorber head of the first HXMA photon shutter (Fig. 1).

Figure 1: Illustration of the pinhole leak discovered on HXMA PSH1. Leak location is aligned precisely with water jet location of the tube in tube cooled absorber.

through the head of the absorber. The leak developed at (or very near) the centre of the absorber's face (Fig. 1). There are six other photon shutters that employ this exact same design currently in use at CLS. There are also 12 photon shutters that are derivatives of this design. Their cooling system and operational parameters are almost identical. Therefore, it is necessary to identify why failure occurred, how it can be prevented, and/or if other components are at risk to fail.

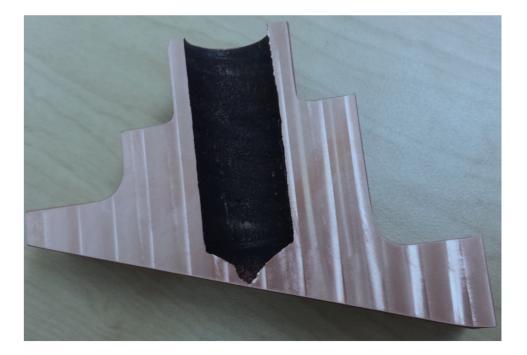
The PSH1 was cut apart to reveal its interior structure (Fig. 3). After visual inspection and discussions, cause was

Figure 3: Section cut of failed PSH1, used to investigate extent of damage and location of erosion.

suspected to be degradation of the copper walls due to corrosion, erosion, or impingement damage. Operating conditions of HXMA PSH1 (at >7.12 m/s) exceeded CLS's maximum flow velocity standard of 2.5 m/s [1]. The typical maximum

The large amount of pitting was most likely caused by erosion-corrosion. The velocity of the water (7.2 m/s) was nearly three times the maximum recommended speed [1]. Excessive speed creates high amounts of turbulence that strips away the walls of the pipe. This was evidenced by the extensive pitting inside the inner tube, and smooth surface of the outer tube (where the velocity was reduced to 0.82 m/s). Inside the base cavity, where the supply flow makes contact with the inner absorber cavity, the erosion had a spiral profile. The disfigured surface at the base of the cavity appeared to be eaten away by a high velocity stream or vortex. Large amounts of localized turbulence can attack the pipe wall and absorber, carrying away material leaving a pitted surface [4].

To prevent further degradation in similar photon shutters, flow rate should be evaluated to determine if a lower velocity is adequate (reducing the likelihood of similar HXMA PSH1 failures). Continuing to operate under current conditions may lead to further absorber failures, water leaks, and vacuum leaks. Due to damage they may have sustained operating under similar operating conditions, PSH of this design currently in service should be either examined or replaced at the CLS's earliest convenience. PSHs installed during the Phase II expansion are similar in design and operating conditions; flow velocity settings should be reviewed, but these absorbers may not need replacement.

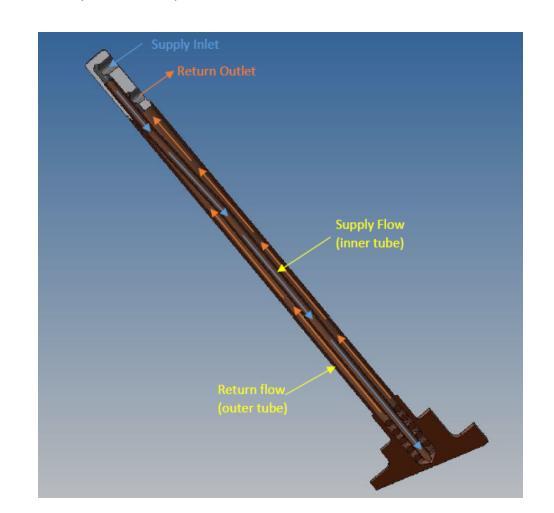
The HXMA PSH1 is based off of the APS design (Fig. 4). Jeffrey T. Collins, an APS employee, was contacted to determine if this style of photon shutter had a history of leaking. He was the lead author on a paper detailing the heat transfer benefits of using a coil insert for high heat load components [2]. APS has not dealt with such an issue before, but Jeffrey provided CLS with a report on a RF window that had suffered a pinhole water leak into vacuum [3]. The report explains that the RF window's cooling water caused large erosion-corrosion on the copper walls due to excessive flow rates (>5.3 m/s). The inner surface above the coil insert

Figure 4: Illustration of the tube-in-tube configuration of PSH1. Cooling water enters from the inner tube and exits the outer tube passage.

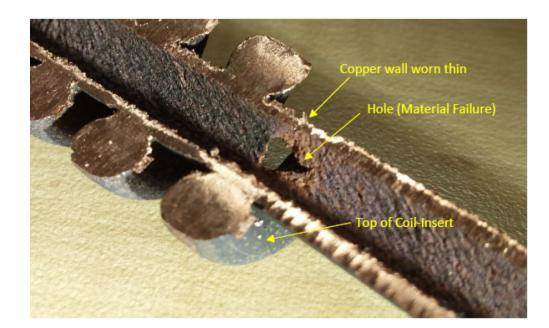
At the very top of the coil, a hole on the wall of the inner tube formed, allowing water to escape into the return flow without travelling to the base cavity. The hole is roughly 4 mm long and 3 mm wide. The holes sits directly beneath the end of the coil (Fig. 5). There is significant material degradation around the hole and the pipe wall is very thin.

Figure 5: Section cut of eroded inner copper tube.

The mechanism causing failure of the sidewall (Fig. 5) is not well understood. Its effect on the system is difficult to determine for the following reasons:

It is clear, however, that the location that the hole formed was unique. The hole sat right at the end of the coil, near a change in diameter on the outside of the tube. The pattern of erosion/corrosion on the inside surface changed abruptly on either side of the hole.

The hole may have formed for a multitude of reasons. There may have been localized turbulence as the fluid exited the spiral, increasing the rate of erosion-corrosion. Faulty brazing/soldering work between the coil insert and the tube may have weakened the tube wall. The hole may have formed along the edge where the tube diameter changed creating a larger stress concentration.
